# **SOUTH FORK DOGFISH CREEK RESTORATION MASTER PLAN**

July 2010

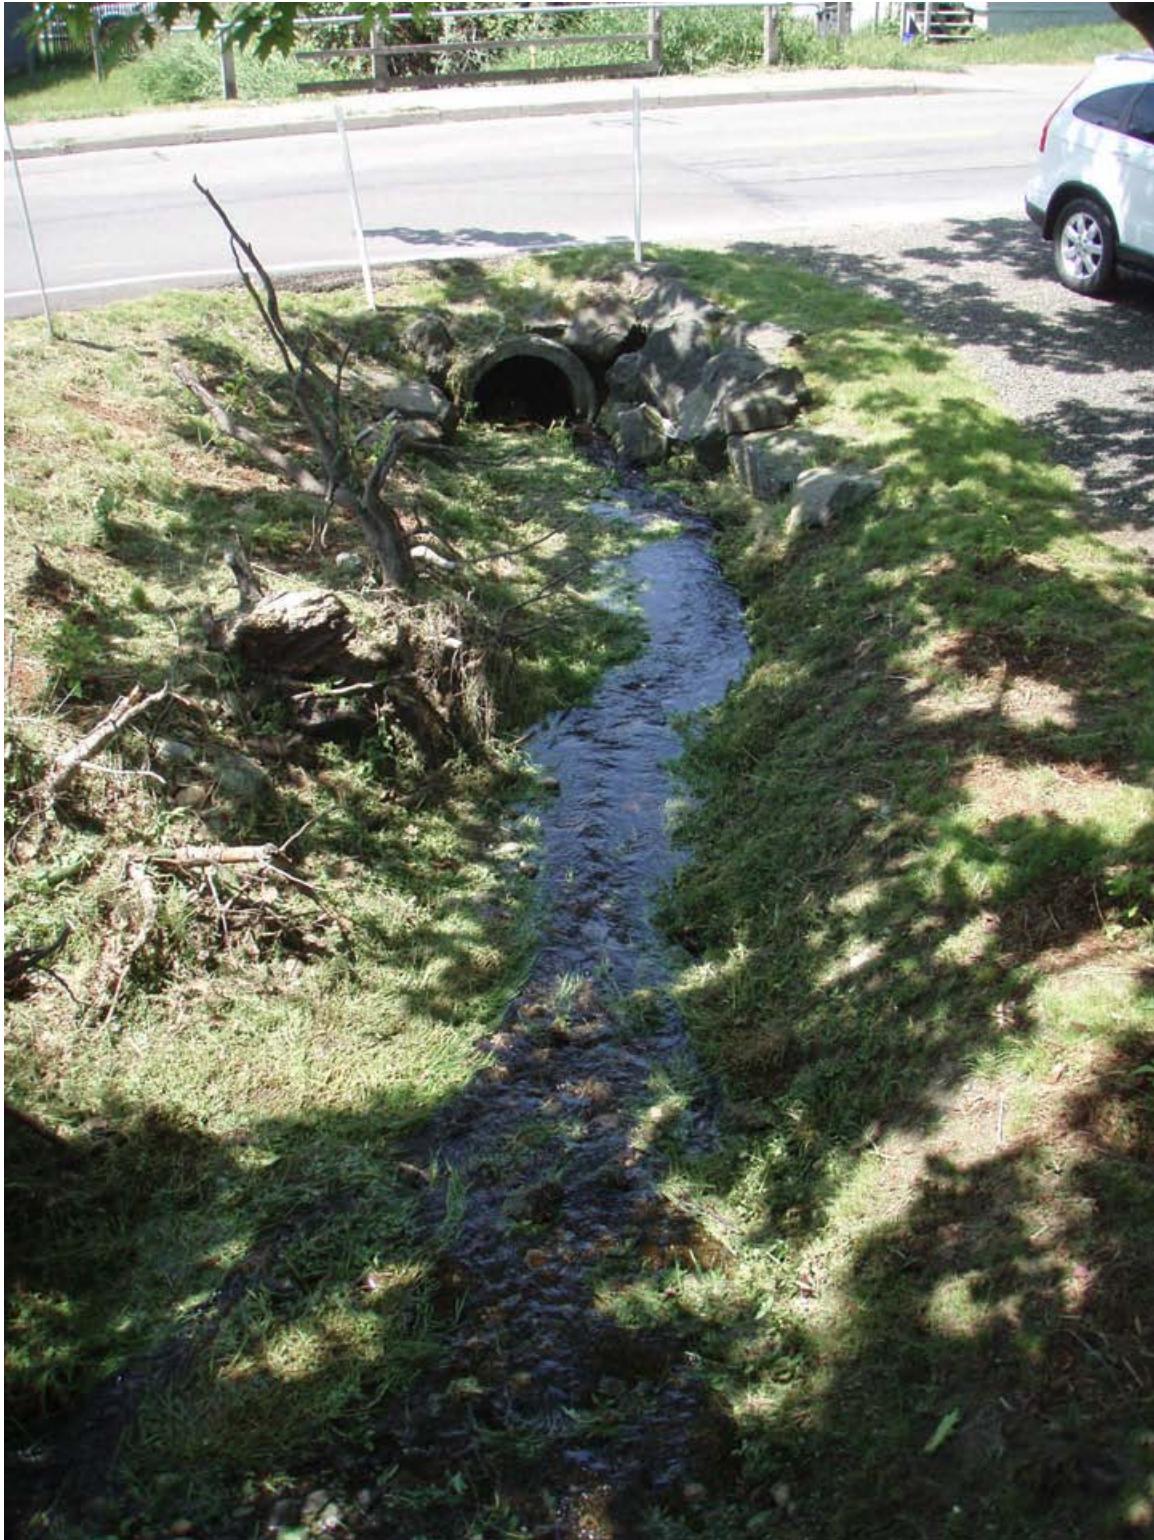
**Photo 1. Undersized culvert at 8th Avenue NE, facing downstream**

- The one culvert not replaced by WSDOT conveys South Fork Dogfish Creek beneath 8th Avenue NE, immediately east of the Public Works buildings. This culvert is a 30-inch round precast concrete pipe and is considered undersized (Appendix A, Photo 1). Two culverts upstream, at Iverson Road NE and SR 305, which were replaced by WSDOT, have spans of 10 feet and 13 feet, respectively. These culverts will convey water downstream more efficiently (Appendix A, Photos 2 and 3).

Only one culvert downstream of Wilderness Park was not replaced by WSDOT as part of the SR 305 improvements: culvert #10 at 8th Avenue NE. During this study, the culvert at 8th Avenue NE was identified as undersized and appears to be at least a partial barrier to both juveniles and adult

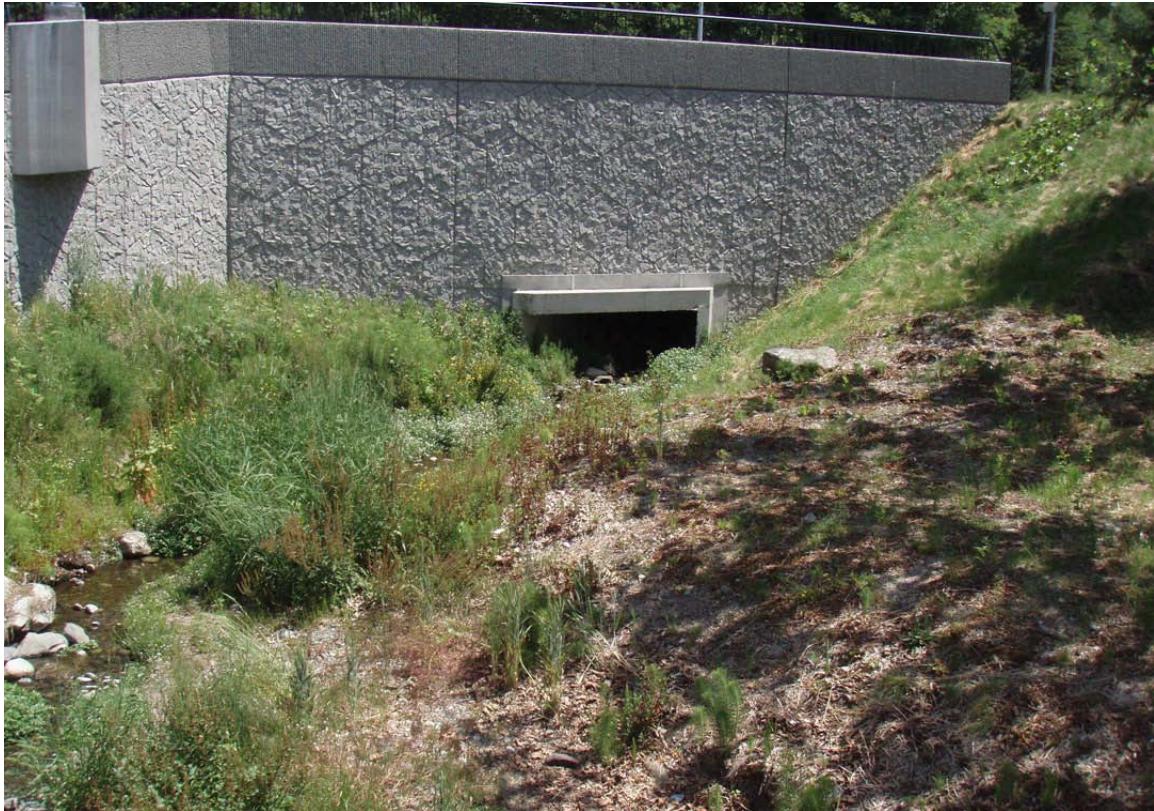
**Photo 2. Culvert beneath SR 305 and Iverson Road NE facing upstream**

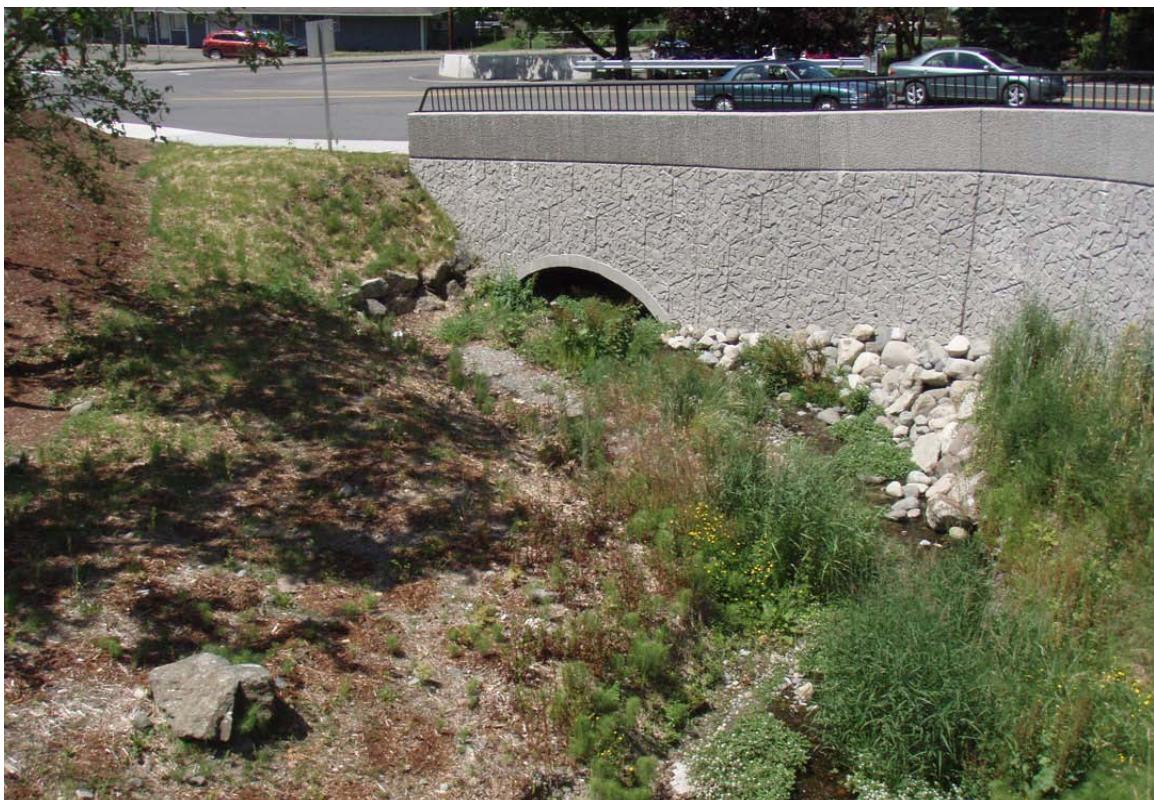
**Photo 3. Culvert beneath SR 305 and Iverson Road NE facing downstream**

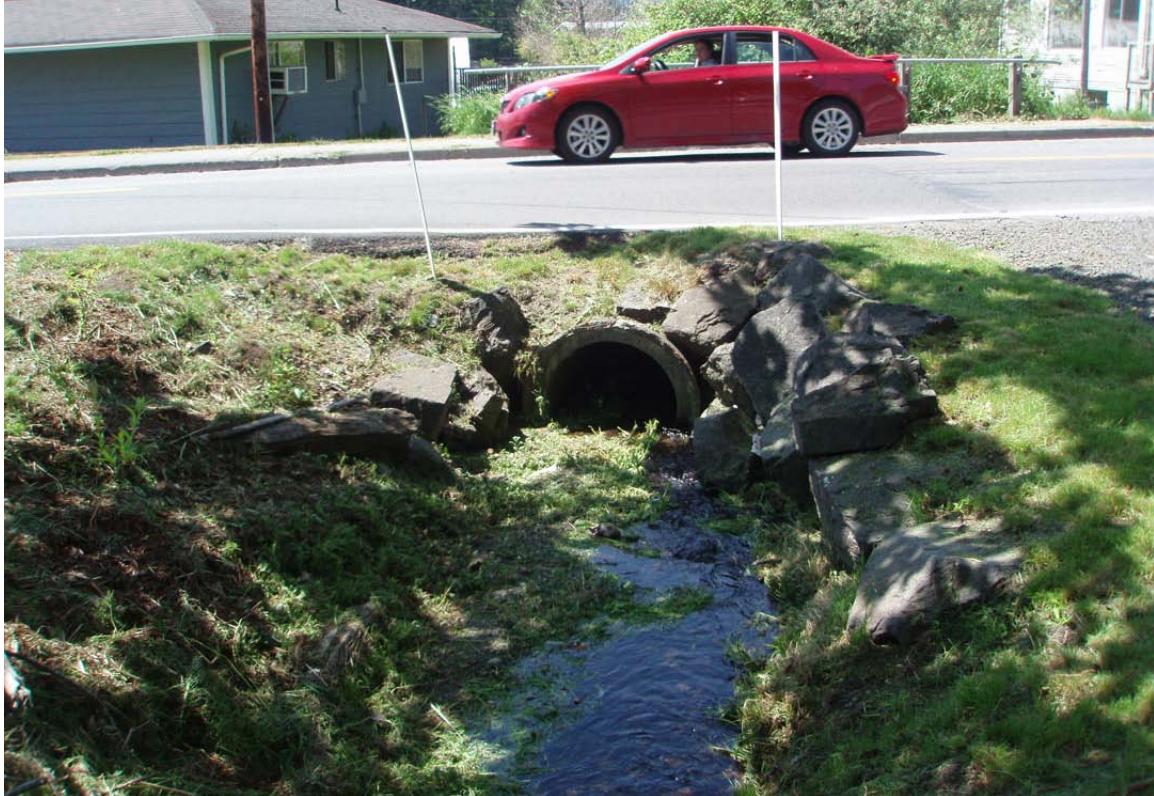
**Photo 16.** Riparian zone surrounding undersized culvert at 8th Avenue NE, facing downstream

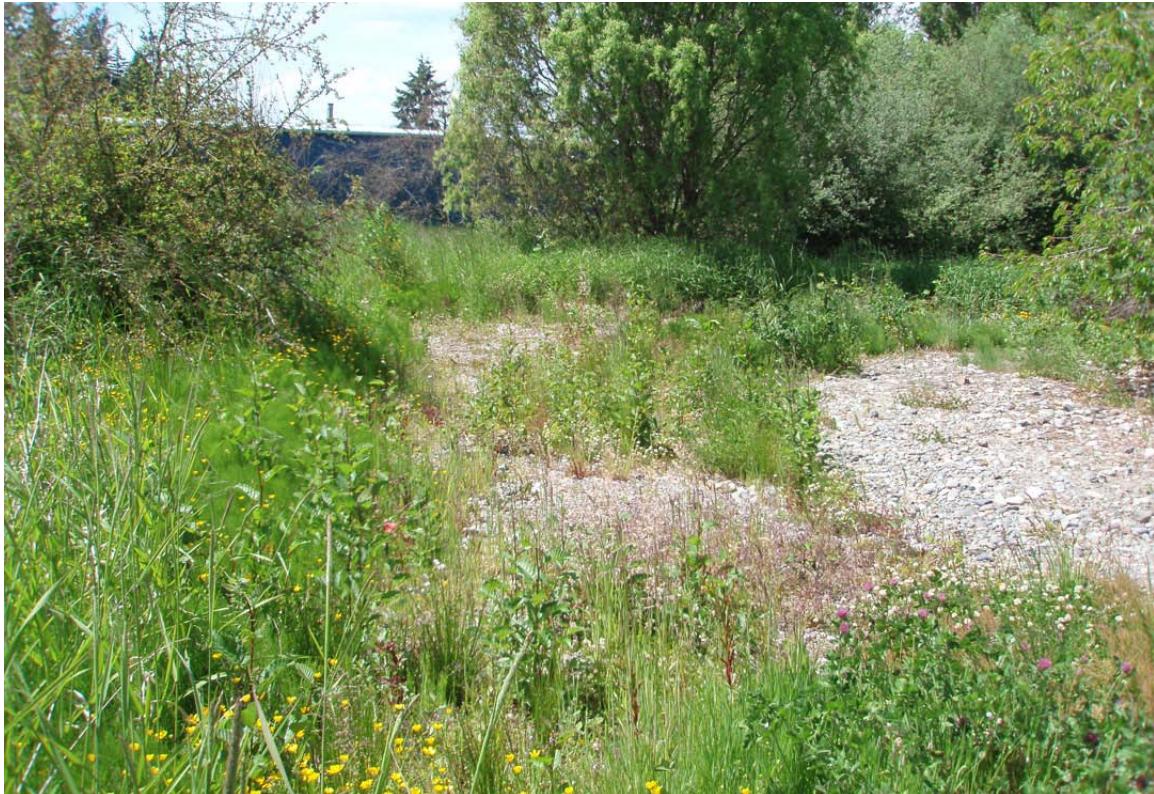
**Photo 17.** Stream channel loses definition, residential property adjacent to Public Works office on 8th Avenue NE

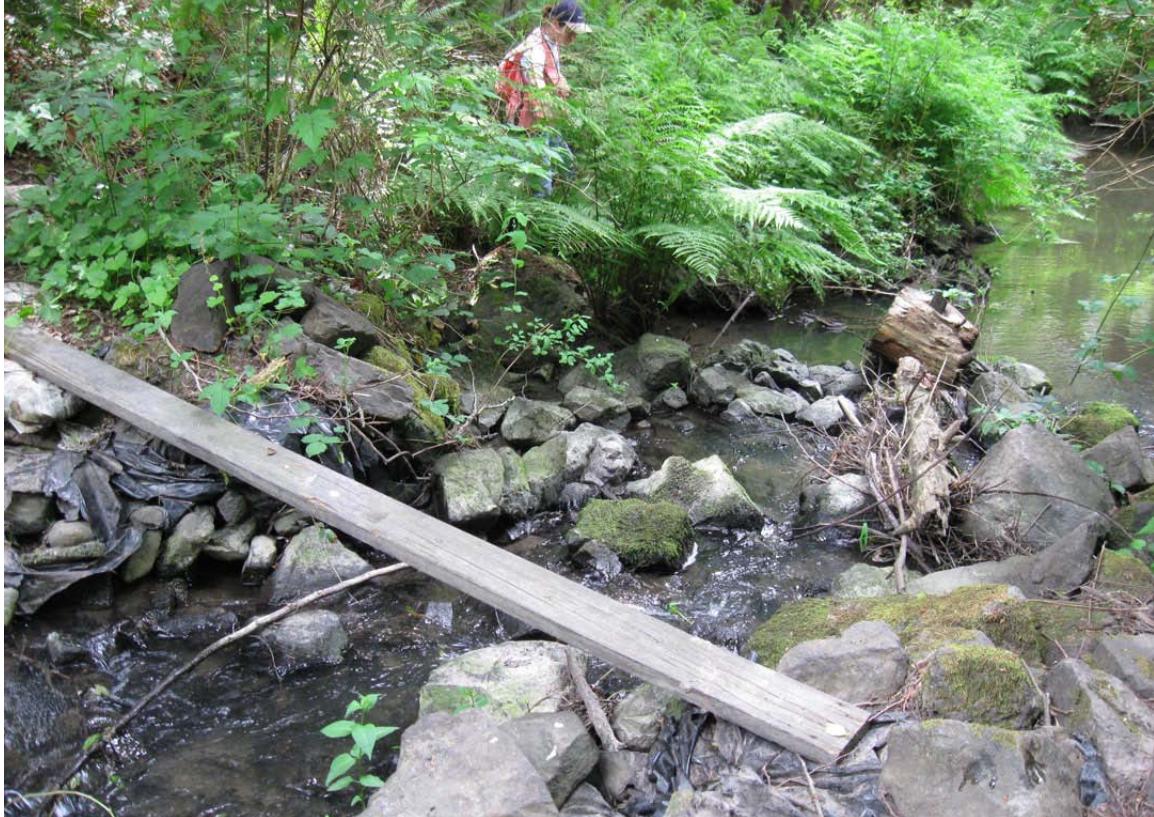
**Photo 24.** Rock weir and stream channel

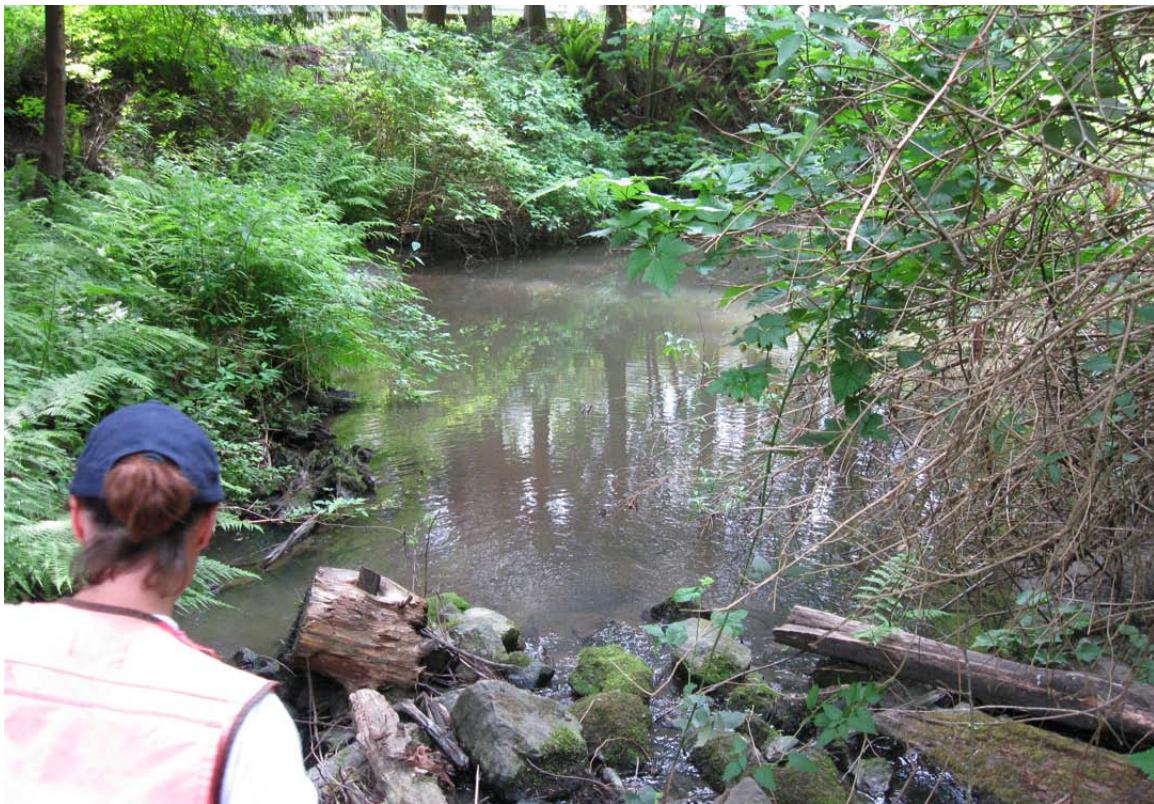
**Photo 25.** Pool behind upstream rock weir

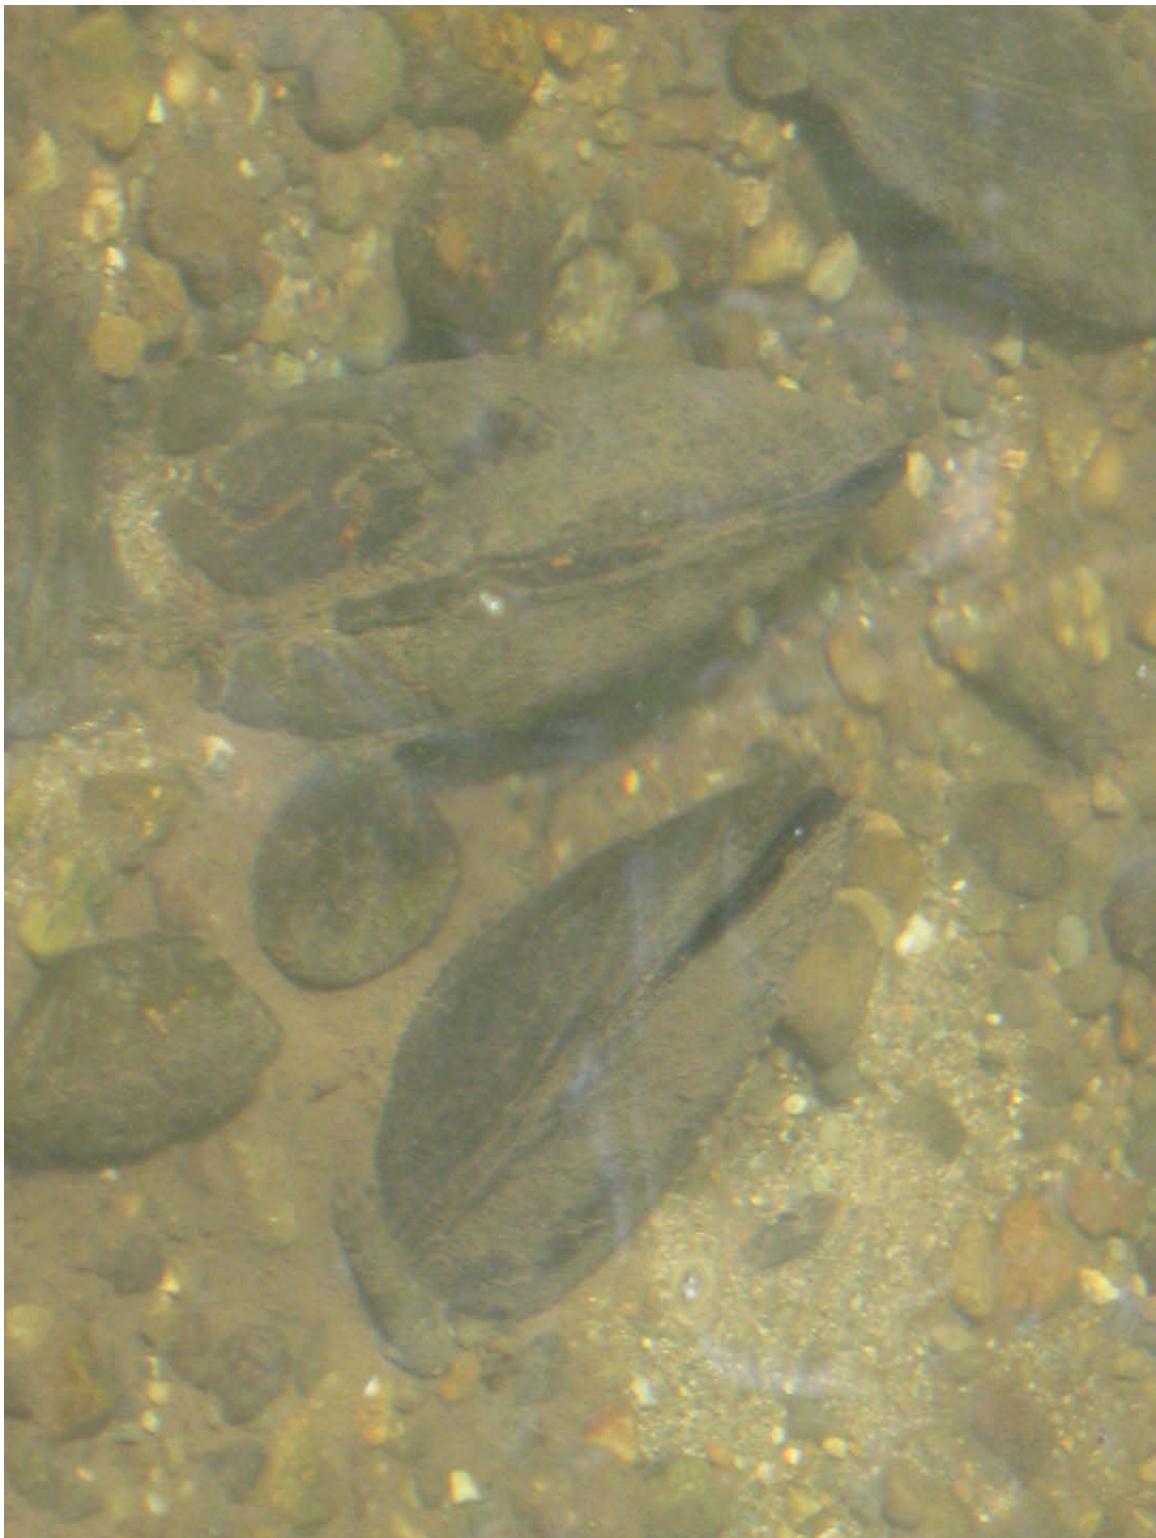
**Photo 26. Western pearlshell mussels in stream bed, behind North Kitsap Medical Center**

The western pearlshell (*Margaritifera falcata*), a freshwater mussel found in Pacific drainages from California to British Columbia and southern Alaska, is also prevalent in the lower subbasin. It prefers cold, clean creeks and rivers that support salmonid populations, preferring sand, gravel, and cobble substrates in stable areas of the stream bed. It does not tolerate sedimentation (Nedeau et al. 2009). The western pearlshell depends on anadromous salmonids, including native cutthroat trout, Chinook salmon, coho salmon, sockeye salmon, rainbow trout, and nonnative brook and brown trout, to complete its lifecycle; the gills of these fish provide a host for the mussel's larval stage. It does not reach sexual maturity for 9 to 12 years and has an average lifespan of 60 to 70 years. It is capable of living over 100 years, making it one of the longest-lived animal species on Earth (Nedeau et al. 2009). The western pearlshell is considered an indicator of stream health, water quality, and suitability for salmonids. No surveys of extent or population size of western pearlshells in South Fork Dogfish Creek have been conducted; however, locations and numbers of western pearlshells were noted during the stream surveys conducted as part of the existing conditions documentation, as described in section 3.4.

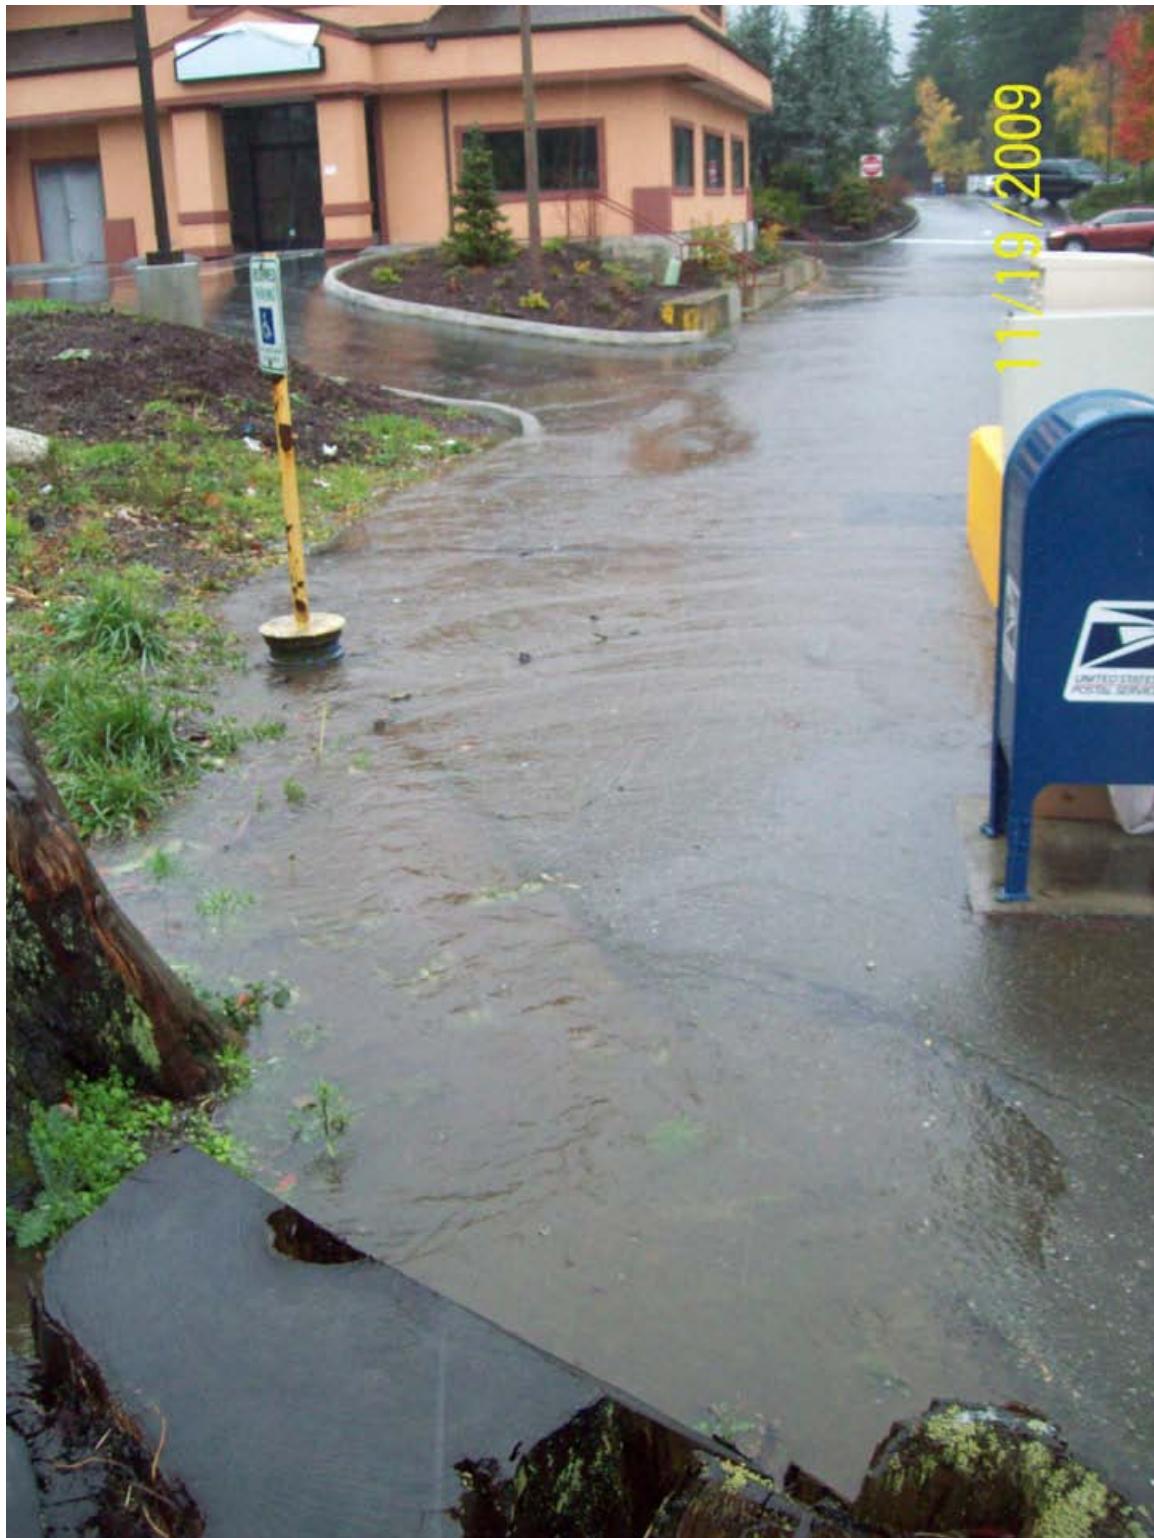
**Photo 32. Flooding in Poulsbo Village, November 19, 2009 (photo from City of Poulsbo)**

- Public Works staff reported that flooding at Poulsbo Village generally occurs when the storm drains/catch basins are not cleaned out prior to a significant storm event. Flooding of Poulsbo Village is not caused by South Fork Dogfish Creek over-topping its banks. Opinion of staff was that maintenance of open storm drains/catch basins by Poulsbo Village owners/occupants would alleviate flooding of the parking lots at Poulsbo Village.
- WSDOT recently completed improvements to SR 305 through the City of Poulsbo. As part of these improvements WSDOT replaced nine culverts within the lower reaches of South Fork Dogfish Creek (described in section 3.4.1 below as Reaches 2, 3 and 4). Some of the original culverts were undersized and created constrictions during storm events. Since these culverts

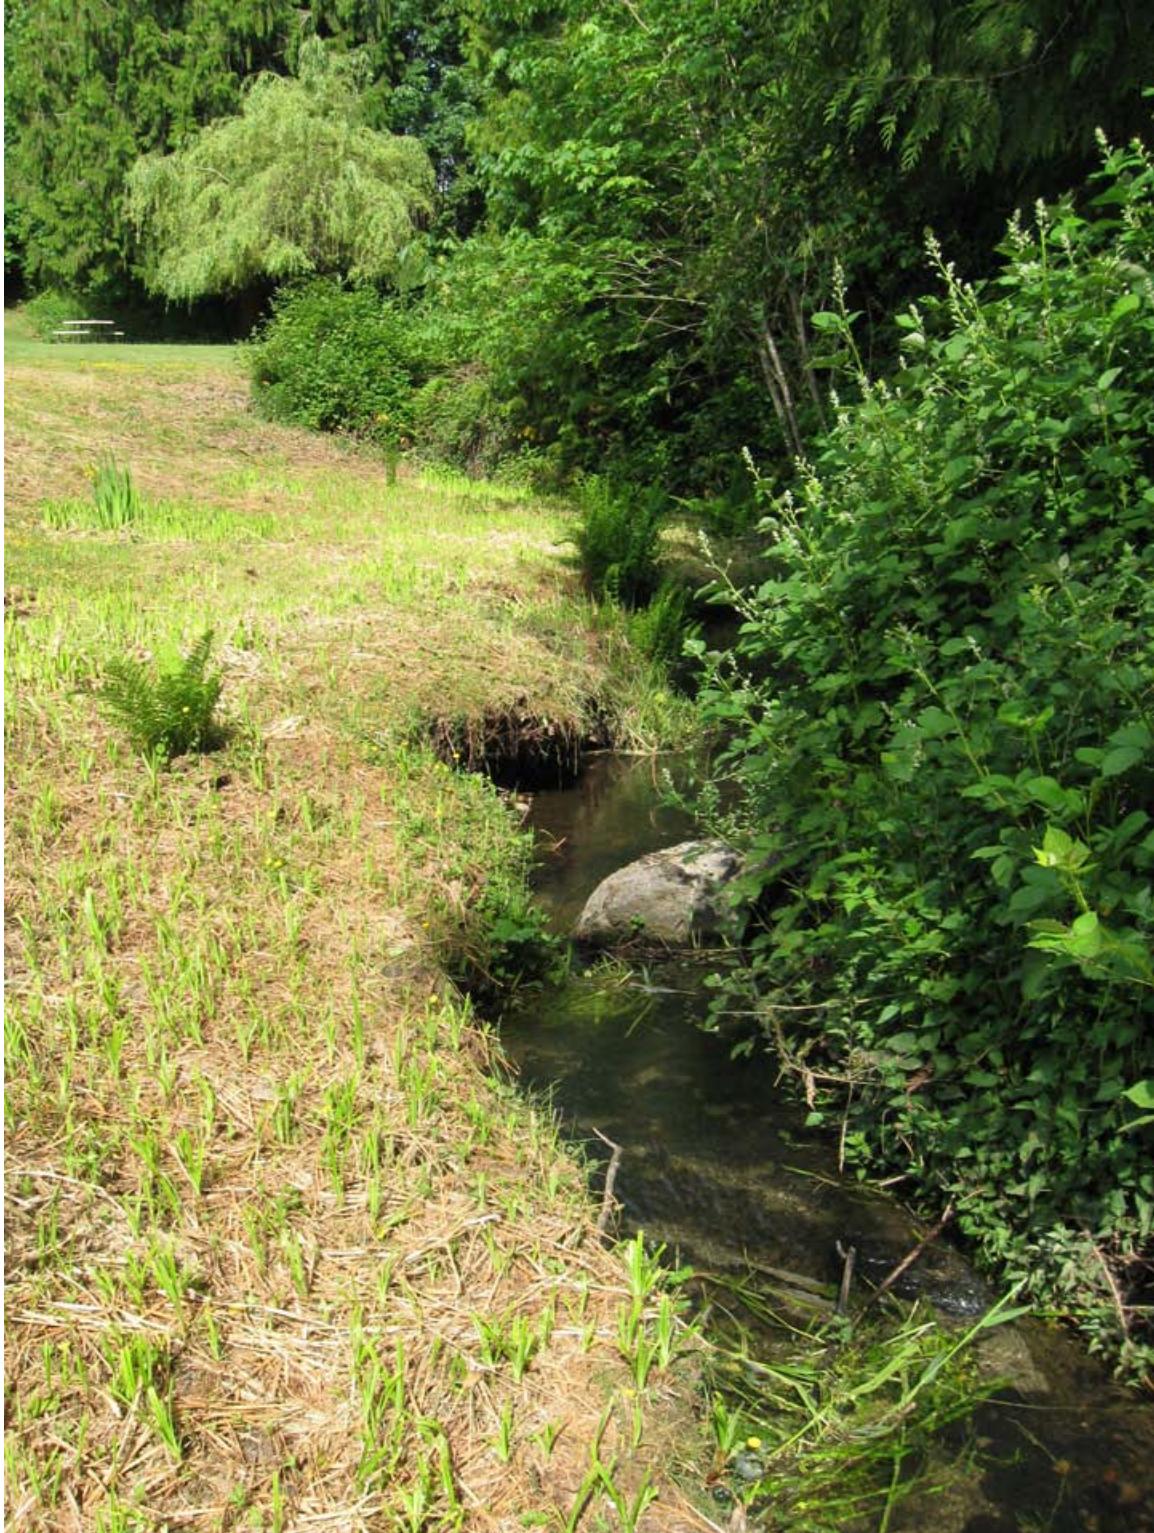
**Photo 33. Cleared bank of stream behind Bondwood Apartments, facing downstream**
