BGE13_02500
August 15, 2013

TECHNICAL MEMORANDUM

RE: **Plat of Blue Heron, Response to Critical Area Conditions and Assessments**

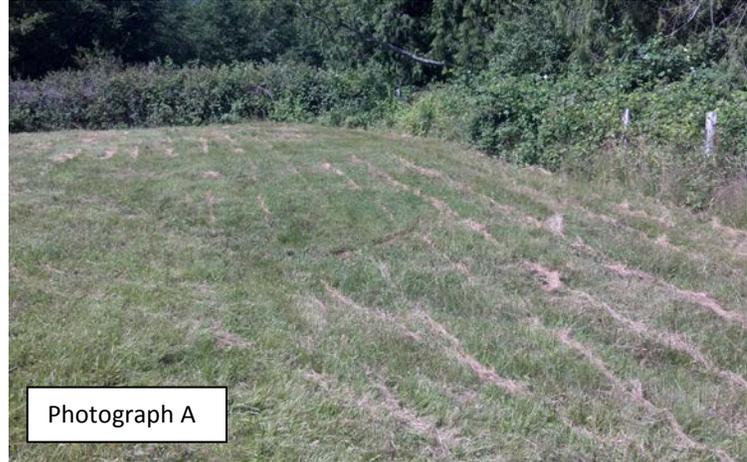
Photograph A

No channel or demarcation of seasonal surface water flow was observed in the area at the time of the field investigation; area shown in Photograph A. Topography does however suggest a linear path where the typed stream was documented as observed. This area does reflect a slight indication of topographical relief with an apparent emphasis, as the vegetation is slightly darker in hue. Species composition is consistent in the landscape, although the area had recently been mowed.

Classification for defining a stream as set forth in WAC 222-16-031 of the DNR Water Typing System, requires that a defined channel be present. The project site does not contain a channel and therefore, does not contain a Type 5 stream. Investigations up gradient, confirmed no channel present and that observed down gradient appeared to originate at a lower elevation, as groundwater, as opposed to a surface water conveyance.

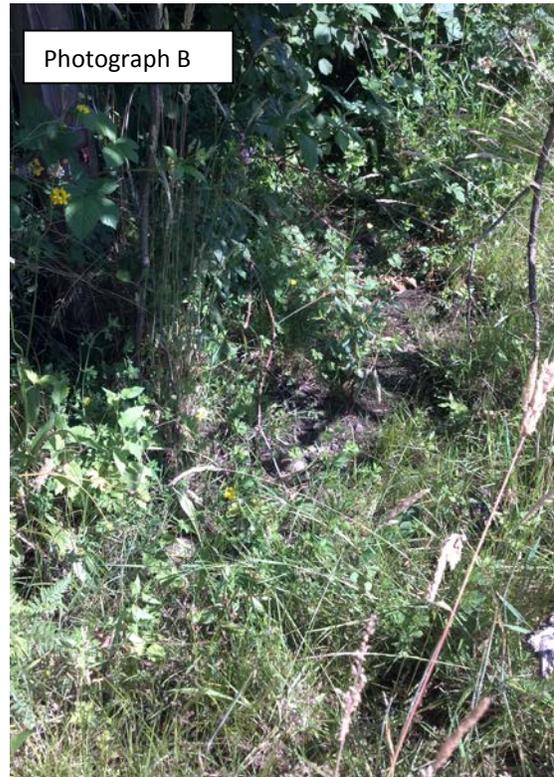
Photograph B

BGE^{LLC} staff walked the northern perimeter of the fence line, up gradient of the area in question, peering under the dense cover of salmonberry for any signs of originating hydrology, to include, depressional areas absent of vegetation, rubble piles, scoured soils and/or hummocked vegetation. No hydrologic indicators were found. Staff then provided the same reconnaissance to the eastern property boundary, down gradient of the area in question, consistent with the general landform, to investigate any outlet to surface water formation. One area right at the fence line in the lowest point, revealed a slight indication of ponding; difficult to capture visually yet shown in Photograph B. The area was small, less than one square foot and did not appear to continue easterly, off-site.

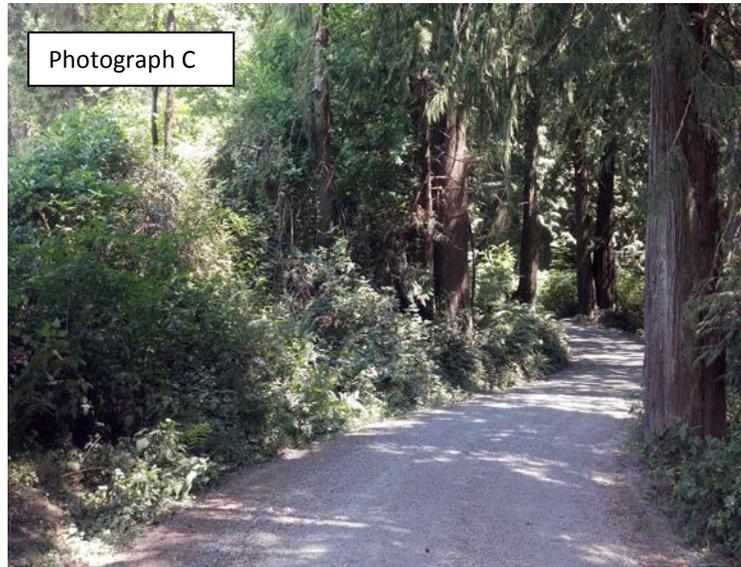
Within the standard buffer, between the proposed Blue Heron Plat and Lemolo Creek, is the road easement for NE Heron Pond Lane. This road is graveled and meanders through a mature forest with dense shrubs and ground cover. Road width is approximately 23 feet wide, lacks shoulders, and was

constructed into a benched setting adjacent the riparian corridor of Lemolo Creek. A road segment is shown in Photograph C with Lemolo Creek to the right.

A general exemption is respectfully requested under the conditions herein provided by definition as an “Interrupted Wetland and Fish and Wildlife Habitat Conservation Area Buffers” (Title 16.20.120 PMC). The request and application of the exemption is based on the presence of the road within the buffer and the minimization of disturbance proposed with the Blue Heron Plat. The proposed platted property is currently under agricultural land use. Defined as open horse pasture the parcel area is used in its entirety. The projects perimeter, or parcel boundary, is currently fenced and rotated for feed and horse pasture. Beyond the fence line, the landscape is native, mature

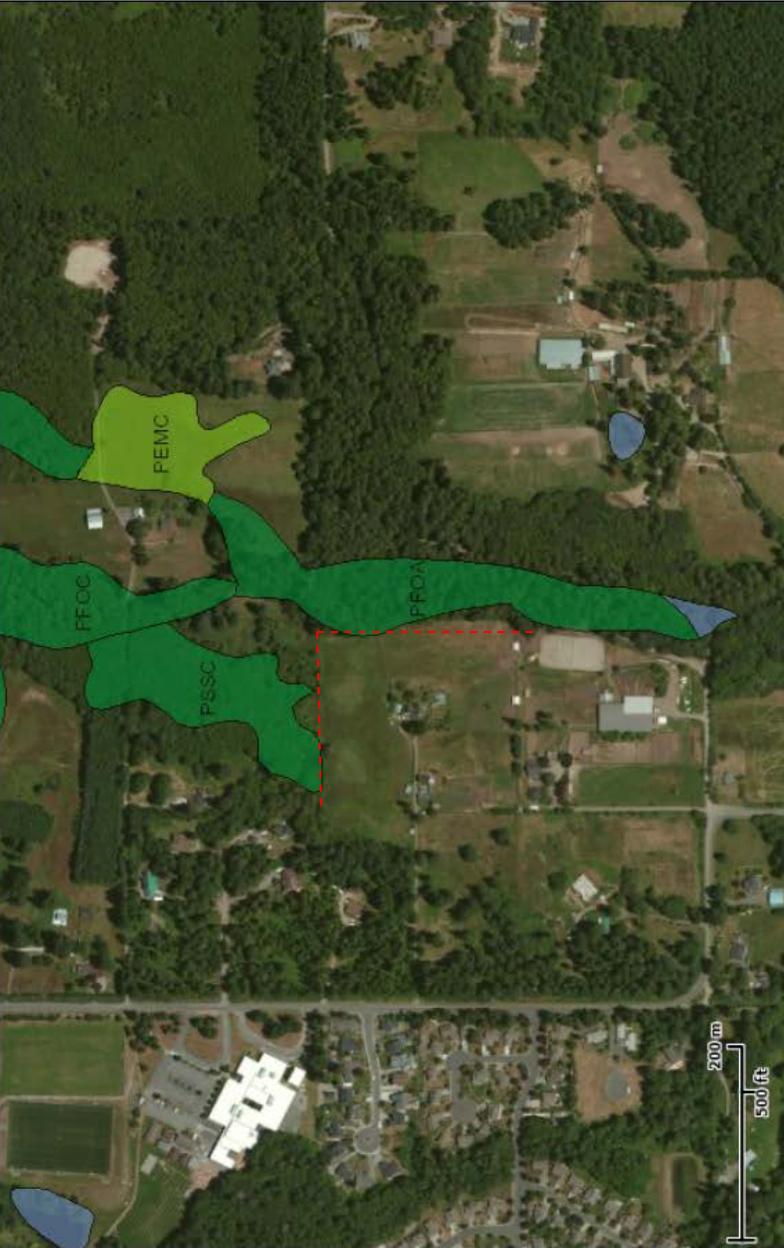
U.S. Fish and Wildlife Service National Wetlands Inventory

Wetlands

- Freshwater Emergent
- Freshwater Forested/Shrub
- Estuarine and Marine Deepwater
- Estuarine and Marine
- Freshwater Pond
- Lake
- Riverine
- Other
