HABITAT MANAGEMENT PLAN

Revised May 5, 2020

Johnson Ridge PRD *Poulsbo, Washington*

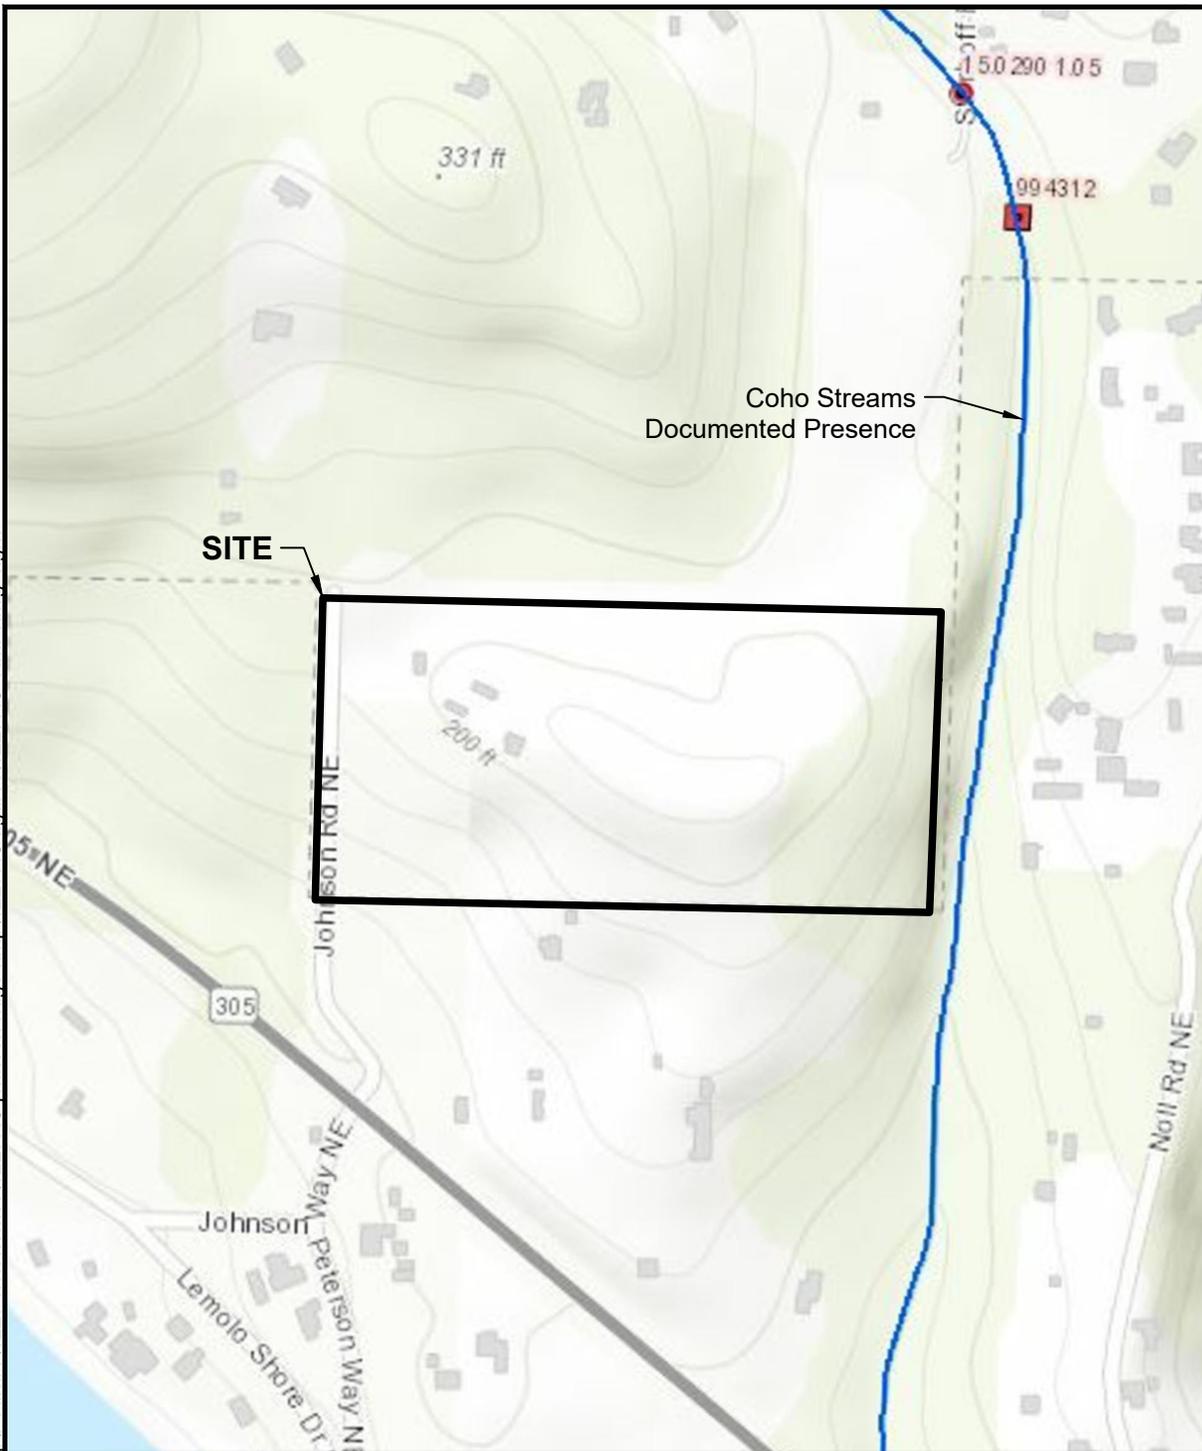
Figure 6
SALMONSCAPE MAP
 Johnson Ridge Habitat Management Plan
 Holt Homes
 Poulsbo, Kitsap County, WA
 Section 25, Township 26N, Range 1E, W.M.

NOTE: Map provided on-line by Washington State
 Department of Fish & Wildlife at web address:
<http://apps.wdfw.wa.gov/salmonscape/map.html#>

The Washington Department of Fish and Wildlife Salmonscape website (WDFW 2019b) maps the stream in the same location as the other mapping websites and indicates documented presence of coho salmon (Figure 6). Salmonscape also indicates that Bjorgen Creek is part of Distinct Population Segment (DPS) for winter and summer steelhead and is part of the Evolutionary Significant Unit (ESU) for Puget Sound/Strait of Georgia Coho (*Oncorhynchus kitsuch*) and Chum (*Oncorhynchus keta*) salmon. Salmonscape does not include Bjorgen Creek in the ESU for Chinook salmon.

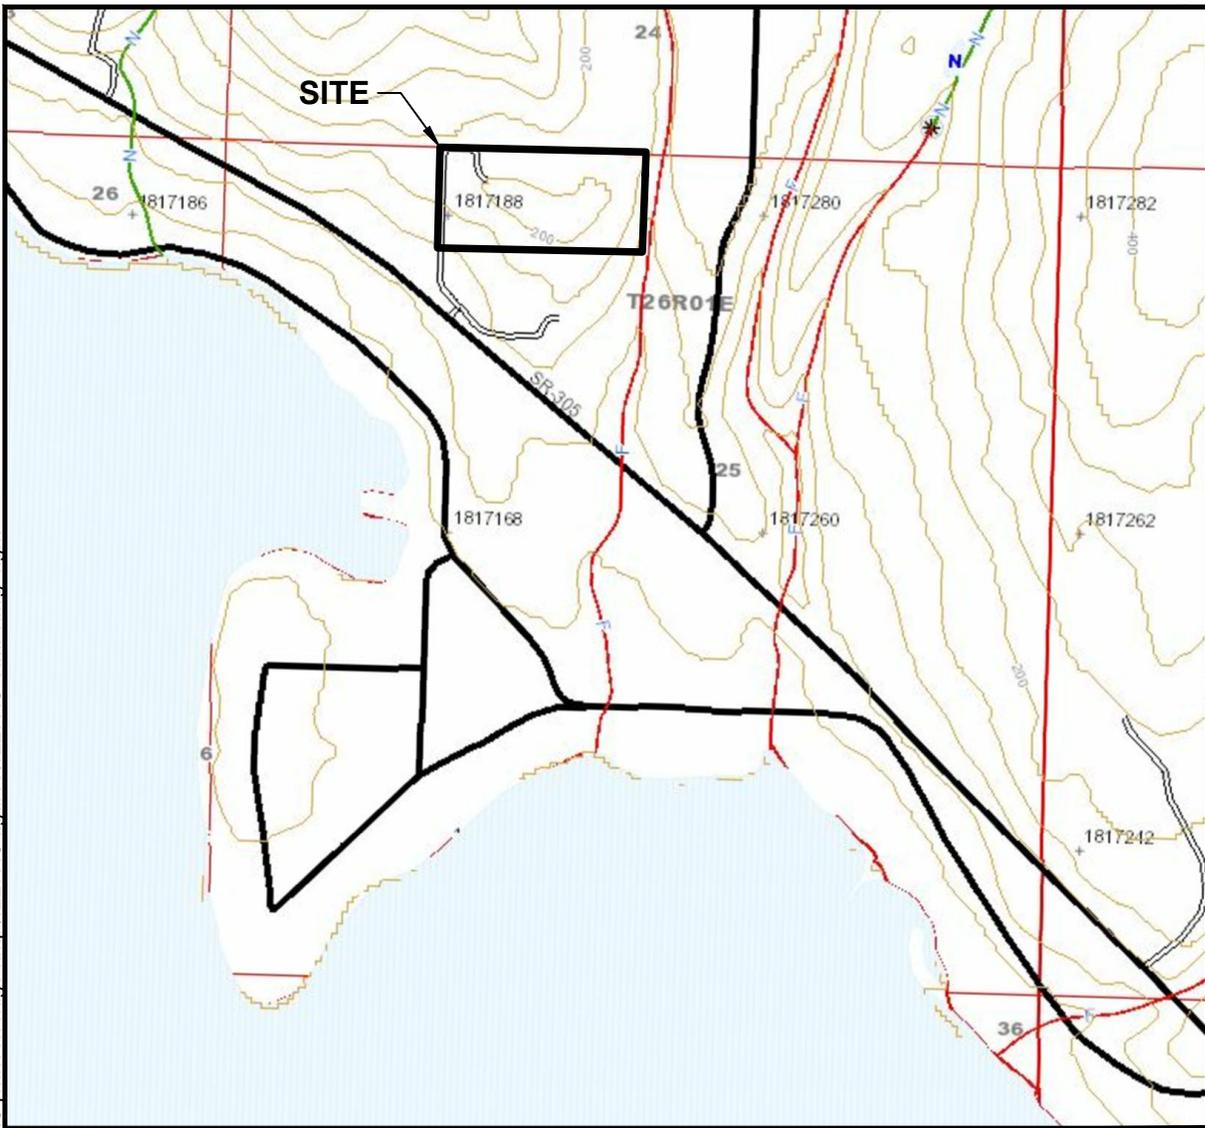
No mapped streams indicated onsite by the Washington State Department of Natural Resources (DNR).

2019a). The mapping indicates the stream is a Type F water on the east edge of the property (Figure 7). The Washington State Department of Transportation (WSDOT) replaced deteriorating culverts at State Highway 305 downstream of this property that now allow access to Bjorgen Creek by anadromous fish species. Additional blockages on private properties currently limit access to the upper reaches of Bjorgen Creek.

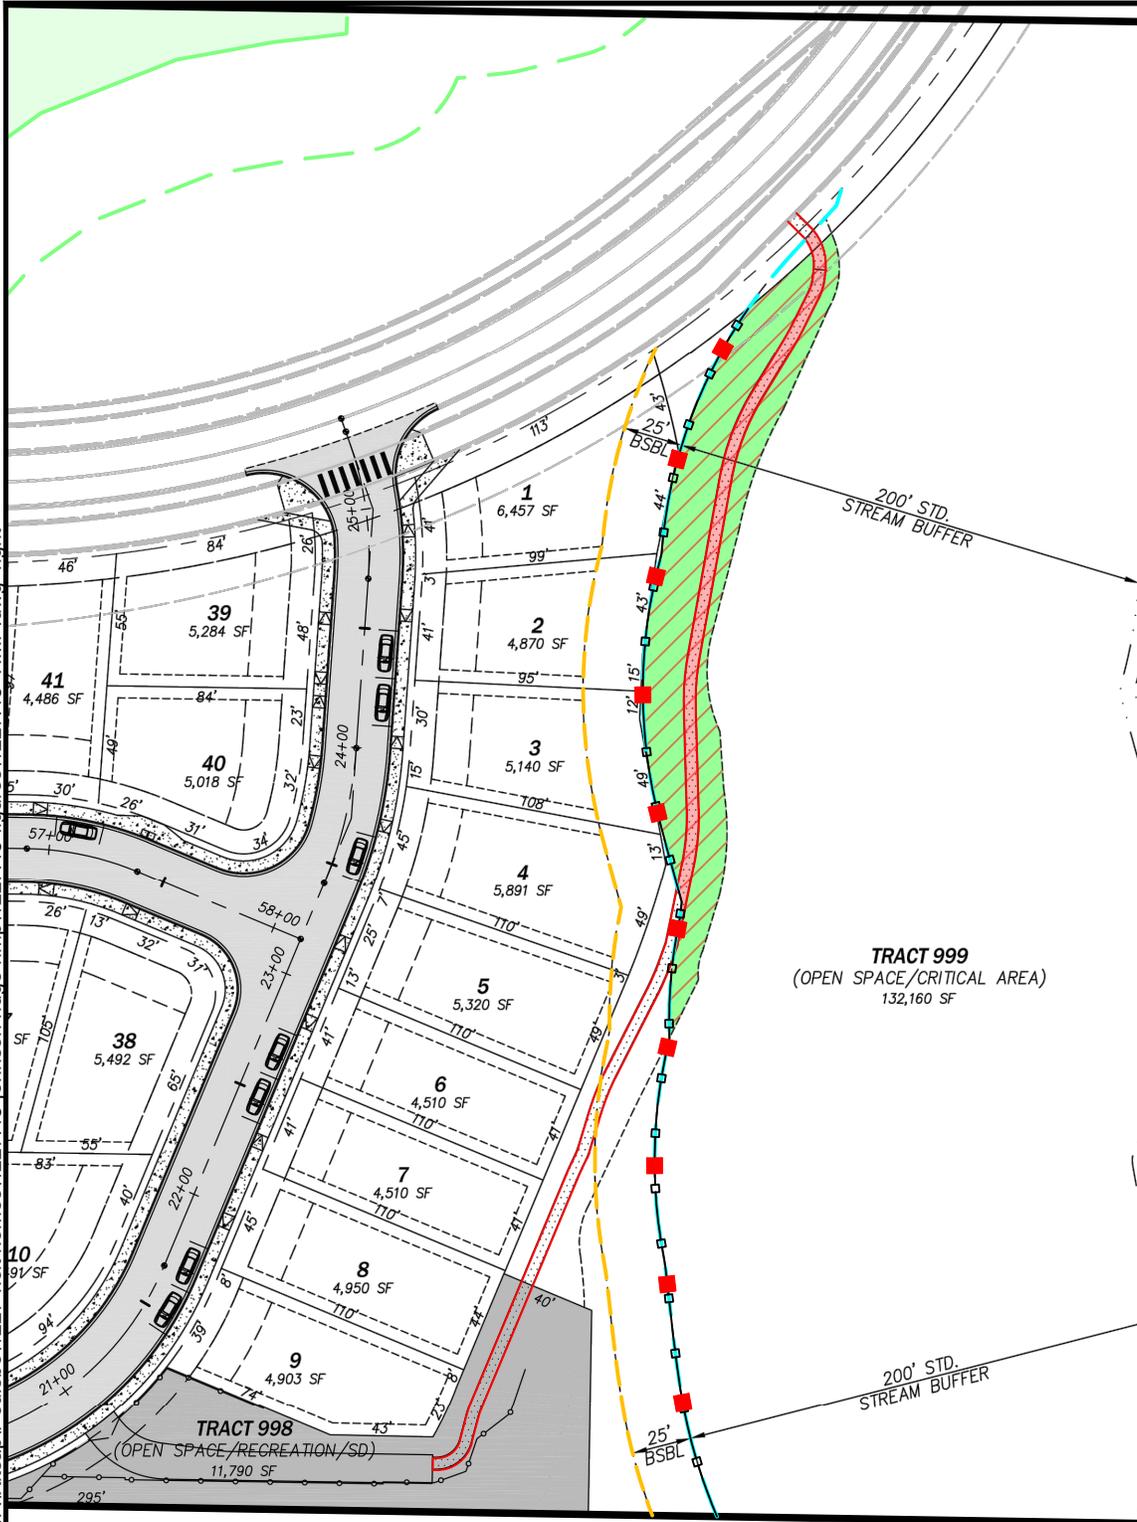
- Site Boundary
- Wetland Boundary
- Wetland Buffer
- Stream w/ Flow Direction
- Stream Buffer (200')
- 25' Building Setback
- Fence
- Wetland Buffer Sign (50')
- Temporary Buffer Impacts (8,772 sq.ft.)
- Trail Impacts (1,474 sq.ft.)
- Buffer Restoration Area (7,329 sq.ft.)

The Johnson Ridge project was revised to remove the stormwater facility from the buffer eliminating 33,311 square feet of impact. The current proposal will include temporary impacts in the outer 25 feet of the 200-foot buffer caused by grading of the lots next to this area of buffer. A trail will be constructed within this section following grading activities. The temporary impacts total 8,772 square feet, which includes the trail area. The trail is a permanent feature within the buffer but will not affect the function of the buffer because it is at the outer edge and native vegetation will be planted on both sides. Restoration of vegetation will take place following construction activities to replace the functions lost and possibly increase functions by installing a diversity of species. The remainder of the 200-foot buffer will remain untouched.

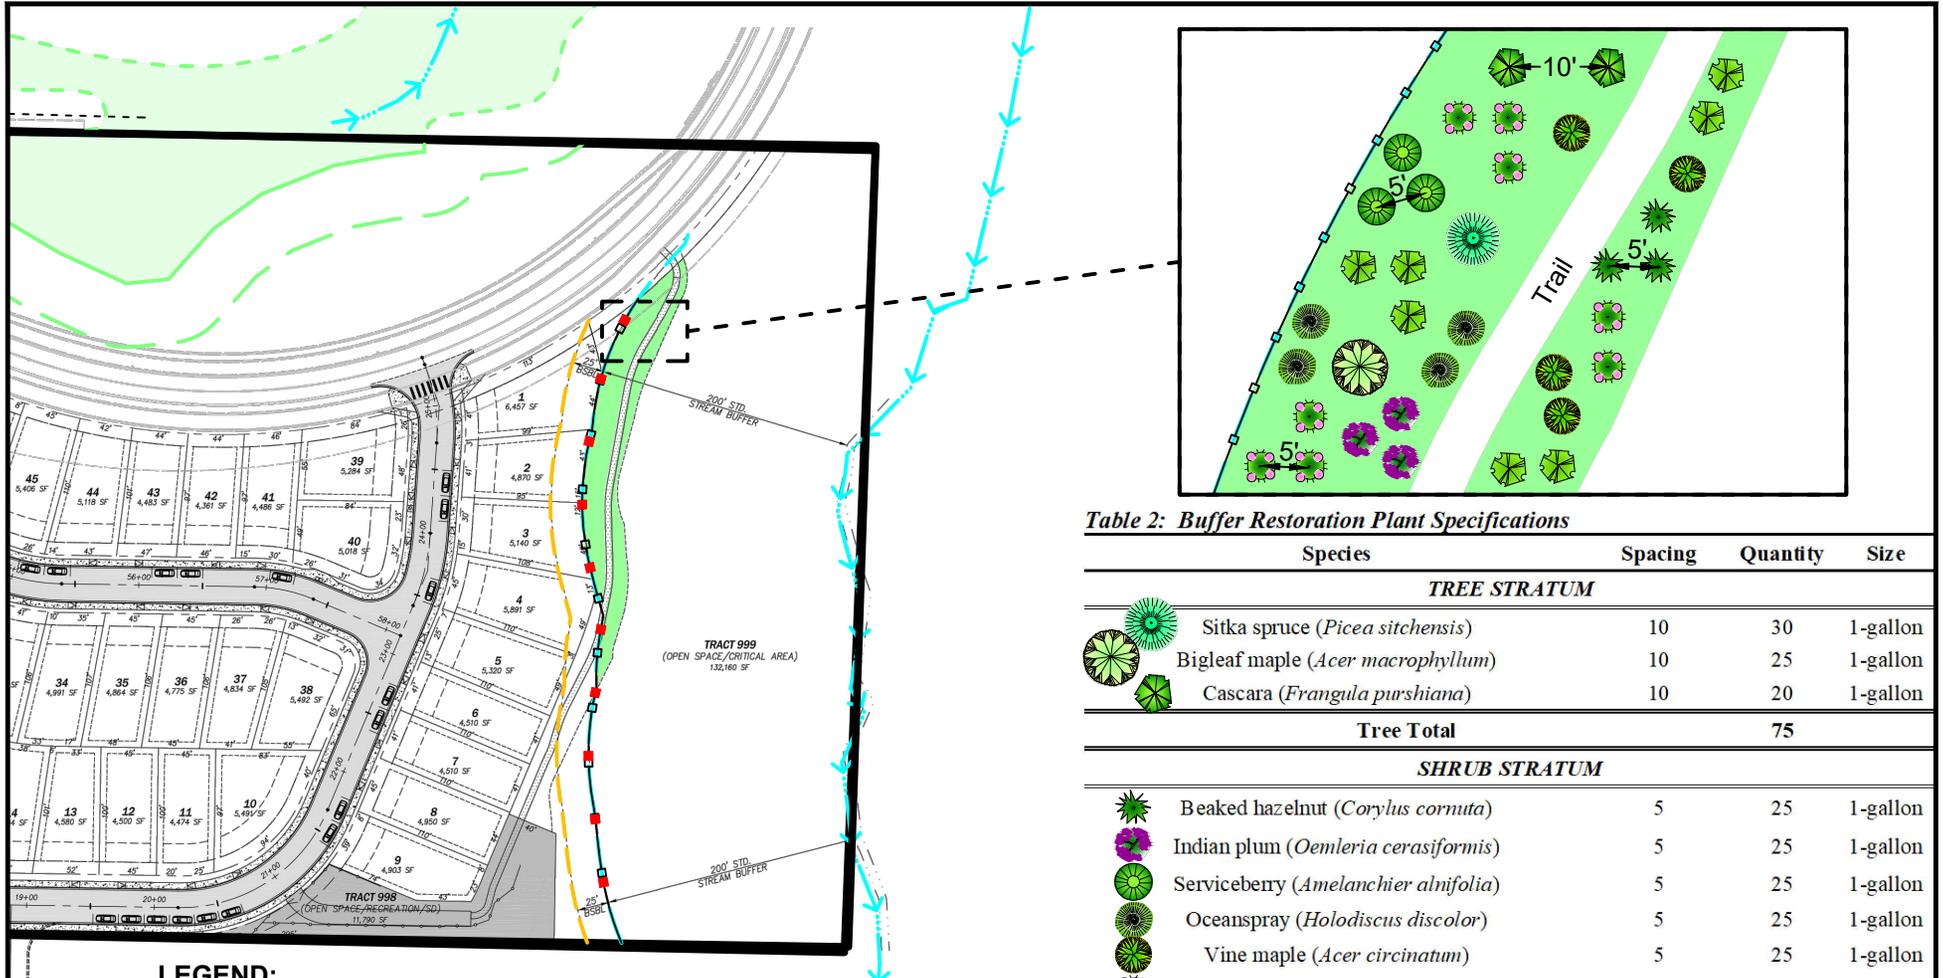
Figure 9
BUFFER RESTORATION PLANTING PLAN
 Johnson Ridge Habitat Management Plan
 Holt Homes
 Poulsbo, Kitsap County, WA
 Section 25, Township 26N, Range 1E, W.M.

- Site Boundary
- Wetland Boundary
- Wetland Buffer
- Stream w/ Flow Direction
- Stream Buffer (200')
- 25' Building Setback
- Fence
- Wetland Buffer Sign (50')
- Buffer Restoration Area (7,329 sq.ft.)

The project has minimized the temporary impacts and proposes restoration to replace the removed vegetation. The temporary impacts will affect 8,772 square feet near the buffer edge and are necessary to create the grades required for Lots 1 through 5. The vegetation removed will be replaced with native trees and shrubs to restore the area to native vegetation and to restore the temporarily impacted buffer function. Topsoil and mulch will be spread across this area to begin the restoration process. Fencing will be placed along the buffer edge to discourage intrusion into the buffer and critical area signs shall be placed along the entire length of the buffer. Monitoring is proposed for a period of 5 years to track the development of the desired vegetation community.

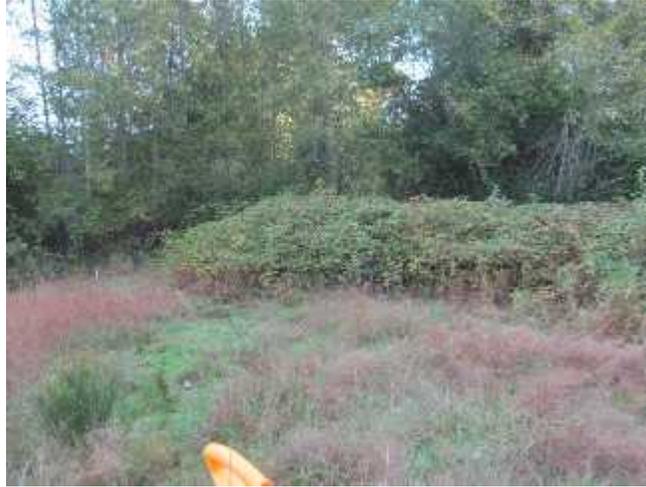
Photo 1 was taken from the centerline of the new Noll Road alignment on the east end of the Johnson Ridge PRD. It looks north across the field and blackberry thickets occupying the northeast corner.

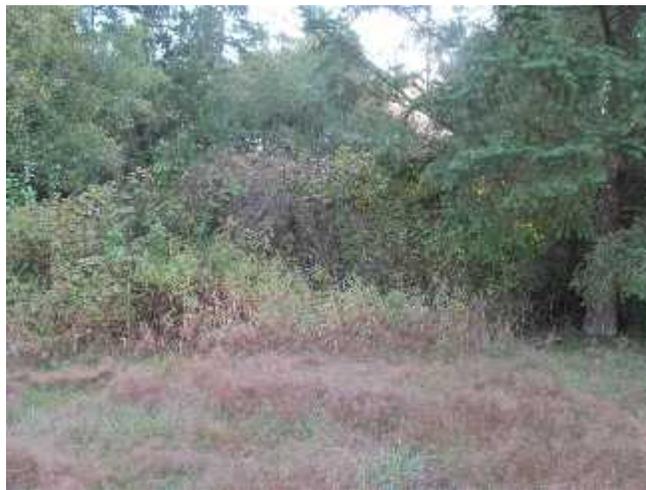
Photo 2 was taken from the same location as Photo 1 and looks east toward the stream ravine. The blackberry thickets continue to a small Douglas fir tree visible on the right edge.

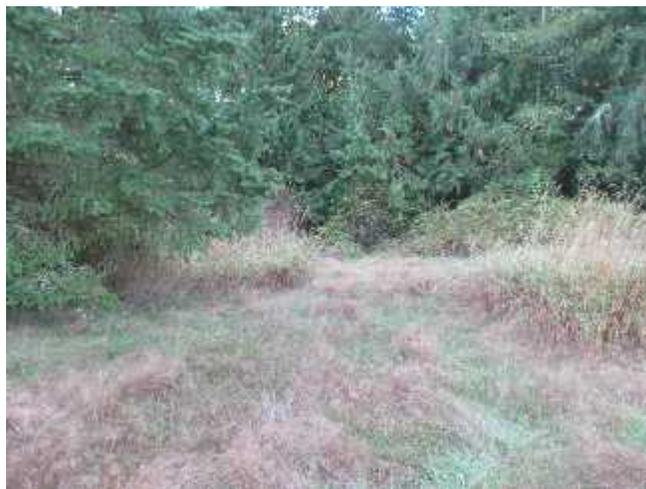
Photo 3 was taken from the same location as Photos 1 and 2. It looks southeast toward the transition from the field and blackberry thickets to the forested buffer area.

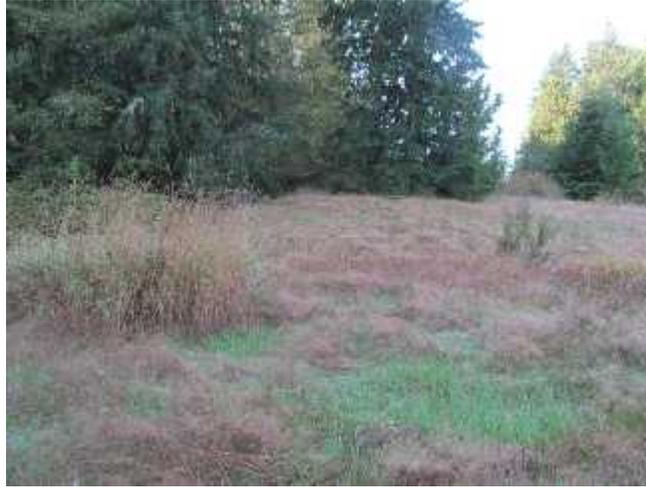
Photo 4 was taken from the same location as Photos 1, 2, and 3. It looks south up the north facing slope at the transition between the field portions of the property to the forested slope down to Bjorgen Creek.

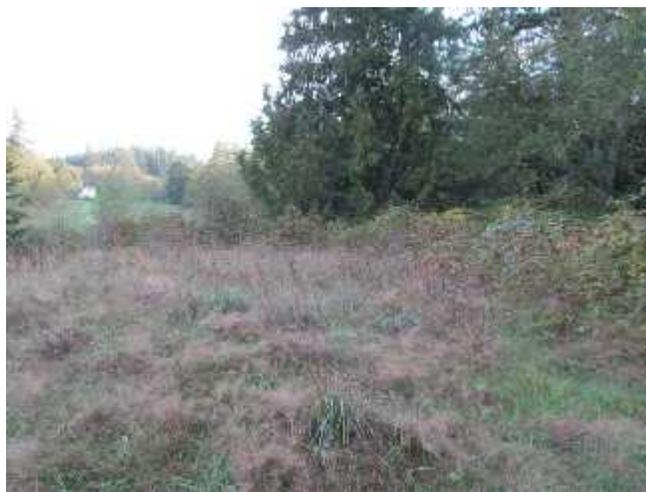
Photo 5 was taken from the top of the slope shown in Photo 4. It looks north across the plateau that begins at the top of the slope. Blackberry thickets run along the entire edge of the forest that extends down the slope toward the stream.

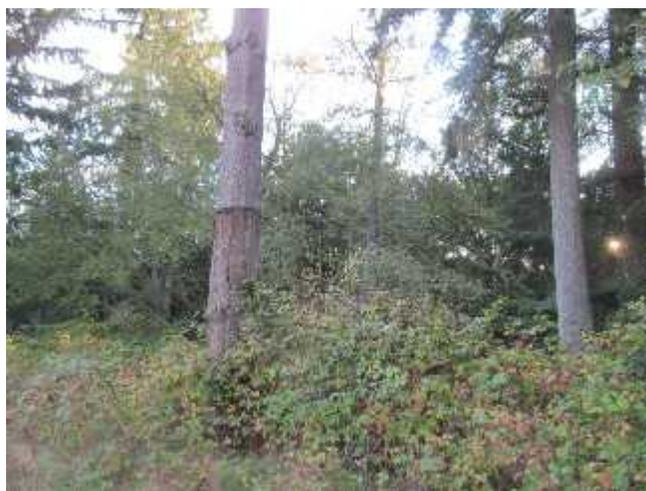
Photo 6 was taken from the same location as Photo 5. It looks easterly toward the top of the ravine slope into the start of the existing forest.

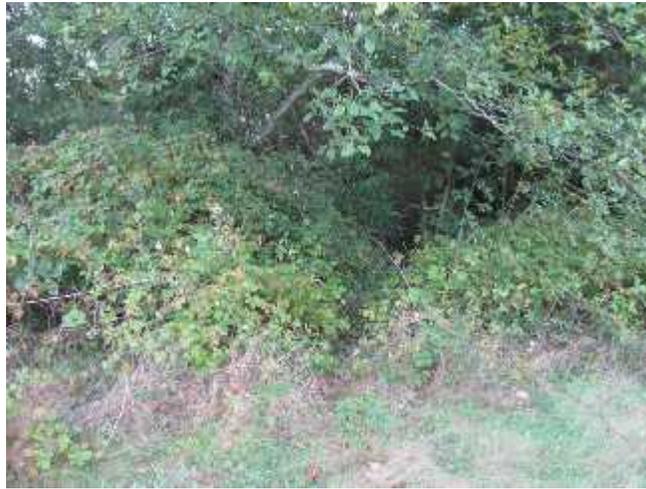
Photo 7 was taken from the same location as Photos 5 and 6. It looks easterly toward the top of the forested ravine.

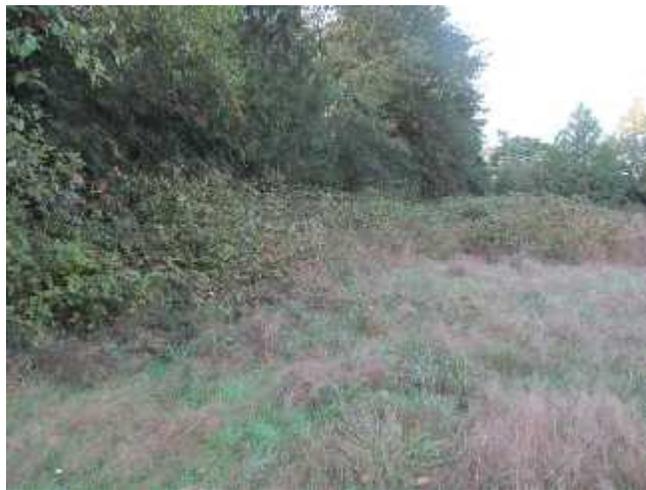
Photo 8 was taken from the same location as Photo 7 and looks south along the forest/blackberry edge.

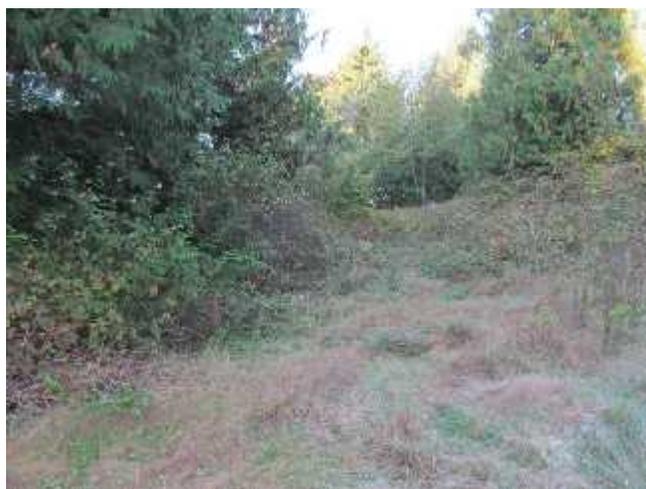
Photo 9 was taken from near the southeast corner of the property. Forested conditions are present along the south edge of the property (to the left).

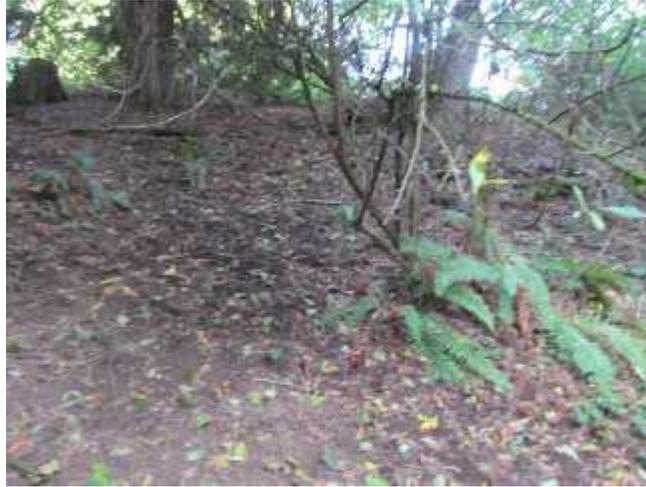
Photo 10 was taken from within the existing forest that begins at the top of the ravine slope. This photo looks back up the slope where there is minimal shrub and herbaceous plant cover.

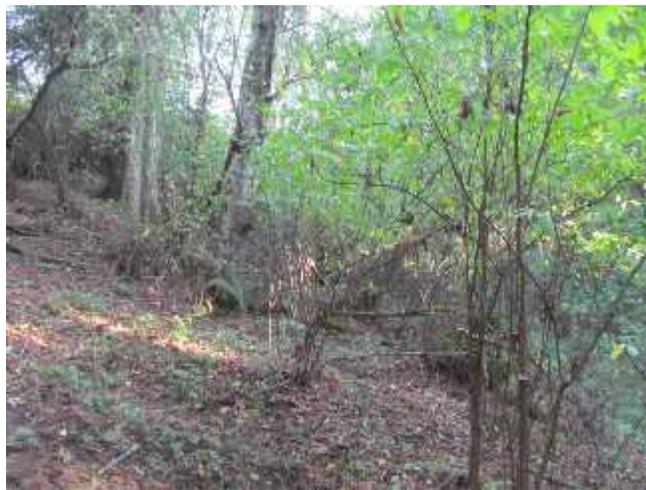
Photo 11 was taken from the same location as Photo 10 and looks north along the ravine slope. The shrub layer is slightly denser further down the slope than the area pictured in Photo 10. The herbaceous layer is still fairly bare.

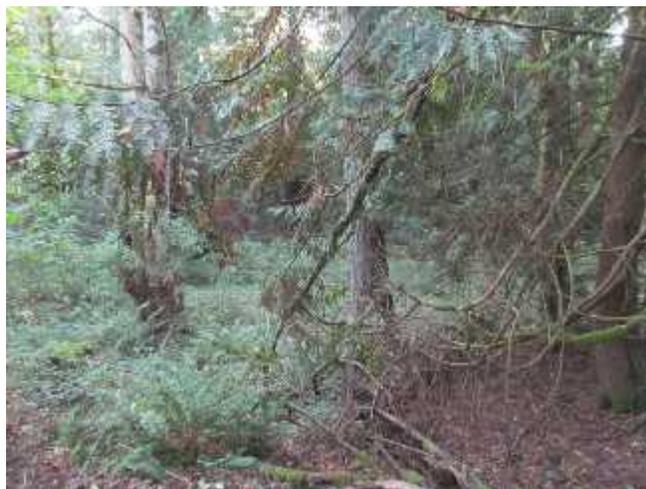
Photo 12 was taken from the same location as Photos 10 and 11. It looks down the slope toward the stream where the shrub layer is sparsely vegetated by the herbaceous layer is thicker with sword fern.

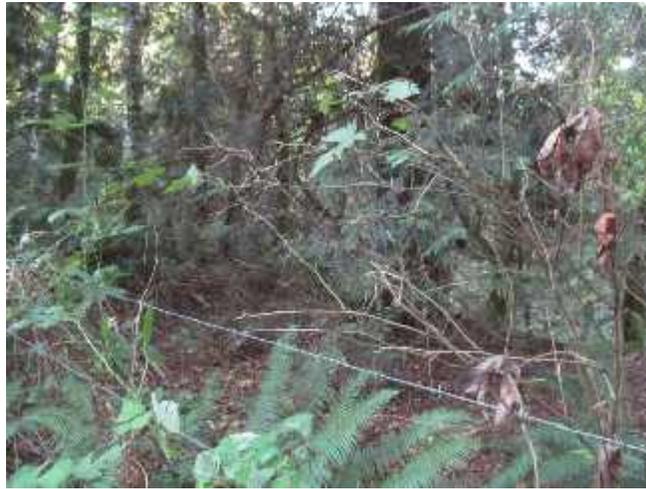
Photo 13 was taken from further down the slope at the edge of the terrace about halfway down the ravine. There is increasing cover in the shrub and herbaceous layers.

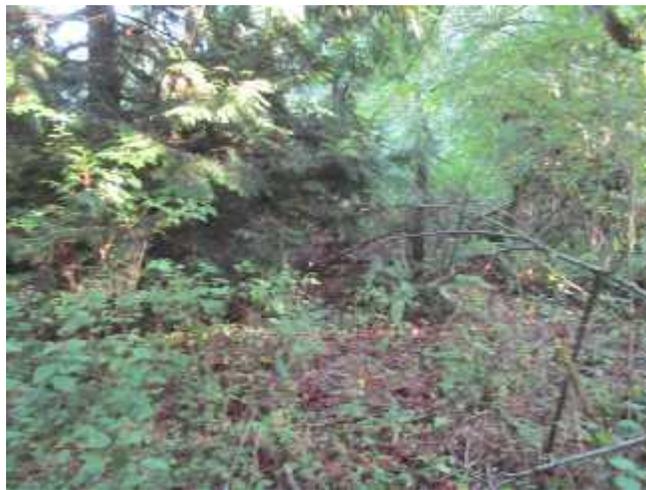
Photo 14 was taken from the same location as Photo 13 and it looks easterly to the east edge of the terrace. The trees in the background are growing on the slope below.

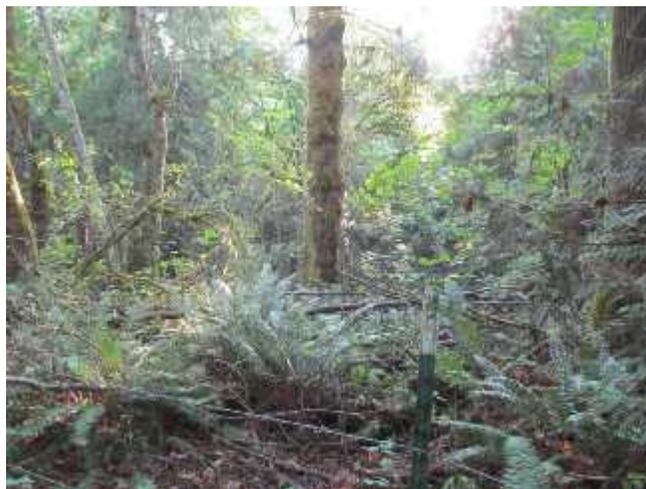
Photo 15 was taken from the same location as Photos 13 and 14. It provides another view of the edge of the terrace and the start of the vegetation growing on the slope below.

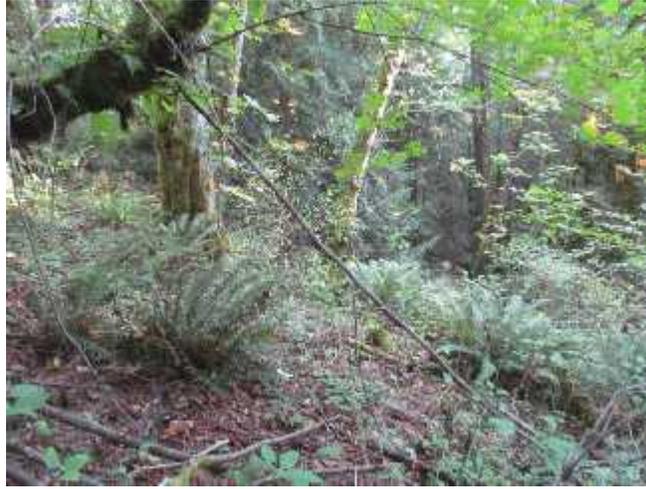
Photo 16 was taken from the edge of the terrace pictured in Photos 13, 14, and 15. It looks northeasterly down the slope below which is Bjorgen Creek.

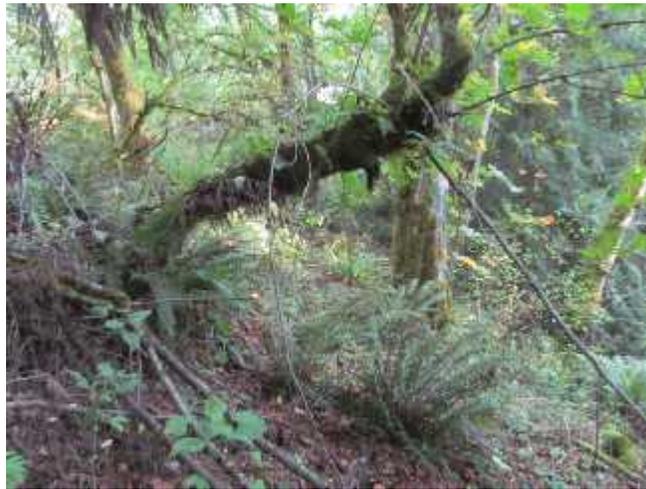
Photo 17 was taken from the same location as Photo 16 and looks east northeast down the slope. There is a fairly dense forest canopy and herbaceous layer with a sparsely vegetated shrub layer.

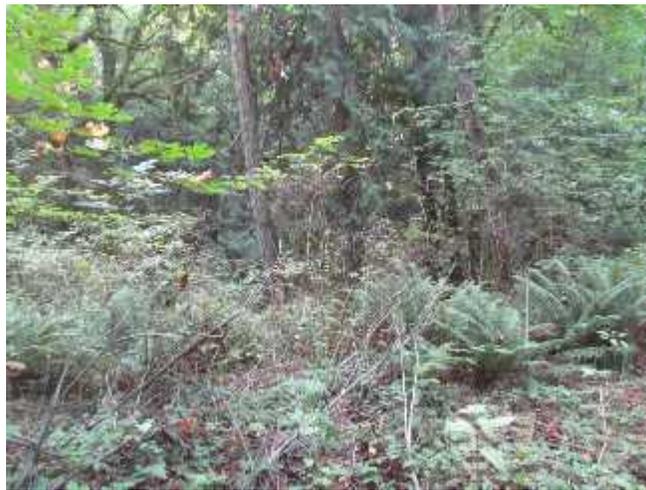
Photo 18 was taken from the same location as Photos 16 and 17. It looks easterly down the slope where there is a denser shrub layer.
