CRITICAL AREAS REPORT

August 14, 2020 (Revised February 24, 2021)

Oslo Bay Apartments *Poulsbo, WA*

Prepared by
Ecological Land Services
1157 3rd Avenue, Suite 220A • Longview, WA 98632
(360) 578-1371 • Project Number 2407.01

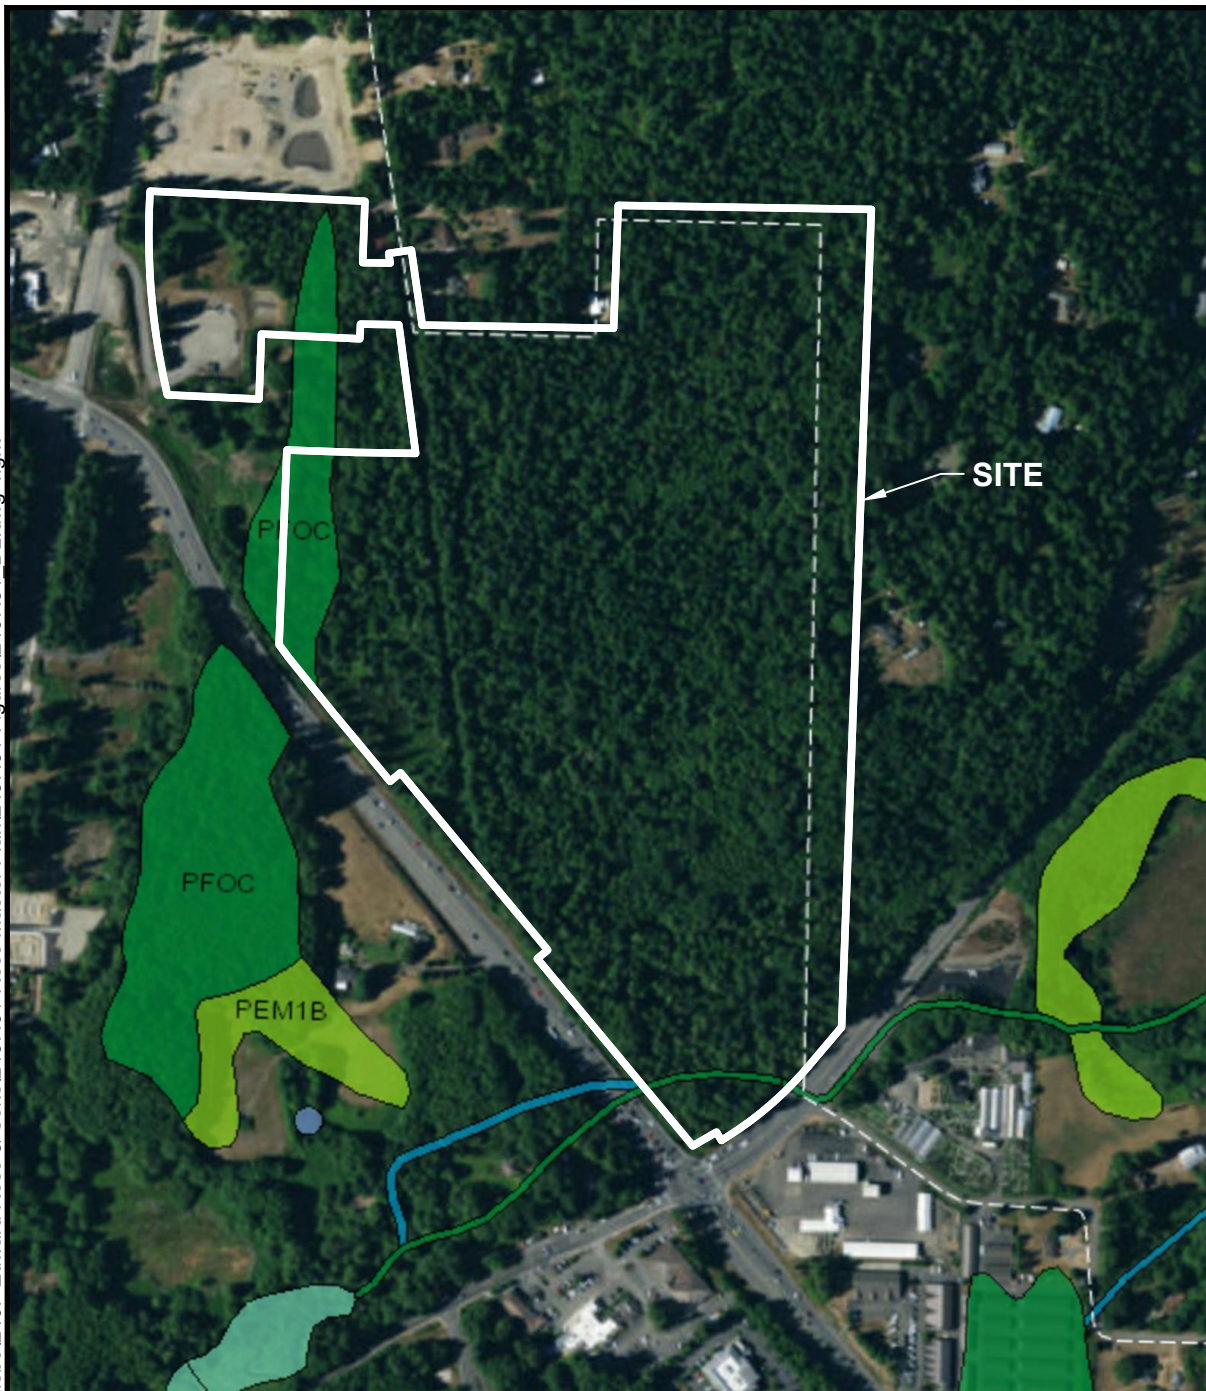
Figure 3
SOIL SURVEY MAP
Oslo Bay Apartments
Edward Rose & Sons
City of Poulsbo, Kitsap County, WA
Section 10 & 11, Township 26N, Range 1E, W.M.

As referenced on the U.S.D.A. Natural Resources Conservation Service (NRCS 2015) website, the soils from west to east across this property include Poulsbo gravelly sandy loam, 0-6 percent slopes (39), Poulsbo gravelly sandy loam, 6 to 15 percent slopes (40), and Poulsbo gravelly sandy loam, 15-30 percent slopes (41), Norma fine sandy loam (37) at the southeast corner and along the west edge, and Bellingham silty clay loam (6) in a small area along the east edge (Figure 3). Poulsbo soils are not classified as hydric, but Norma and Bellingham soils are classified as hydric (NRCS 2015). The identified and delineated wetland areas are located in areas where hydric soils are mapped. Areas mapped as hydric soils do not necessarily mean that an area is or is not a wetland—hydrology, hydrophytic vegetation, and hydric soils must all be present to classify an area as a wetland.

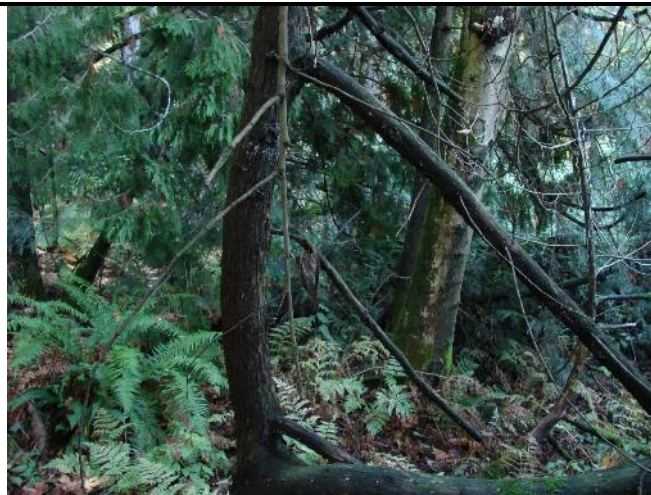
Photo 1 was taken during the 2011 delineation site visit by Wiltermood. It is taken from WB flag A-2 and looks northeasterly across the south end of Wetland A.

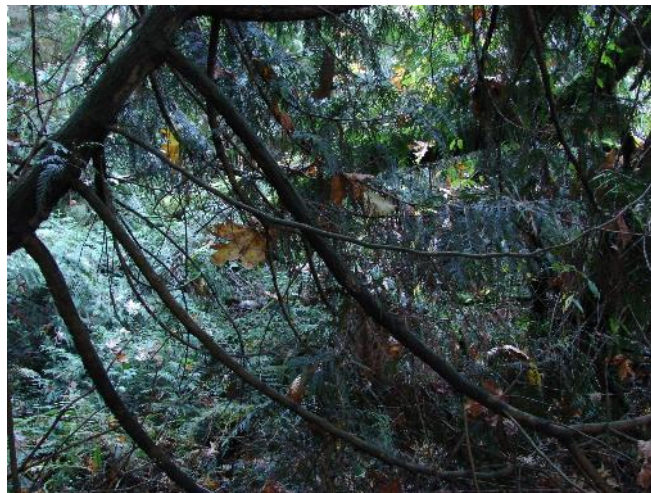
Photo 2 was taken from the same location as Photo 1 and looks easterly across Wetland A.

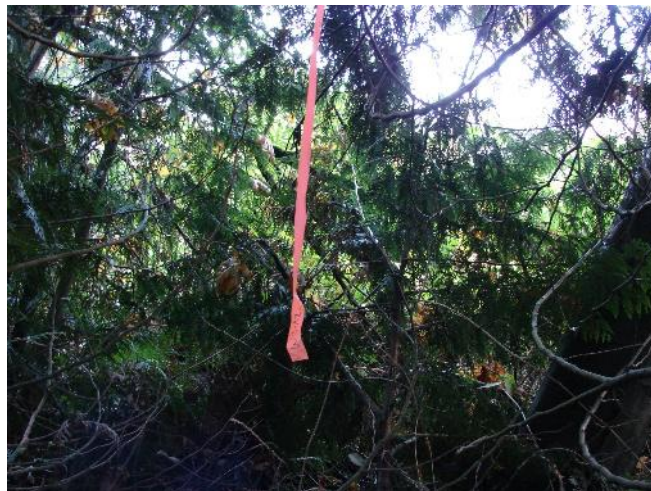
Photo 3 was taken from the same location as Photos 1 and 2. It looks southerly across Wetland A with WB A-2 featured prominently in this photo.

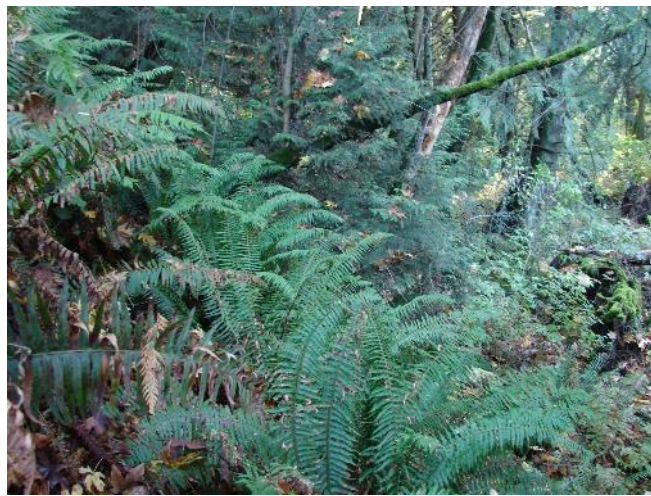
Photo 4 was taken during the 2011 delineation site visit by Wiltermood. This photo looks north along the upland slope that lies just west of Wetland A. Test Plot 2-A was conducted in this area to verify the wetland boundary delineation.

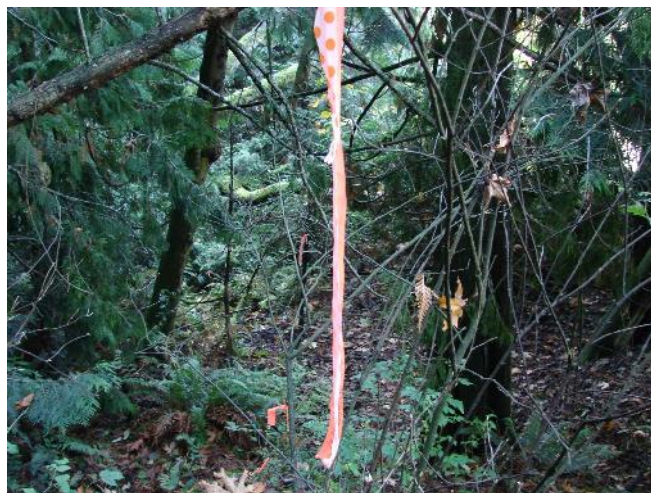
Photo 5 was taken from the same location as Photo 4 and looks directly into the area where Test Plot 2-A was conducted. This area is determined to be upland because it lacks positive indicators for all three wetland parameters.

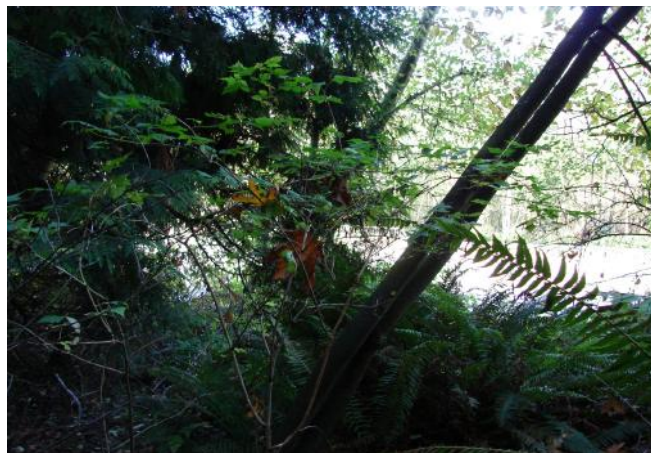
Photo 6 was taken from the same location as Photos 4 and 5. It looks southerly across the upland west of Wetland A toward SR 305, which is visible in the lighted background.

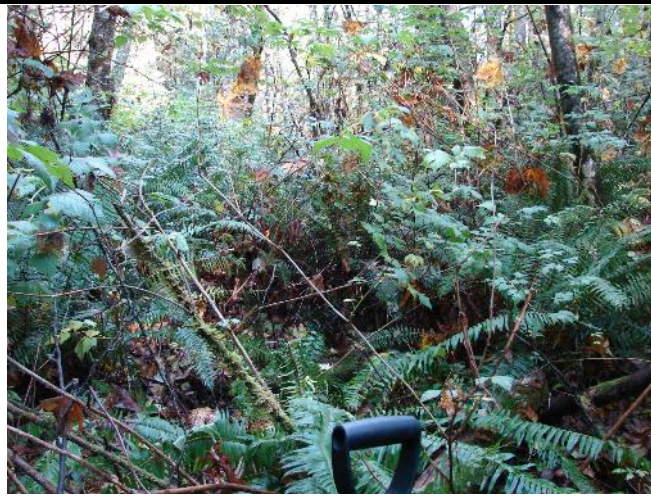
Photo 7 was taken during the 2011 delineation site visit by Wiltermood. This photo was taken from near Test Plot 3-A and looks westerly up a dry swale that originates upslope and ends at the wetland boundary.

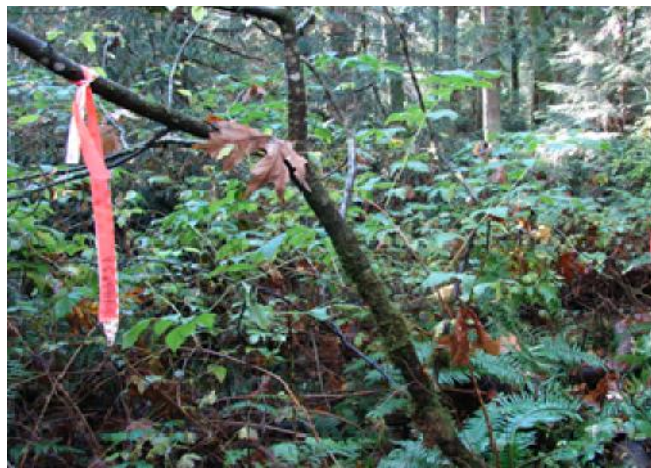
Photo 8 was taken from the same location as Photo 7 and looks northwesterly past Test Plot 3-A. It shows the slope that runs along the dry swale pictured in Photo 7.

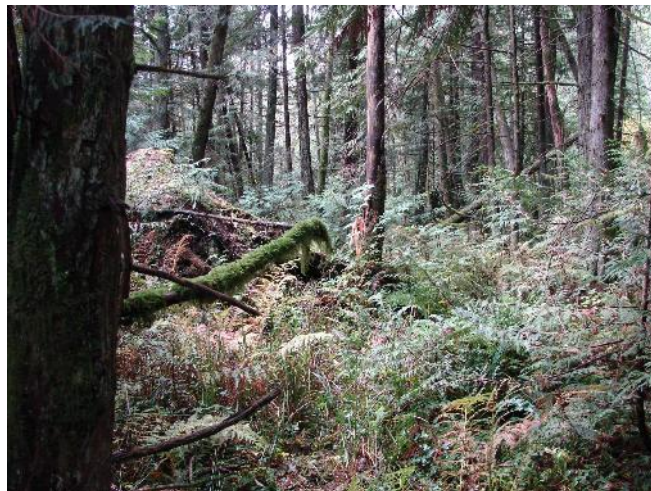
Photo 9 was taken from the wetland boundary between flags WB A-20 and WB A-21. This photo looks westerly up a wider swale that ends at the wetland boundary. This area was determined to be upland because it lacks positive indicators for all three wetland parameters.

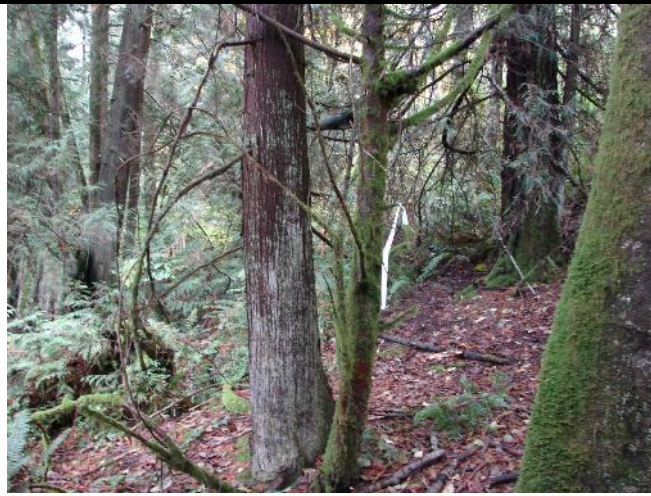
Photo 10 was taken from the same location as Photo 9 (Photoplate 3) between flags A-20 and A-21. It looks southwesterly toward flag A-20. The wetland is on the left side of the photo and upland is to the right.

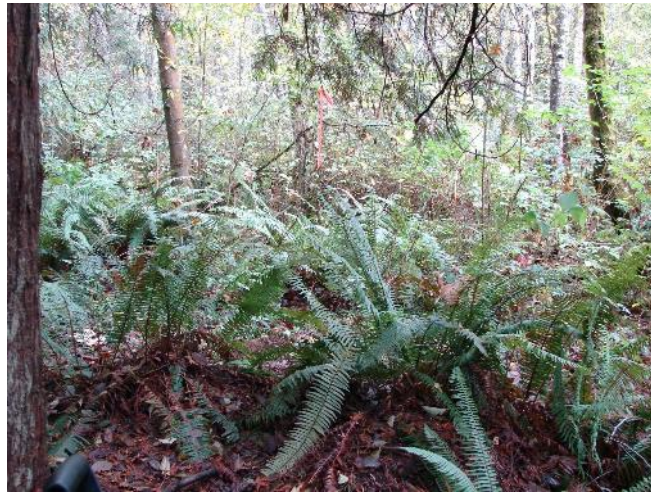
Photo 11 was taken from the same location as Photos 9 and 10. It shows the area of Test Plot 4-A, which is just upslope and north of WB flag A-22. This area is determined to be upland because it lacks positive indicators for all three wetland parameters.

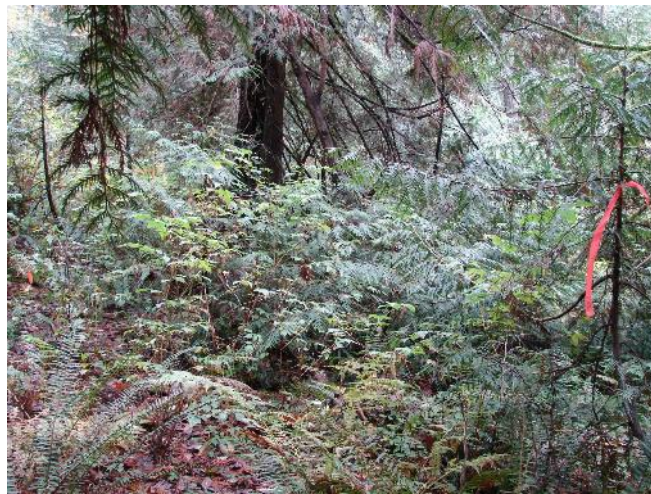
Photo 12 was taken from the same location as Photos 9, 10, and 11. It looks northeasterly along the wetland boundary as flagged at WB A-21. In this photo, the wetland is to the right and upland is on the left.

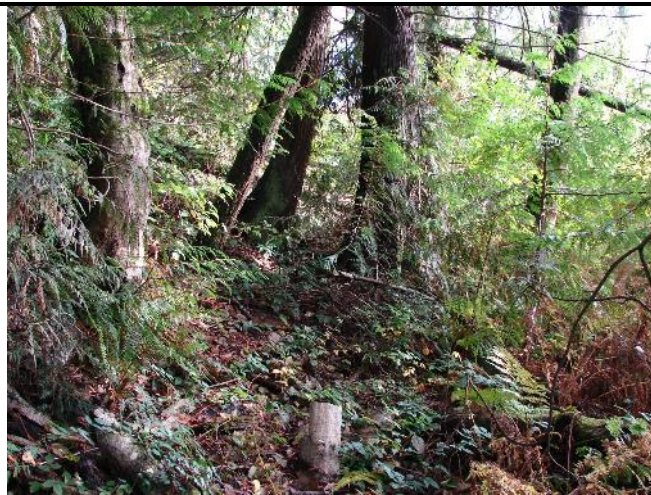
Photo 13 was taken from a point just upslope from Dogfish Creek, which crosses the southeast corner of the project site. This photo looks northeasterly at the forest that lies alongside the stream.

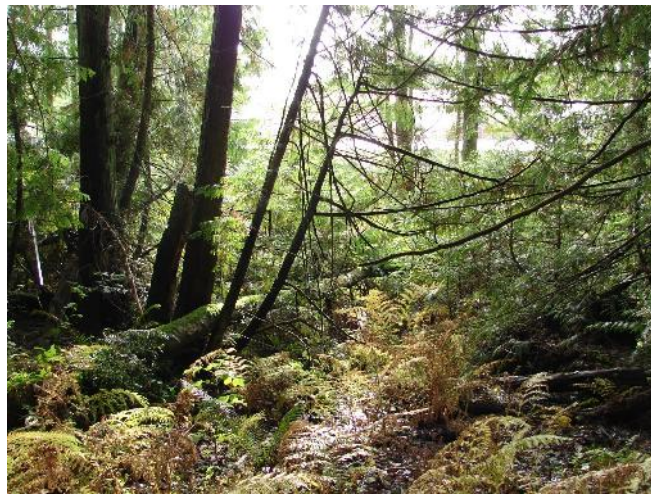
Photo 14 was taken from the same location as Photo 13. It looks easterly across the wetland that lays just upslope of Dogfish Creek. SR 307 appears in the lighted background of this photo.

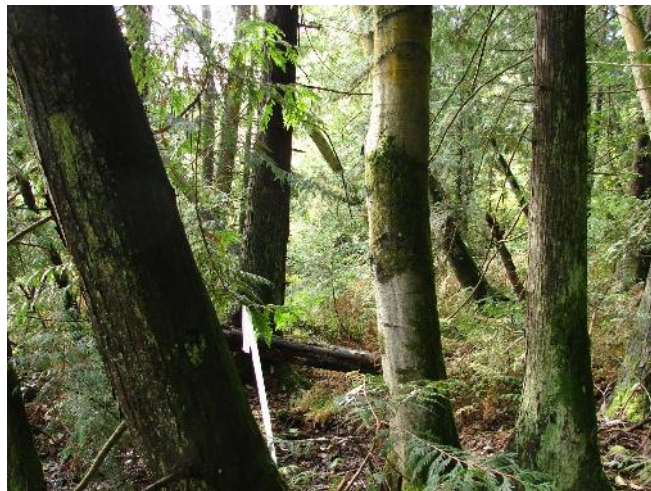
Photo 15 was taken from the same location as Photos 13 and 14. It looks southerly through the lowest portion of Wetland A.

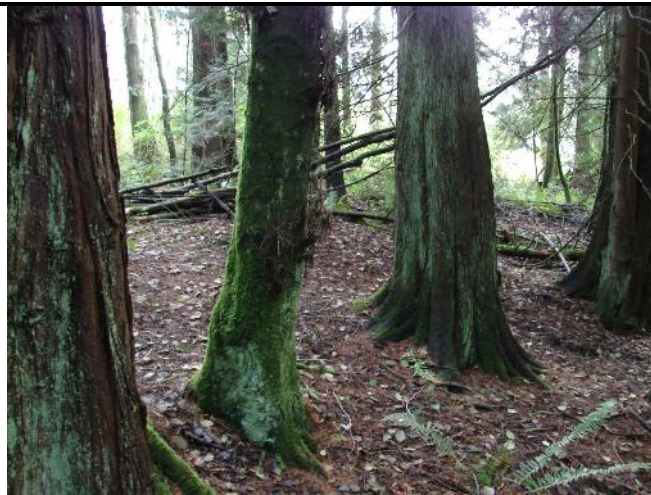
Photo 16 was taken from the north boundary of Wetland A looking toward the upland island that is located in the east half of Wetland A. This photo looks southeasterly into the wetland north of the island.

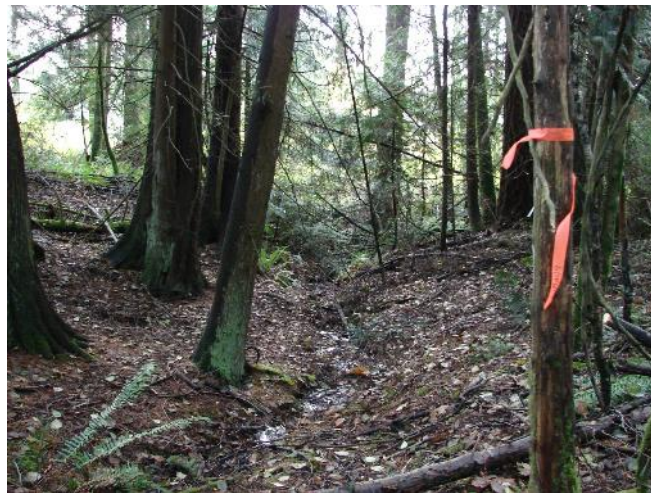
Photo 17 was taken from the same location as Photo 16. It looks southerly down the slope along a rivulet that has formed in the sloping, seep fed wetland. Wetland boundary flag A-40 is on the tree at the right edge of this photo.

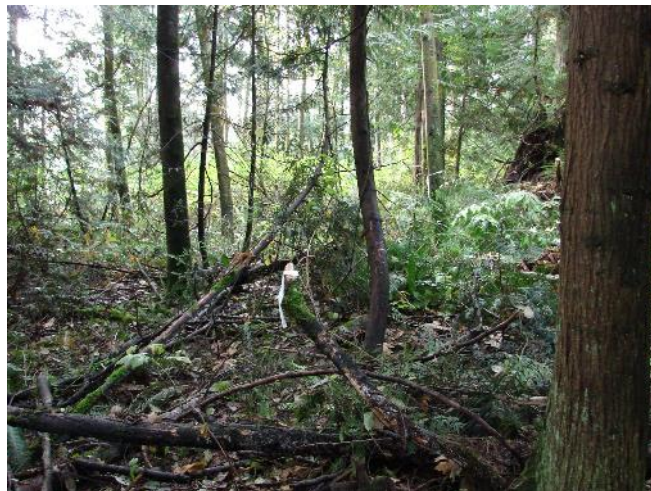
Photo 18 was taken from the edge of the upland island and looks across the northwest west portion.

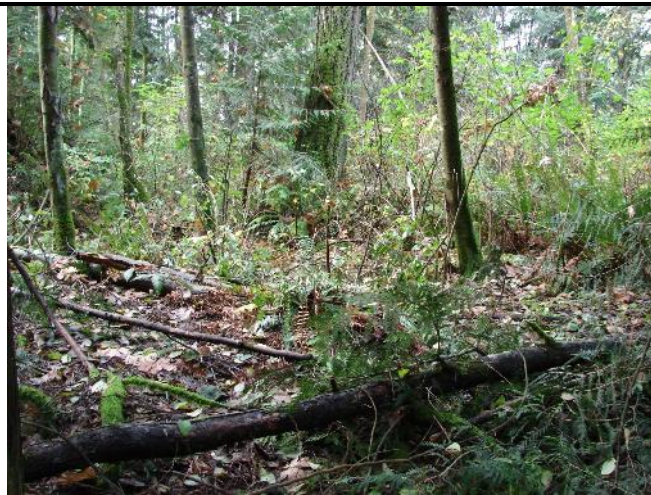
Photo 19 was taken from the same location as Photo 18 and shows the northwestern portion of the upland island within Wetland A. Note the Douglas fir trees growing on the island in the middle background.

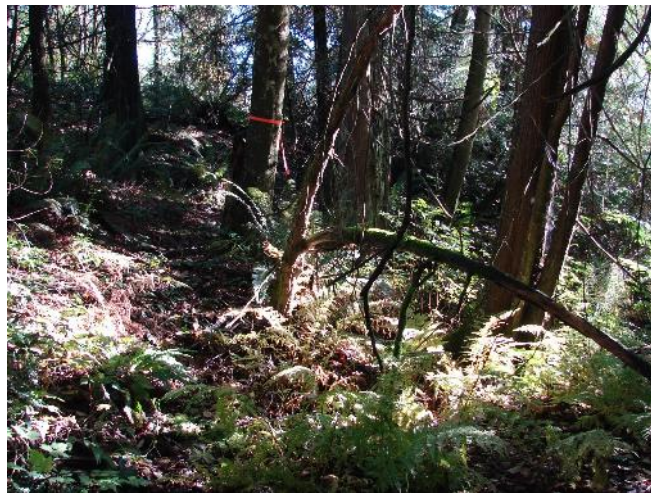
Photo 20 was taken from the east boundary of Wetland B and looks southeasterly toward wetland boundary flag B-21, which is on the tree to the left.

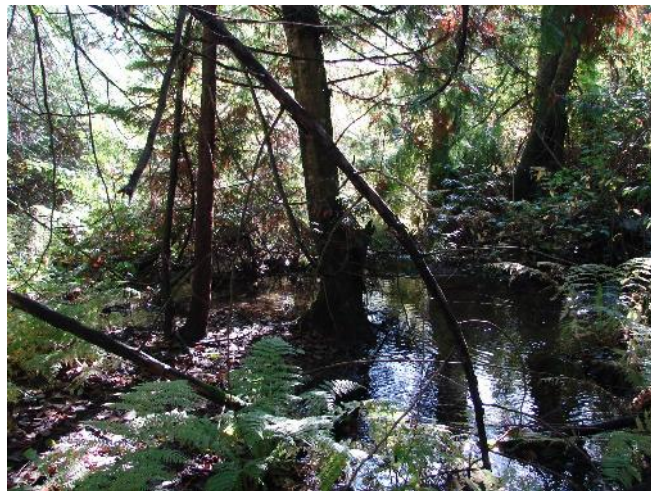
Photo 21 was taken from the same location as Photo 20 and looks southerly across Wetland B.

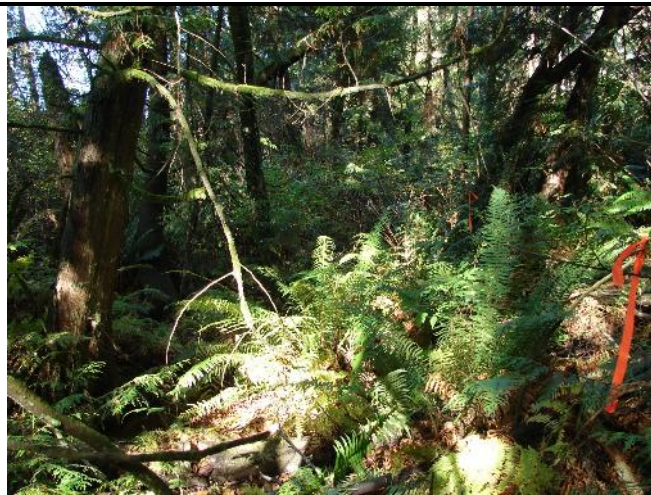
Photo 22 was taken from the same location as Photos 20 and 21 on Photoplate 7. It looks north along the wetland boundary with wetland boundary flag B-20 on the right edge of the photo.

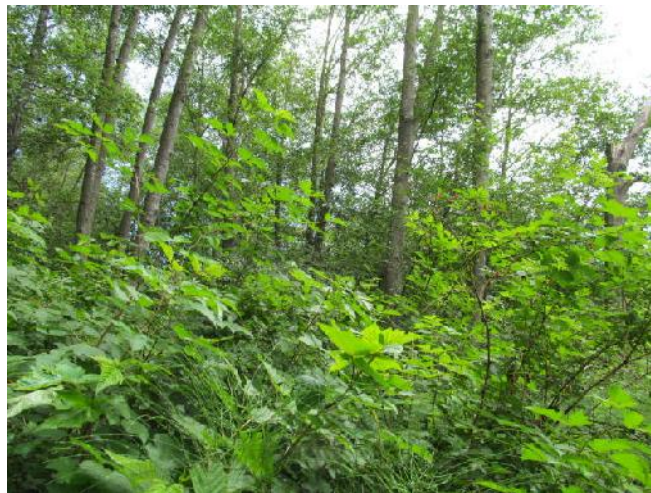
Photo 23 was taken from the west boundary of Wetland C looking northeasterly. It was taken during the June 2016 field visit to verify the wetland boundaries because no photos were included in the 2011 wetland analysis report. This wetland is composed of forested (background) and shrub/shrub communities.

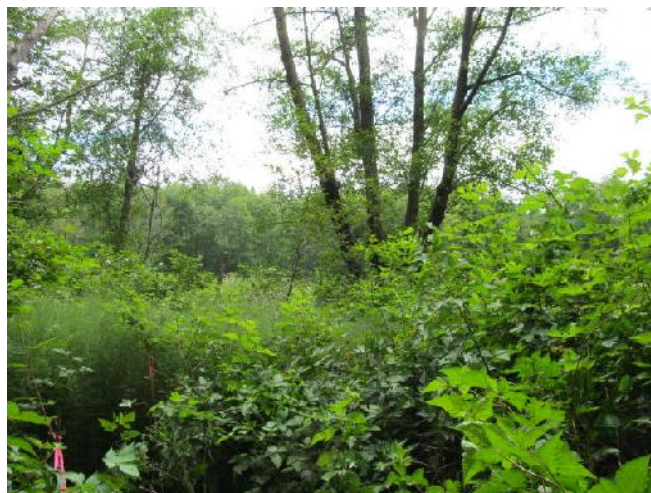
Photo 24 was taken from the same location as Photo 23 and looks easterly across the scrub/shrub portion of Wetland C.

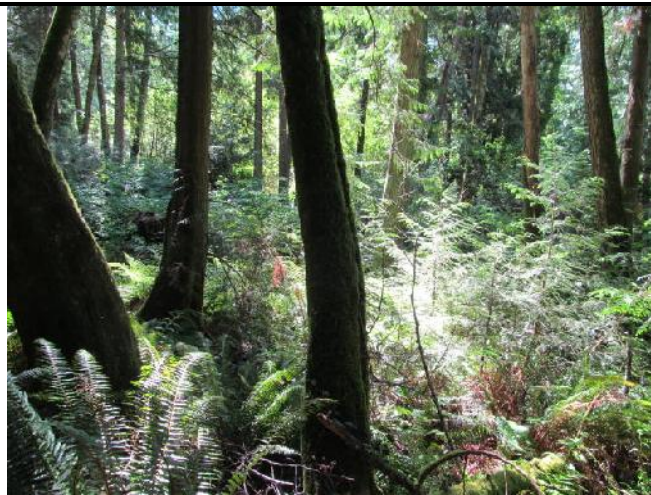
Photo 25 was taken from along the western boundary of Wetland A during the June 2016 site visit to verify the delineation. This photo looks north along the boundary with wetland to the right and the steep slope to the left.

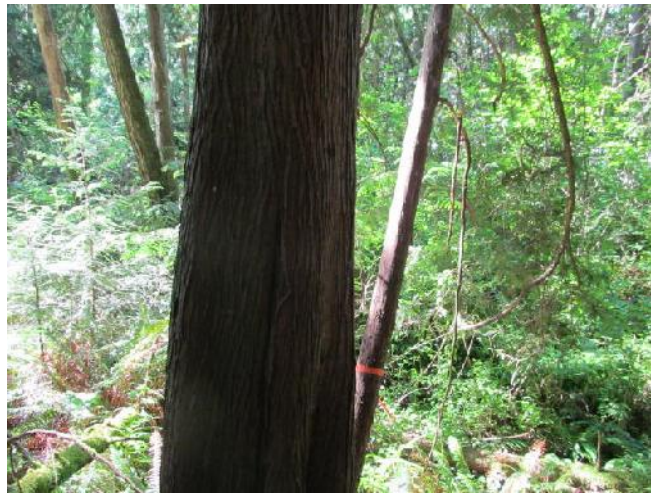
Photo 26 was taken from the same location as Photo 25 during the 2016 field visit. It looks southeasterly into the wetland with a wetland boundary flag visible at the bottom of the small tree.

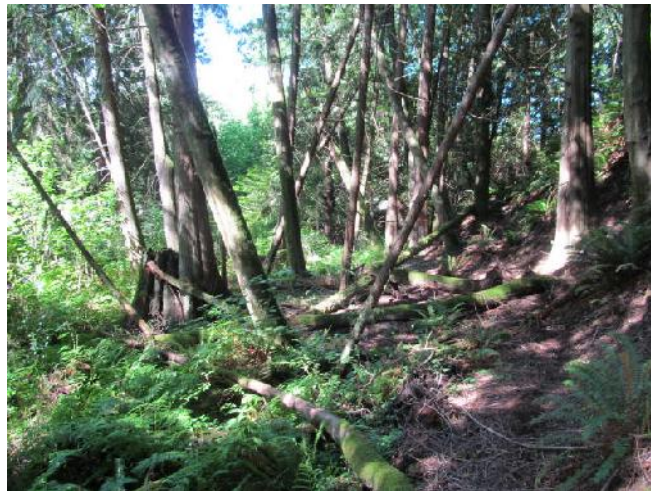
Photo 27 was taken from the same location as Photos 25 and 26 during the 2016 field visit. It looks south along the delineated boundary of Wetland A with wetland to the left and the upland slope to the right.

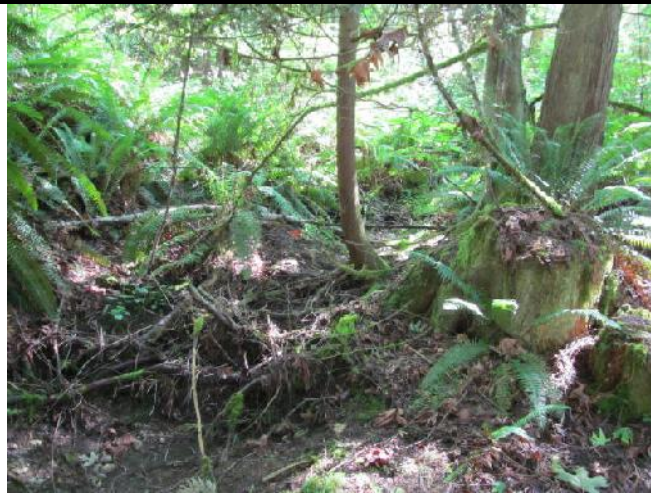
Photo 28 was taken from just outside the northern tip of Wetland B during the June 2016 field visit to verify the wetland delineation. It looks upstream and north of the wetland into the drainage that enters the wetland.

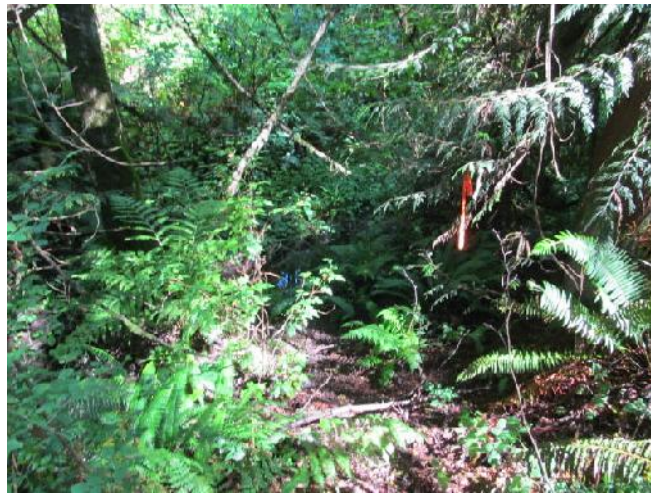
Photo 29 was taken from about midway along the eastern boundary of Wetland B and looks upstream along the edge. The flag in the right half is one of the flags that remain in good condition from the earlier delineations.

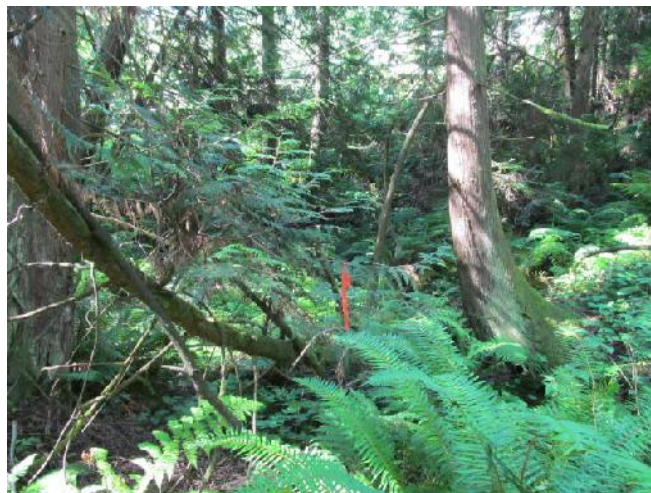
Photo 30 was taken from the same location as Photo 29 and it looks southeasterly toward the downstream portion of Wetland B. The flag in the center remains from the previous delineation.

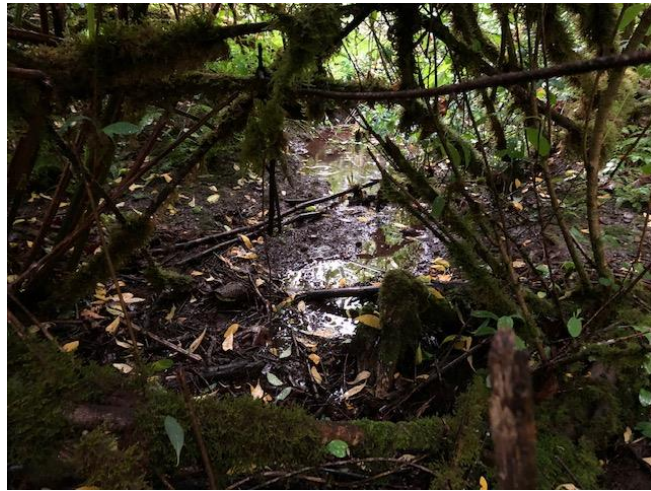
Photo 31 was taken during the mapping of the stream on June 9, 2020. This photo shows a section of the Type Ns 1 stream in the northern half.

The western stream is located along the west edge of the Oslo Bay Apartments project and extends north to the Kitsap Transit Center. Originally the stream was mapped only where it was observed within Wetland B and a short distance north, which was identified as a Type F2 water. After a site review and determination by Nam Siu of Washington Department of Fish and Wildlife (WDFW), the stream was extended north as shown on the City of Poulsbo maps (Appendix C). The stream was further determined to have different types based on the conditions observed during the site review. The Type F2 stream was extended further north, and it now ends on the Red Dragon property that separates the western sections of this project (Figure 2). The remainder of the western stream was determined to be a Type Ns because much of the channel is wide and swale like in some sections with shallow surface water (Photoplate 11). It connects with a Type F water downstream so is considered a Type Ns 1 (Photoplates 11 and 12).

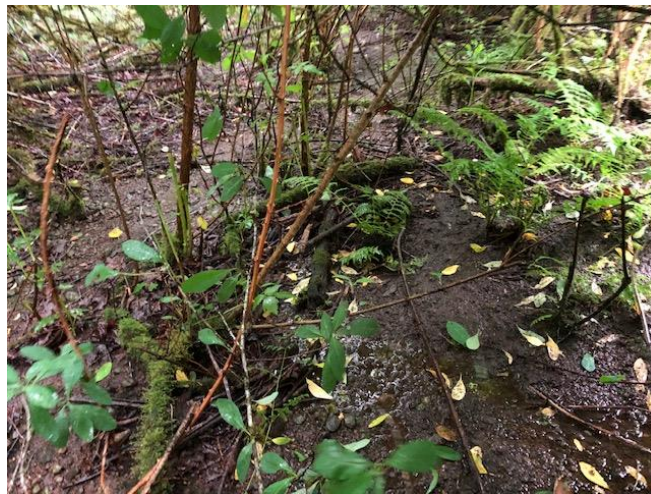
Photo 32 shows another section of the Type Ns 1 stream. This section is relatively flat and with only scattered areas of surface water.

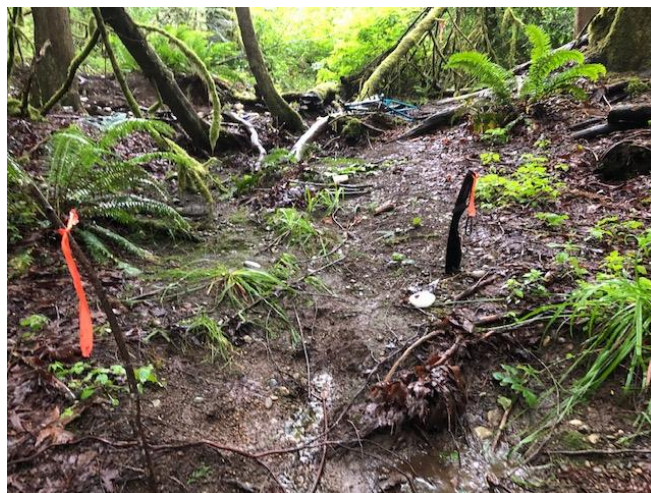
Photo 33 was taken near the transition from the Type Ns 1 section to Type F2 section. This photo looks north at the southern end of the Type Ns 1 section.

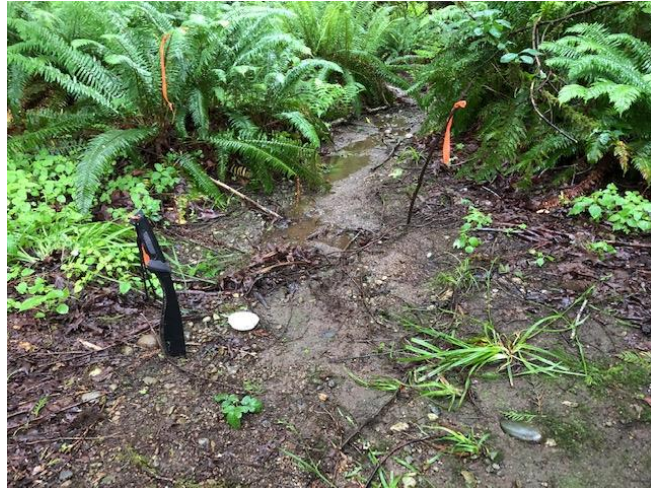
Photo 34 was taken from the same location as Photo 33 and looks southerly at the start of the Type F2 section of the western stream. The transition was roughly near the middle of the stream run and the designation was made where the stream is more channelized and contained water in June 2020.

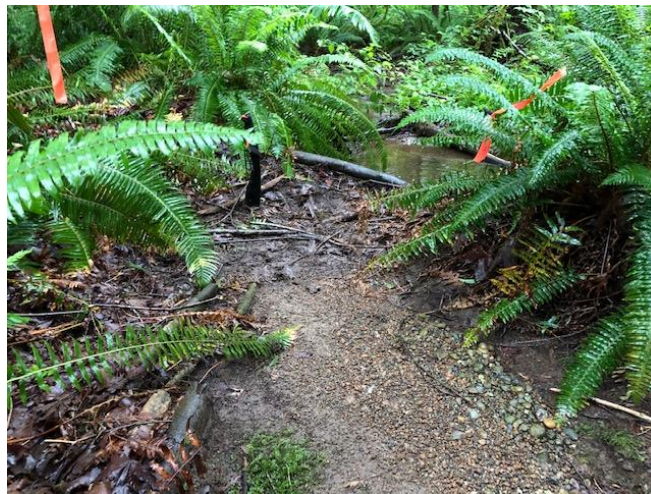
Photo 35 shows another section of the Type F2 stream. The flags represent the OHWM on each side with most water flowing on the right side. The pool in the right background occurs just downstream of the start of the Type F2 stream segment.

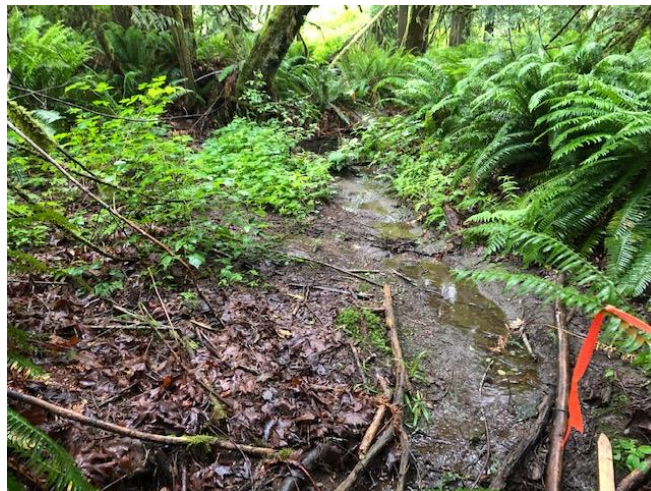
Photo 36 shows another section of the Type F2 stream. The channel width in this location is formed mostly by the topography on the upland slopes.

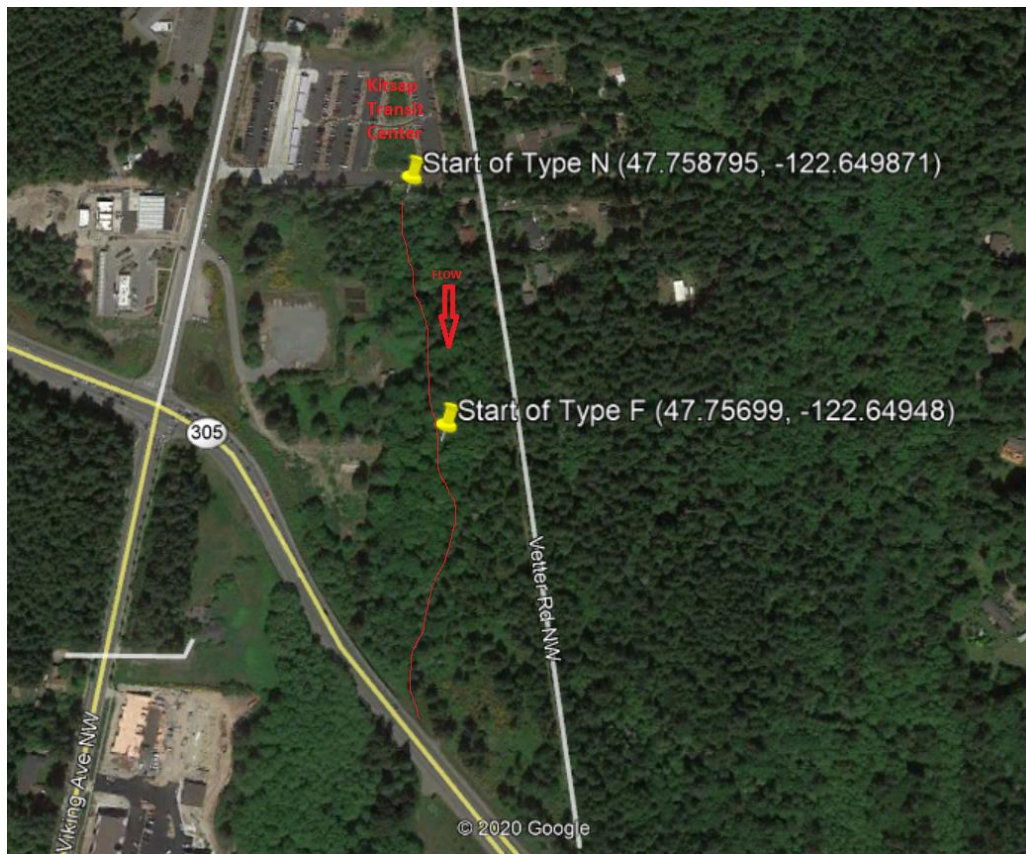
On June 3rd, 2020 I met with Marla Powers and Michael Bateman of City of Poulsbo, Alison O'Sullivan with the Suquamish Tribe; as well as consultants Joanne Bartlett, Robbyn Myers, Berni Kenworthy, and Chad Wallin on site to determine the stream type of the unnamed tributary to Dogfish Creek on the subject parcels. During this site review we identified the initiation of stream to be approximately 15 ft south/downstream of a stormwater outfall and rock rip rap scour pad coming from the Kitsap Transit Center to the north. At this location (47.758795, -122.649871), the Type N stream begins and continues to run south through the subject parcels to the location of the type break (47.75699, -122.64948) where the stream begins to exhibit Type F characteristics. Please see figure below.

This stream typing determination was based on observed physical characteristics of the stream such as presence of sorted sediment and scoured banks, as well as determinations made during previous site inspections by WDFW personnel in August 2001 (attached letter by Jeff Davis), May 2011 (attached email by Gina Piazza), and January 2018 (attached WDFW Fish Passage and Diversion Screening Inventory Database Site Description Report for Site 934421).
