Geotechnical Engineering Report

Project Name: Oslo Bay Apartments

Location: Poulsbo, Washington

Project No. ESC19-G047

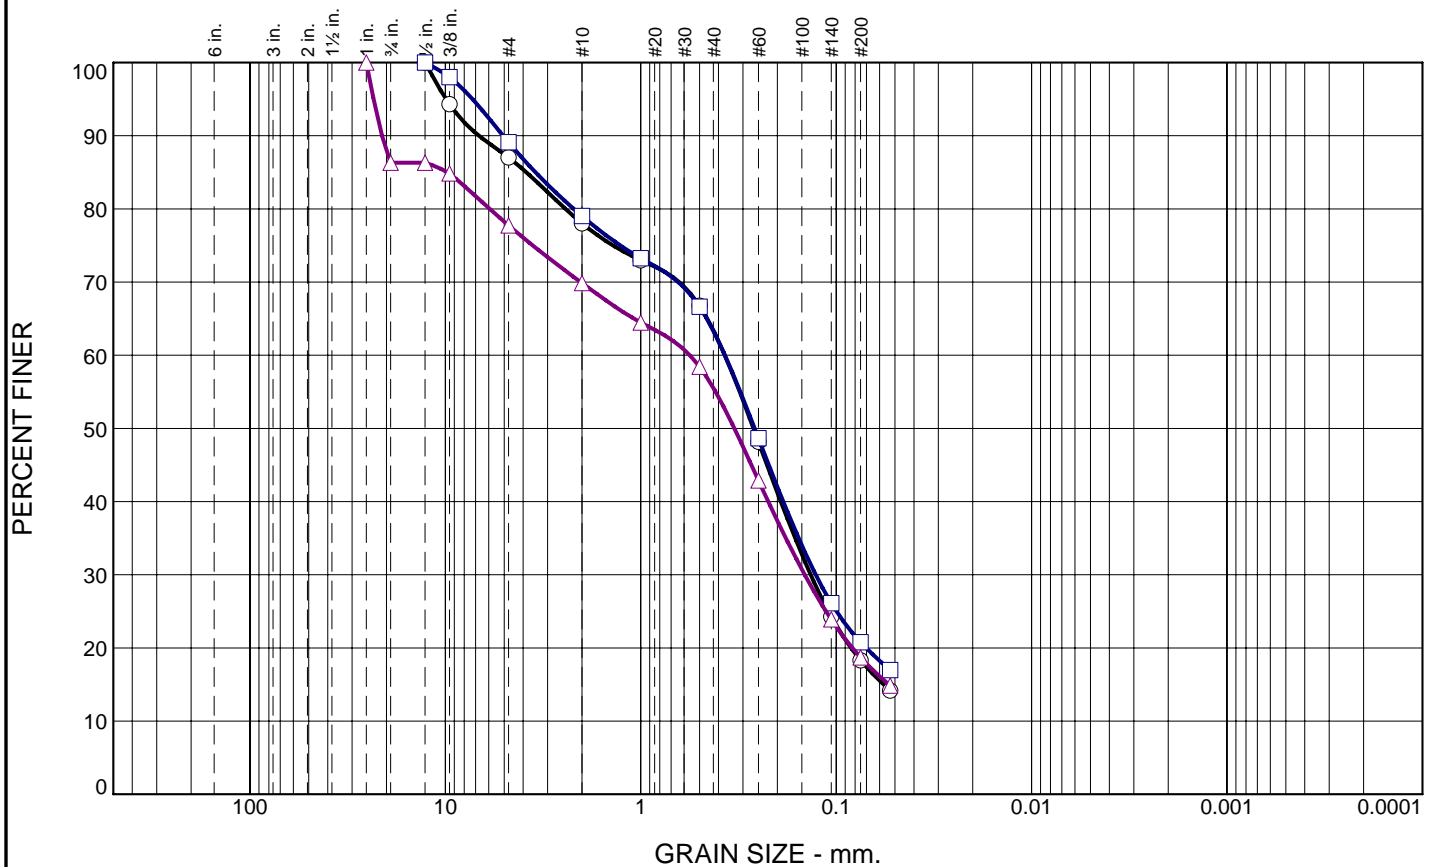
Particle Size Distribution Report

+3"	% GRAVEL	% SAND	% SILT	% CLAY	USCS	AASHTO	PL	LL
○	0.0	22.0	63.8	14.2					
□	0.0	21.0	62.0	17.0					
△	0.0	30.1	55.1	14.8

SIEVE inches size	PERCENT FINER		
	○	□	△
1			100.0
.75			86.3
.5	100.0	100.0	86.3
.375	94.3	98.0	84.8
GRAIN SIZE			
D ₆₀	0.3713	0.3709	0.5606
D ₃₀	0.1351	0.1273	0.1448
D ₁₀			
COEFFICIENTS			
C _c			
C _u

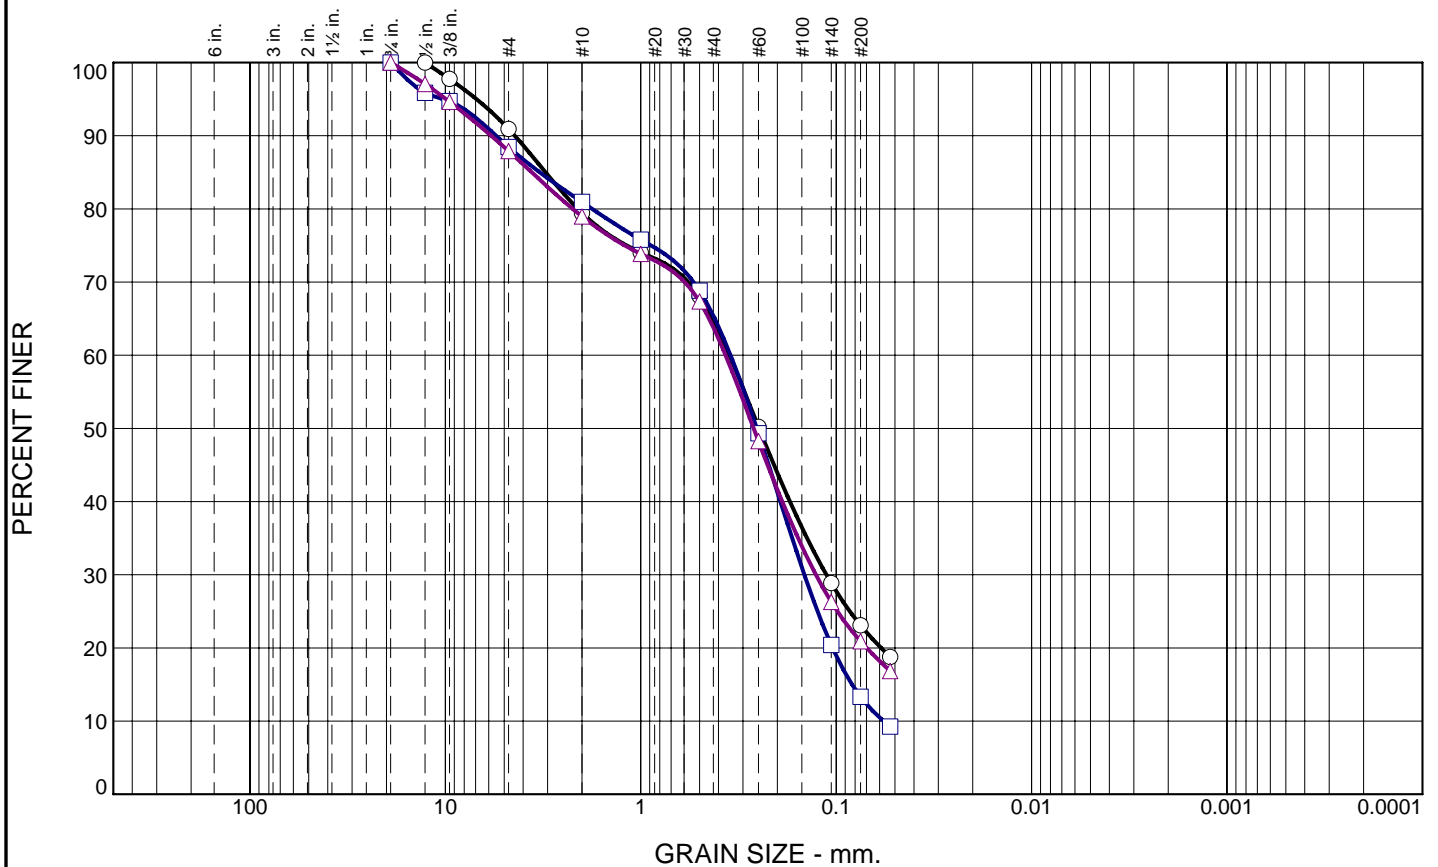
Particle Size Distribution Report

+3"	% GRAVEL	% SAND	% SILT	% CLAY	USCS	AASHTO	PL	LL
○	0.0	20.6	60.6	18.8					
□	0.0	19.1	71.7	9.2					
△	0.0	21.0	62.1	16.9

SIEVE inches size	PERCENT FINER		
	○	□	△
.75	100.0	100.0	100.0
.5	100.0	95.9	97.1
.375	97.8	94.7	94.6
GRAIN SIZE			
D ₆₀	0.3515	0.3471	0.3679
D ₃₀	0.1123	0.1455	0.1271
D ₁₀		0.0571	
COEFFICIENTS			
C _c		1.07	
C _u		6.08

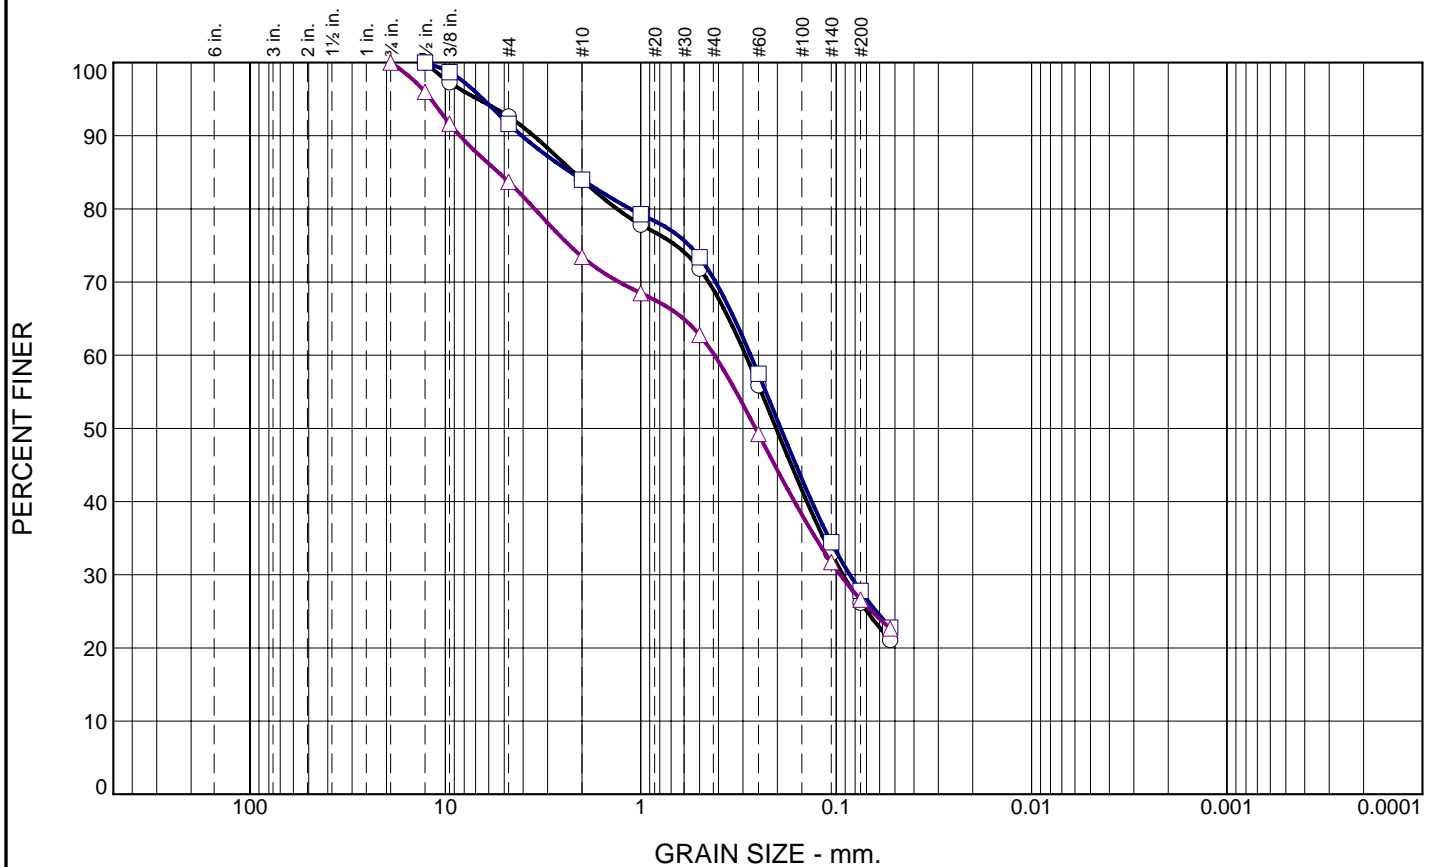
Particle Size Distribution Report

+3"	% GRAVEL	% SAND	% SILT	% CLAY	USCS	AASHTO	PL	LL
○	0.0	16.0	62.9	21.1					
□	0.0	16.0	61.2	22.8					
△	0.0	26.5	50.8	22.7

SIEVE inches size	PERCENT FINER		
	○	□	△
.75	100.0	100.0	100.0
.5	100.0	100.0	96.0
.375	97.3	98.7	91.7
GRAIN SIZE			
D ₆₀	0.2905	0.2741	0.4193
D ₃₀	0.0923	0.0852	0.0953
D ₁₀			
COEFFICIENTS			
C _c			
C _u

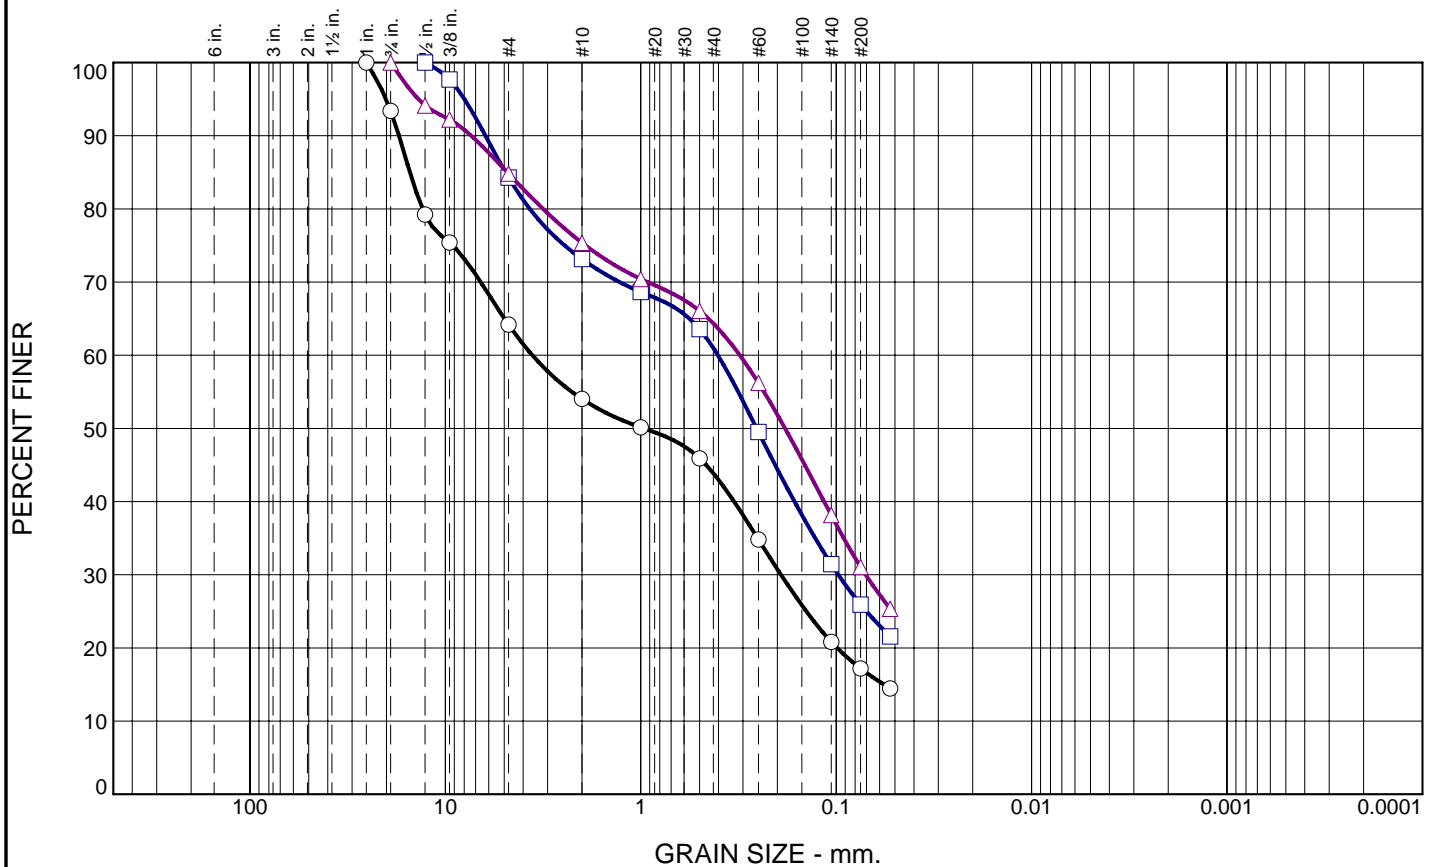
Particle Size Distribution Report

+3"	% GRAVEL	% SAND	% SILT	% CLAY	USCS	AASHTO	PL	LL
○	0.0	46.0	39.5	14.5					
□	0.0	26.9	51.5	21.6					
△	0.0	24.6	50.0	25.4

SIEVE inches size	PERCENT FINER		
	○	□	△
1	100.0		100.0
.75	93.4		100.0
.5	79.2	100.0	94.1
.375	75.4	97.7	92.2
GRAIN SIZE			
D ₆₀	3.5859	0.4028	0.3112
D ₃₀	0.1916	0.0975	0.0707
D ₁₀			
COEFFICIENTS			
C _c			
C _u
