**PHASE I ENVIRONMENTAL
SITE ASSESSMENT
EDWARD ROSE MASTER PLAN
Vetter Road
Poulsbo, Washington**

Project No. ESC10-E012

RE: Phase I Environmental Site Assessment
Edward Rose Master Plan
Vetter Road
Poulsbo, Washington 98370

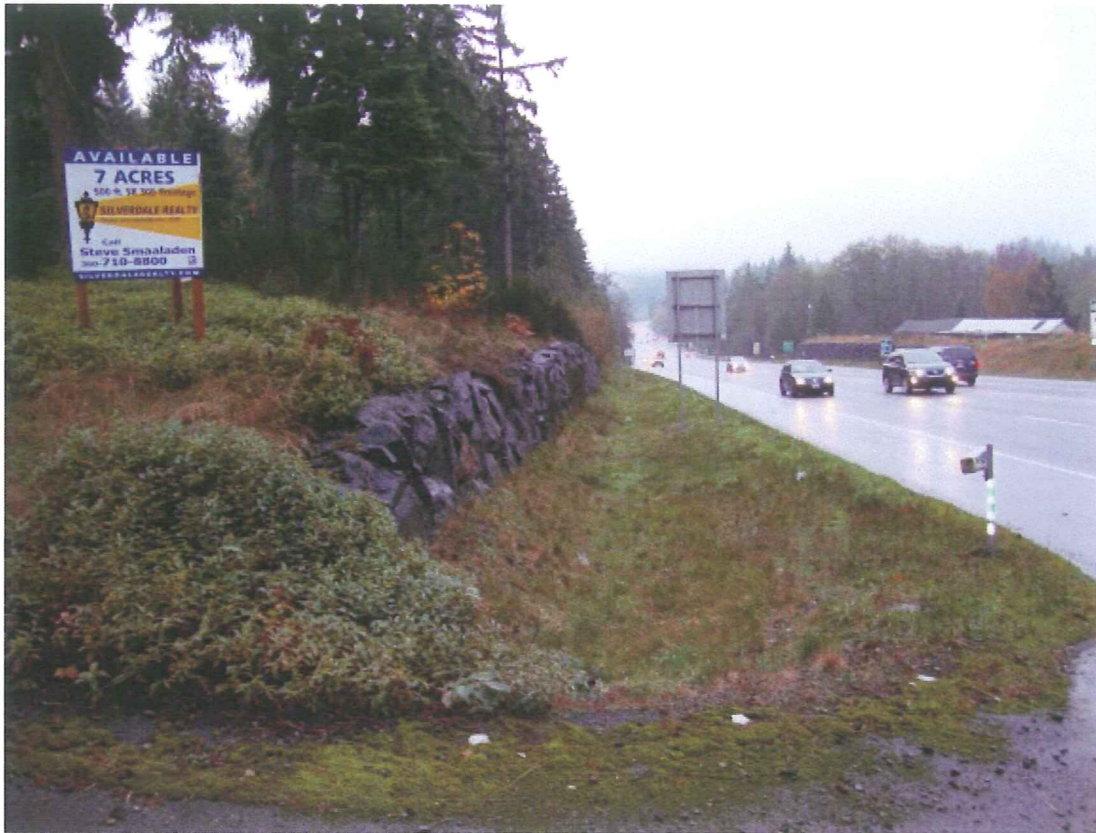
Photo 1. Photo showing access to the Maddocks parcel (looking south).

- The Maddocks parcel has a driveway providing access off of SR 305 (Photo 1). A small shack (well house) and portions of a concrete floor were observed on the parcel (Photo 2). A SFR and detached garage previously on the property were demolished during 2007.

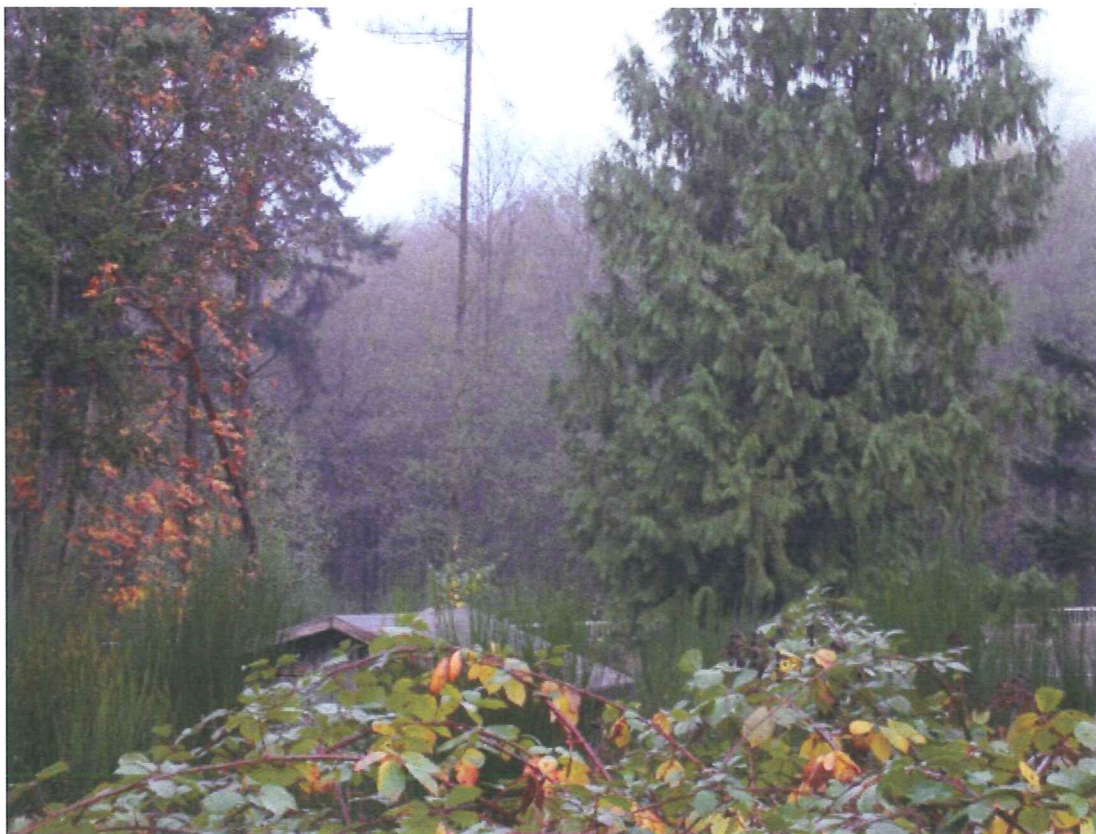
Photo 2. Photo showing well house shed on Maddocks parcel.

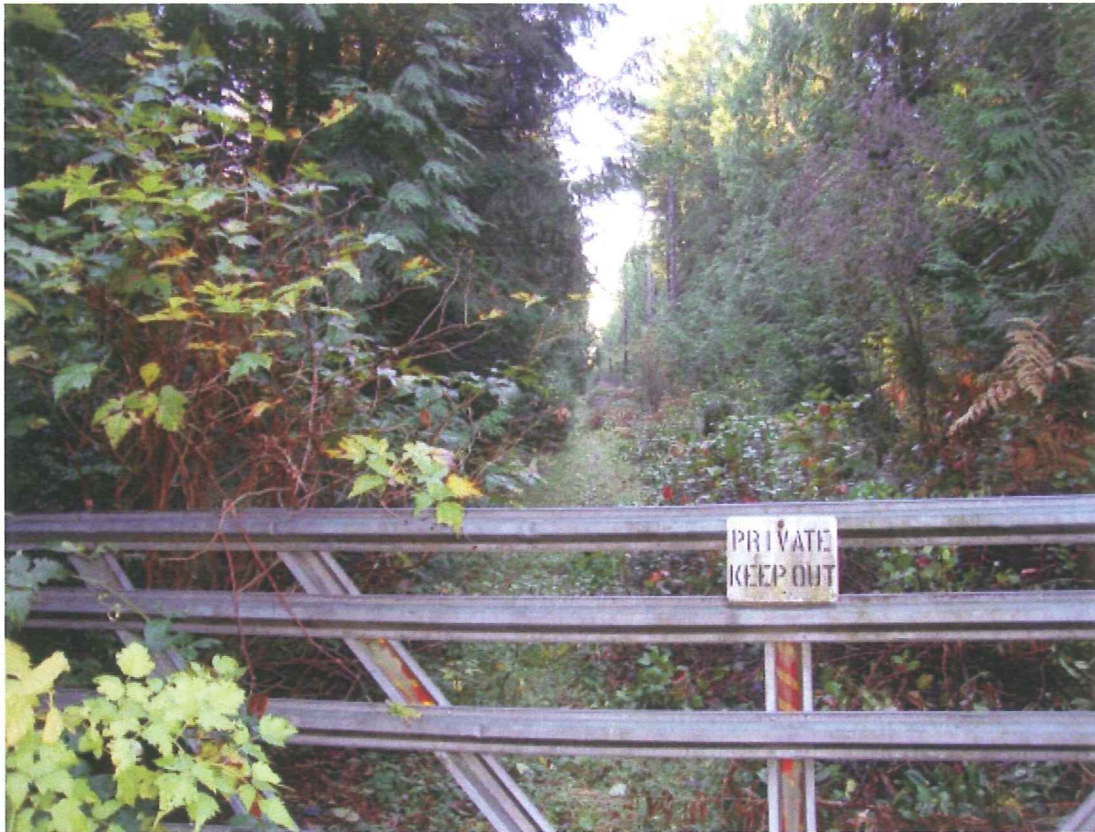
Photo 3. View looking east on access on Vetter Road easement.

- The Kyodai parcels are accessible from the Vetter Road easement (Photo 3). The easement has the remnants of Vetter Road when it was in use (Photo 4). A foot trail meanders on the central portion of the Kyodai parcels (Photo 5) and former logging roads are visible periodically on the parcels. Dogfish Creek flows on the southern portion of the Kyodai parcels.

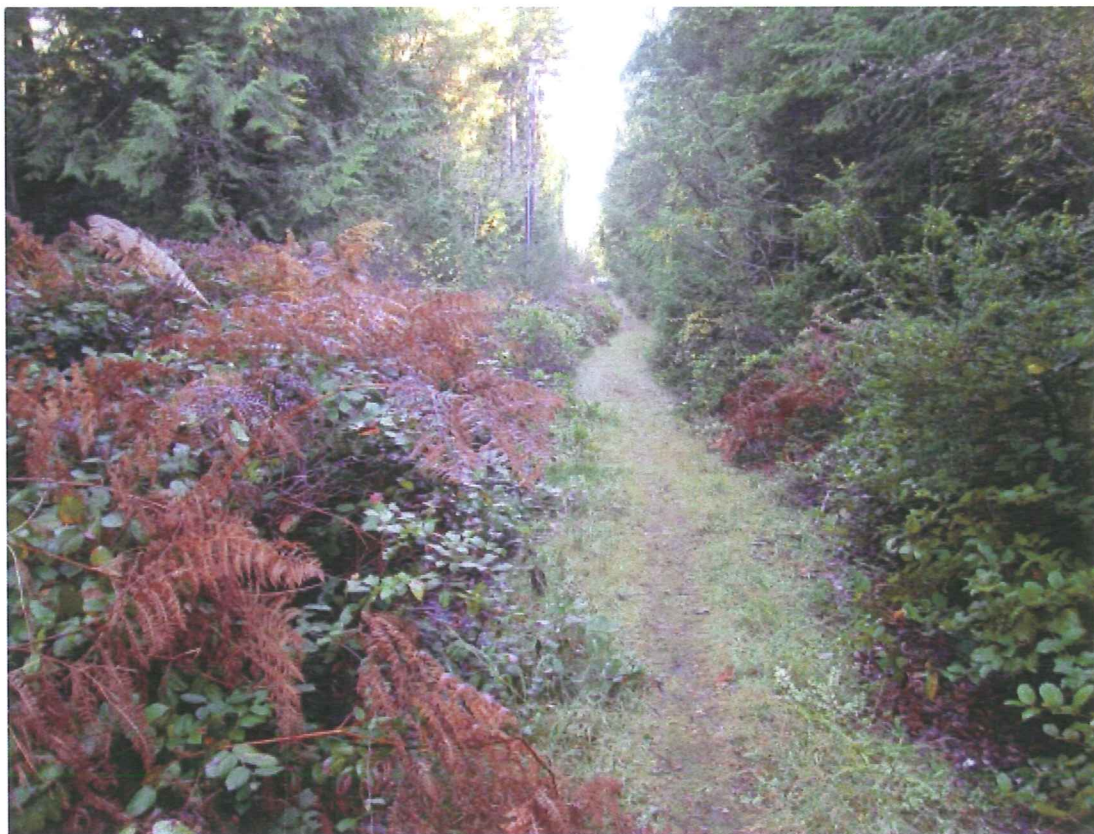
Photo 4. View looking east along Vetter Road easement.

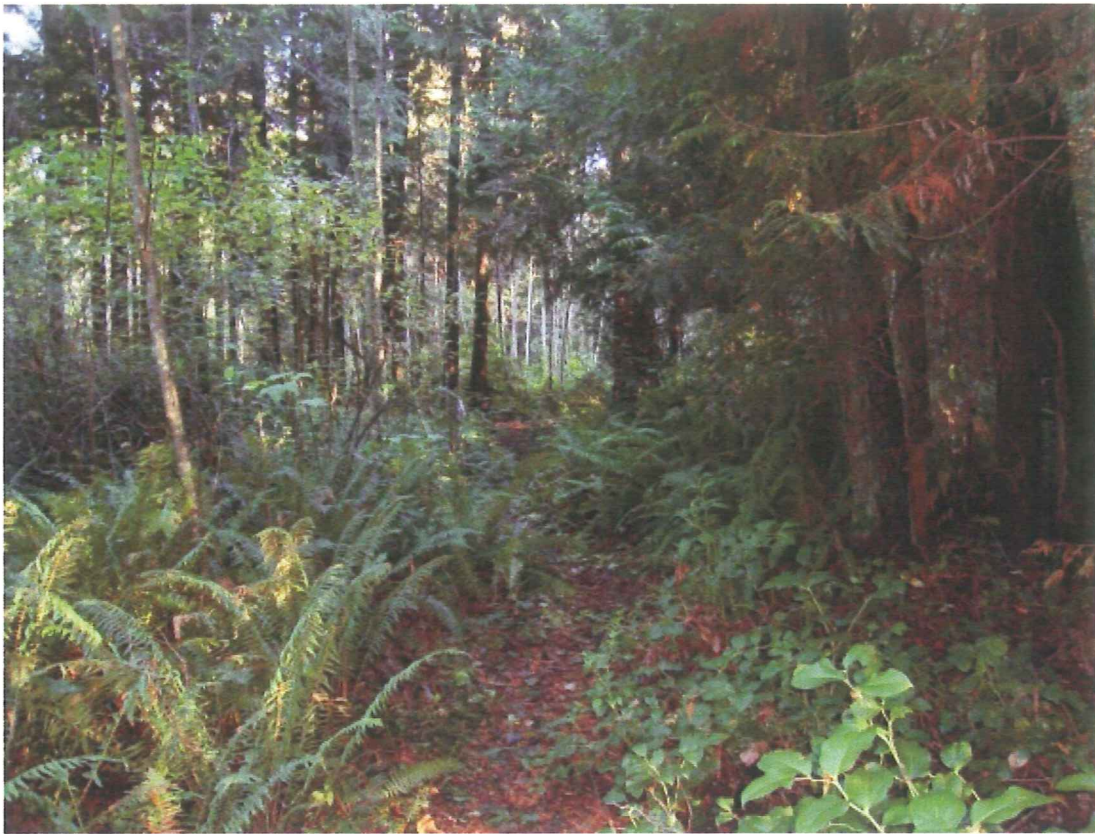
Photo 5. Foot Trail through the Kyodai parcels.

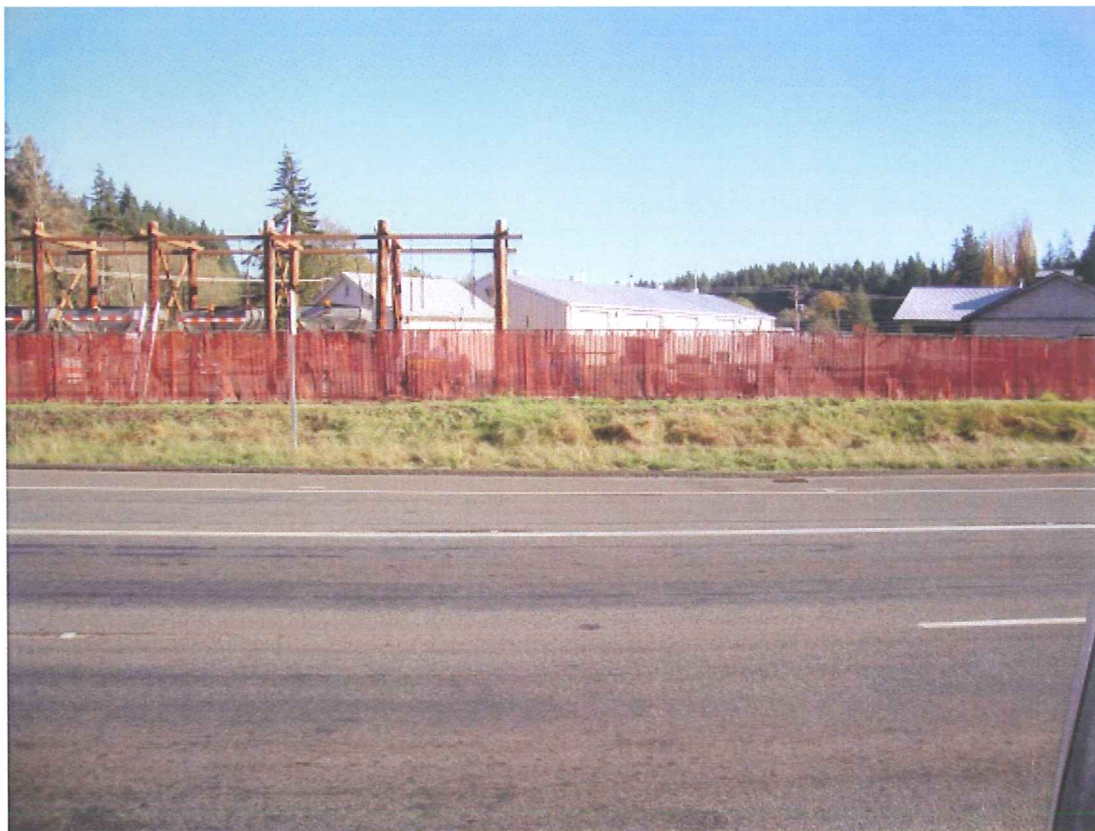
Photo 6. View looking south across Bond Road at the Kitsap County Maintenance Shop.

- A Kitsap County Transportation facility is south of the Kyodai Parcels across SR 307 (Photo 6). The Poulsbo Recycle Center is located to the northwest of the Maddocks parcel (Photo 7).

KITSAP COUNTY NORTH ROAD SHOP (301 Bernt Road) is located approximately 100 feet south of the subject site at a lower elevation. The site has multiple listings as a Leaking Underground Storage Tank (LUST) site, UST site, and a RCRA non generator site. The site had several USTs removed or closed in place with soil and groundwater impacted from releases. The site does not pose a significant threat to the subject property as it is at a lower elevation and it is currently undergoing voluntary cleanup.

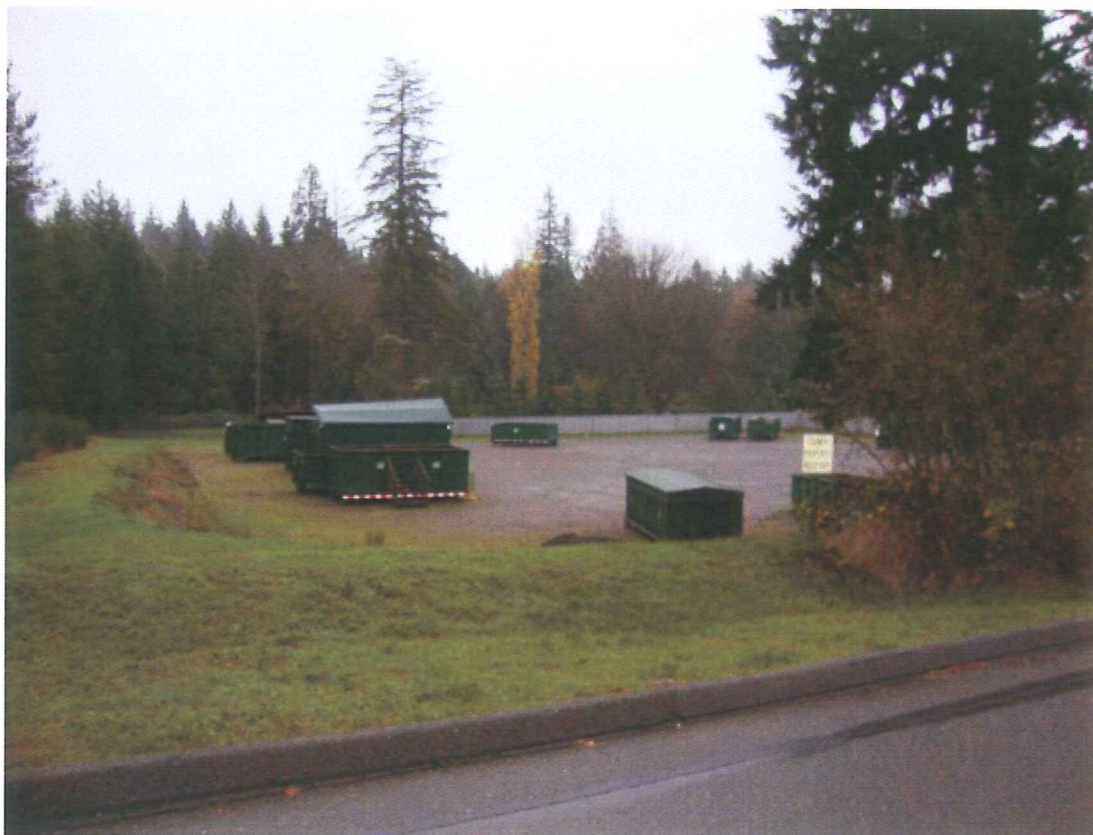
Photo 7. View looking south at the Poulsbo Recycle Center.

POULSBO RECYCLING CENTER (21868 Viking Way NW) is located approximately 100 feet from the Maddocks parcel at a lower elevation but up gradient. The site is listed as SWF/LF. The site does not pose a significant threat to the subject property as it has no recorded releases and is used for temporary storage.

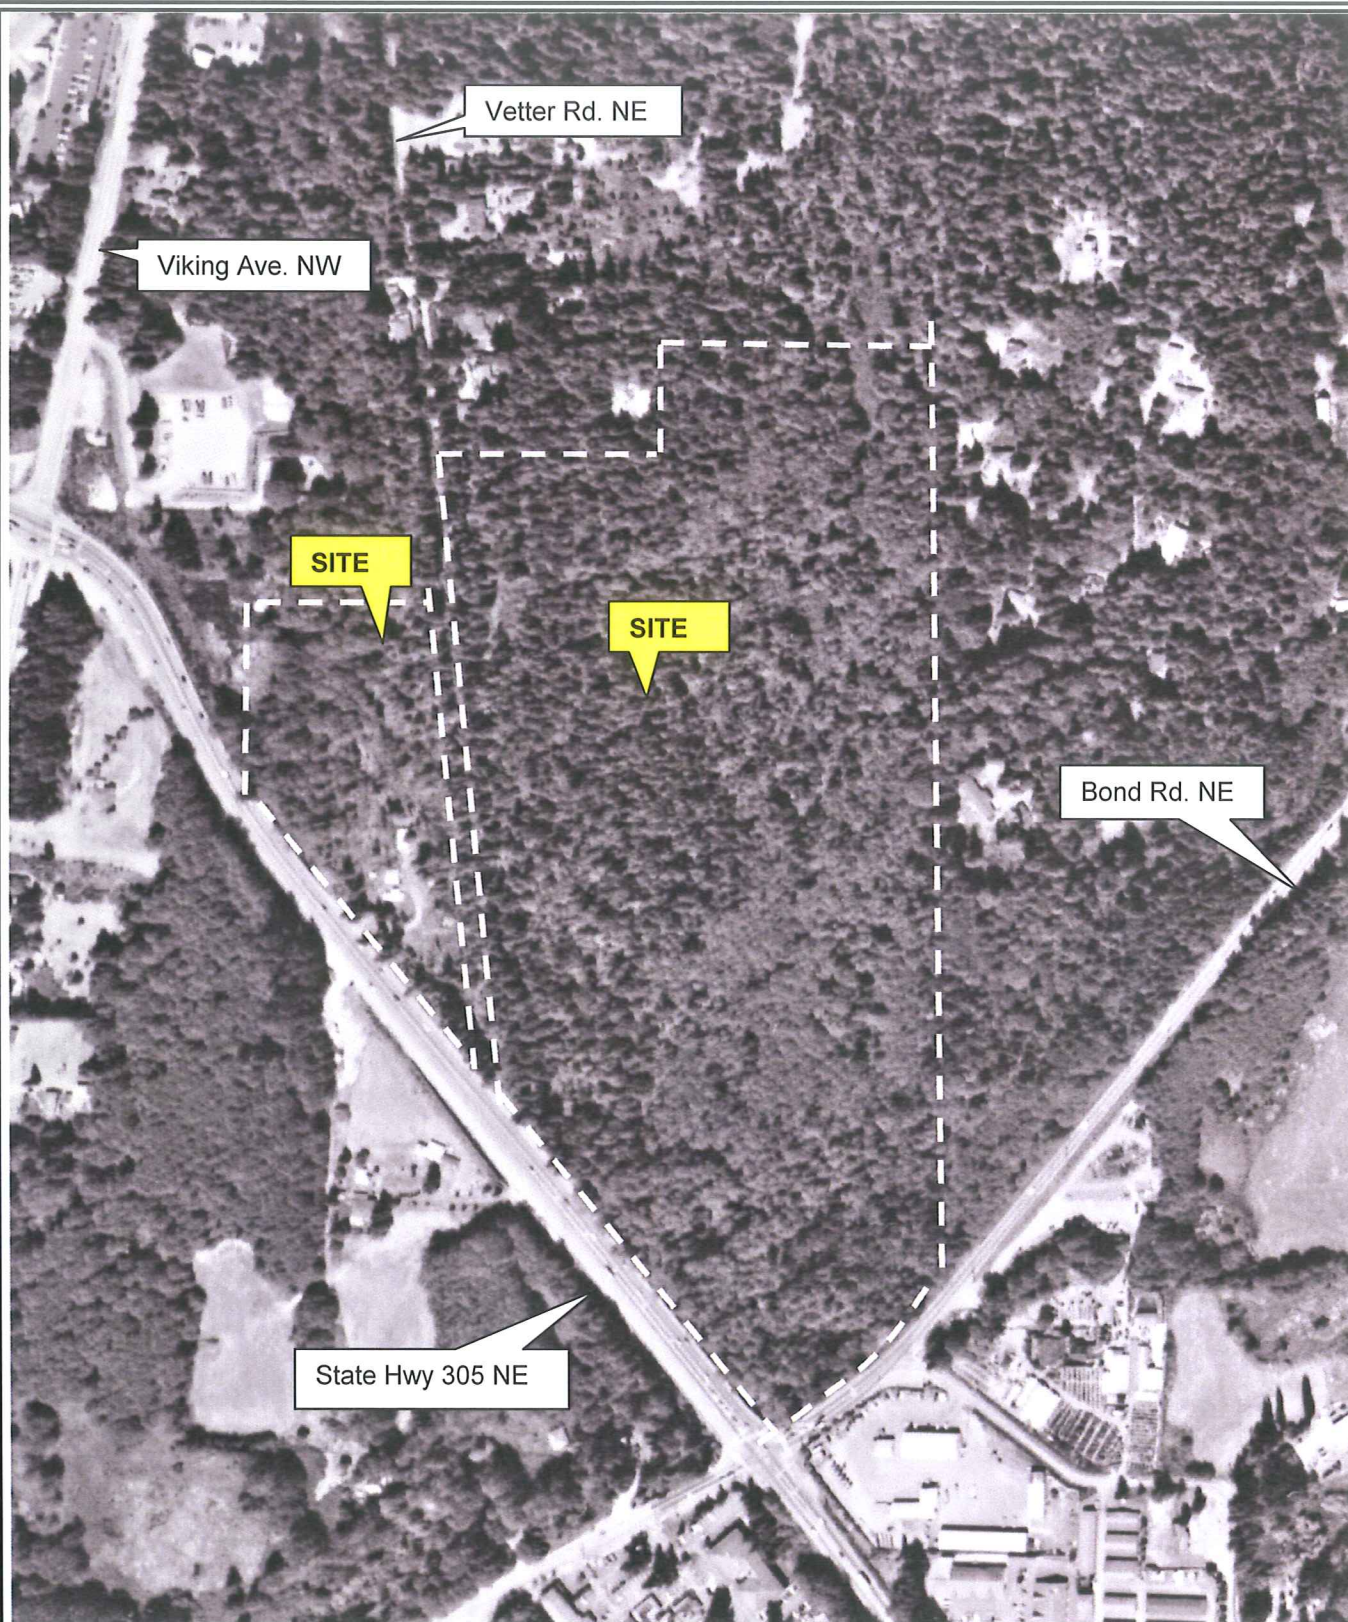
FIGURE 5 2003 Air Photo

Map adapted from Aero-Metric Aerial Photograph (2003).

1985 1"=3,000'	Same as 1977.	The southern portion of the Kyodai parcels have been logged.
1989 1"=2,000'	Same as 1985.	Site and vicinity are similar to 1985.
1997 1"=2,000'	Same as 1989.	Site and vicinity are similar to 1989 except that there are more scattered SFRs to the north of the Kyodai parcels.
2003 1" = 1,680'	Same as 1997.	Poulsbo Recycle Center is in place to the northwest of Maddocks parcel. A SFR is still in place adjacent to the center.
2007	Undeveloped.	The site and vicinity are similar to 2003, except that the SFR on the Maddocks parcel has been demolished, some secondary buildings remain.
