NON-WETLAND DETERMINEATION

July 16, 2020 (revised November 4, 2020)

KCPW Recycling Center
Poulsbo, WA

Prepared by
Ecological Land Services
1157 3rd Avenue, Suite 220A • Longview, WA 98632
(360) 578-1371 • Project Number 2407.02

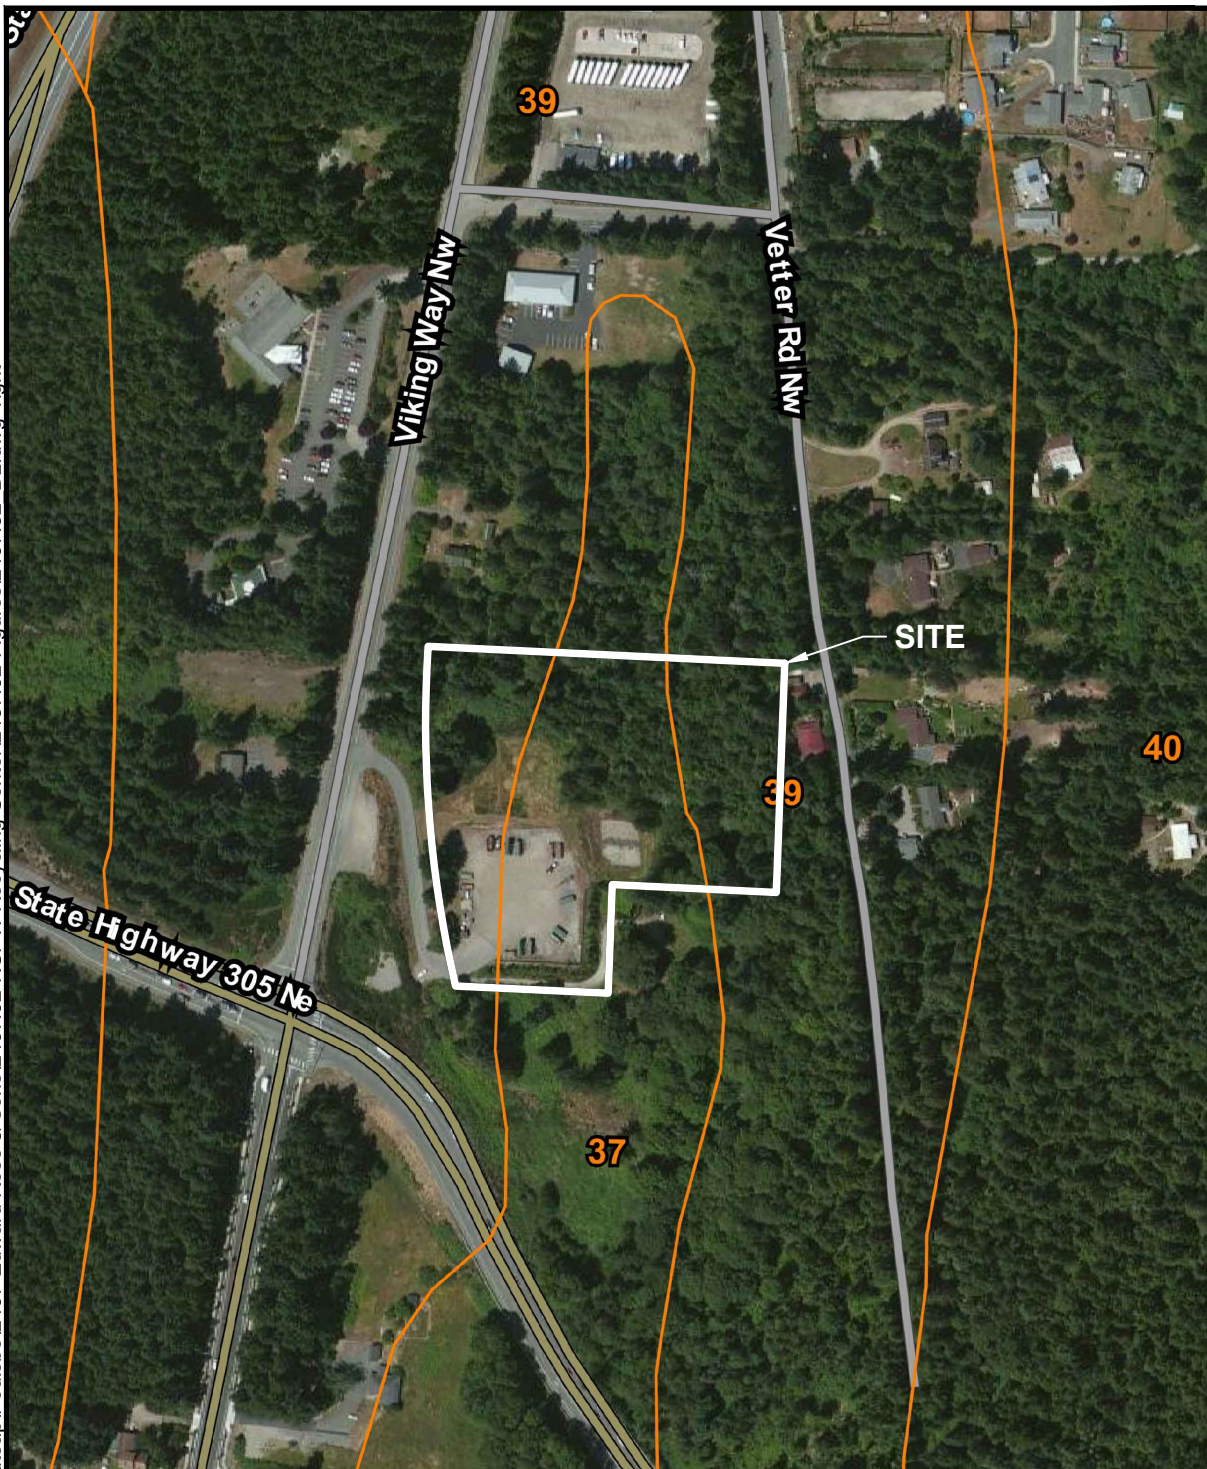
Figure 3
 SOIL SURVEY MAP
 KCPW Recycling Center
 Edward Rose & Sons
 City of Poulsbo, Kitsap County, WA
 Section 10, Township 26N, Range 1E, W.M.

- 37** Norma fine sandy loam. Hydric.
39 Poulsbo gravelly sandy loam, 0 to 6 percent slopes. Not hydric.

As referenced on the U.S.D.A. Natural Resources Conservation Service (NRCS 2015) website, Poulsbo sandy gravelly loam, 0 to 6 percent slopes (39) and Norma fine sandy loam (37) are mapped from west to east across the property (Figure 3). Norma soils are considered hydric and Poulsbo soil types are not classified as hydric (NRCS 2015). Areas mapped as hydric soils do not necessarily mean that an area is or is not a wetland—hydrology, hydrophytic vegetation, and hydric soils must all be present to classify an area as a wetland. In the case of this property, the areas mapped as hydric soil do not exhibit positive indicators for any of the three wetland parameters.

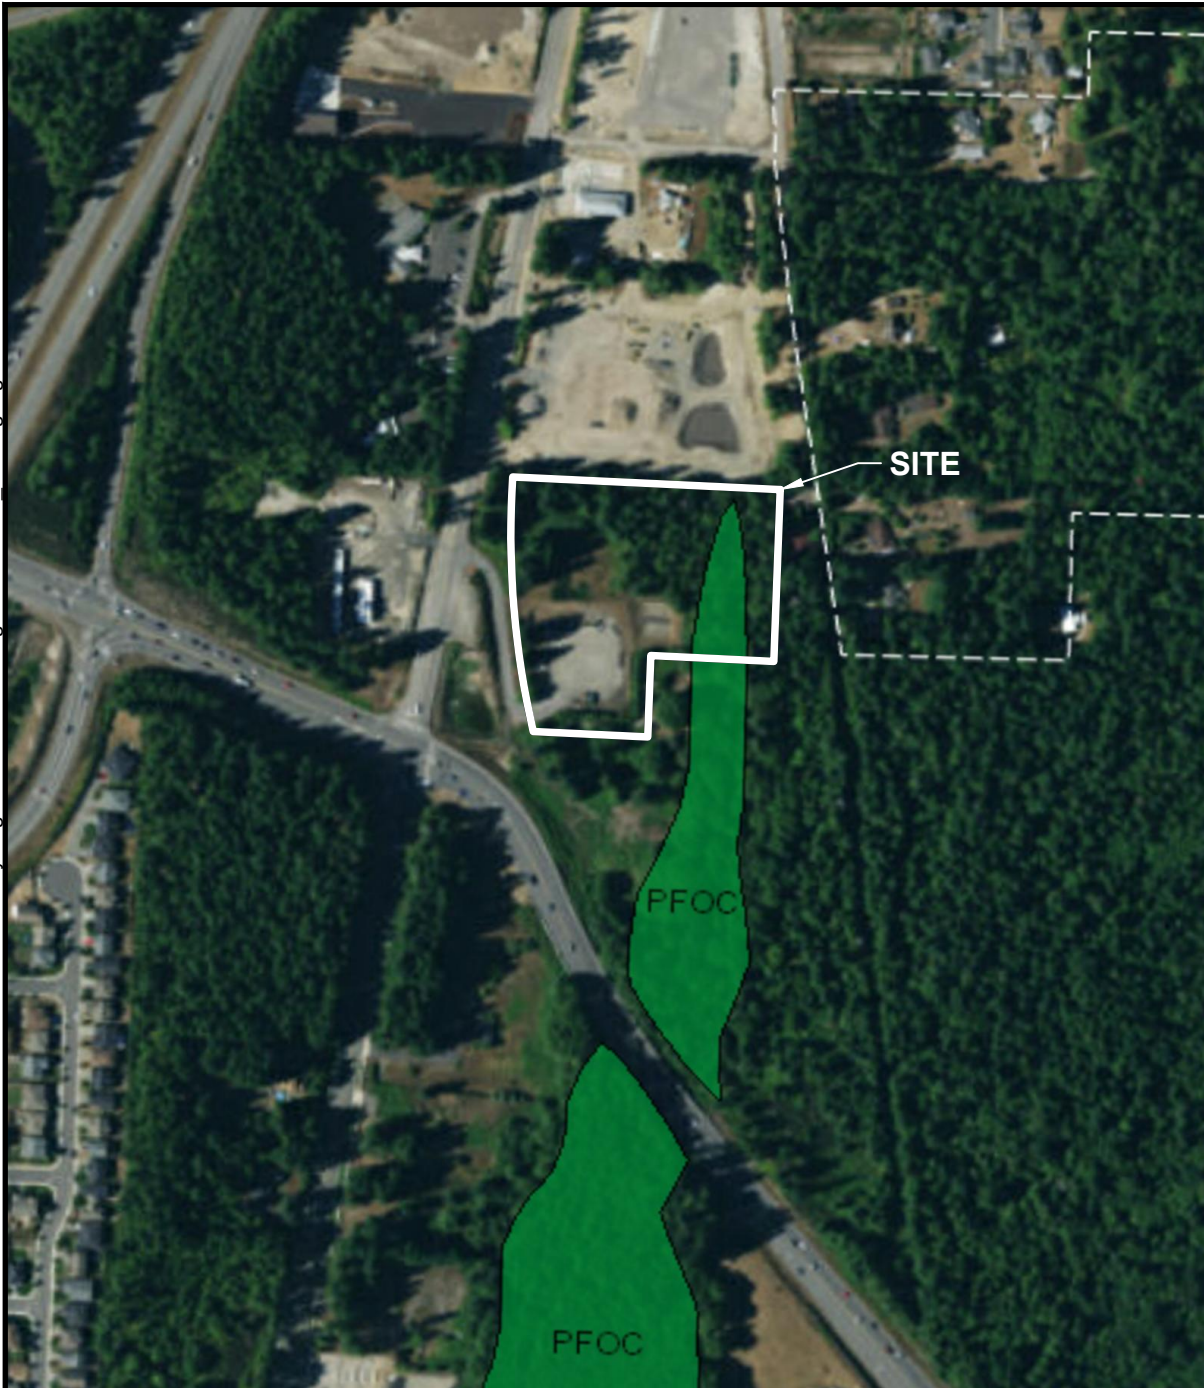
Figure 4

PFOC Palustrine, forested, seasonally flooded.

National Wetlands Inventory (NWI) maps a palustrine, forested, seasonally flooded wetland along the east side of the property (Figure 4). ELS biologists disagree with the mapping because there was no evidence of wetlands on or adjacent to this property based on data collected in the field and general site observations.

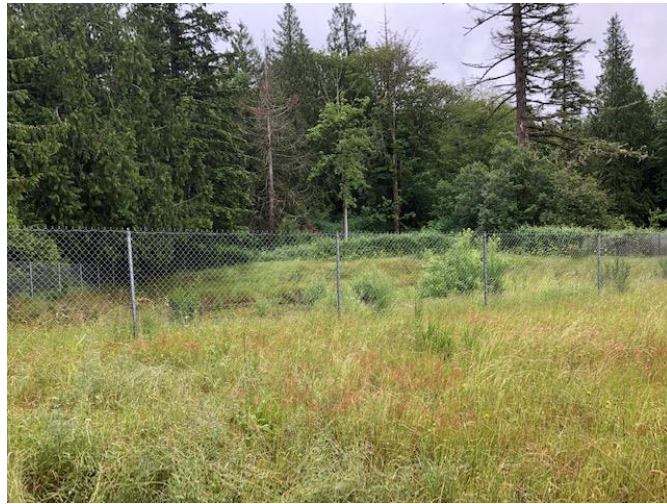
Photo 1 was taken looking east from the gravel pad of the former recycling center. It shows the stormwater ponds that interrupts the function of the western stream buffer.

The old recycling center property, which is composed of a large gravel area and a stormwater pond, is situated just west of the stream. The east edge of the stormwater pond lies within the 75-foot stream buffer. The recycling center pond is an existing feature that is regularly maintained and does not function as part of the forested buffer. The fence around the pond further interrupts the buffer function by creating a vertical barrier that prevents human intrusion but also prevents use of the upland and stream by local wildlife species. Therefore, the functional portion of the buffer ends at the chain link fence. Development will be proposed for the recycling center property in the future and it will utilize the existing gravel pad and stormwater pond. Because the pond and fence will remain in place, they function to prevent future detrimental impacts of future development on the former recycling center property. The interrupted buffer is partially vegetated with blackberry thickets (Photoplate 5), which will be removed to install native plants as part of the habitat management plan mitigation.

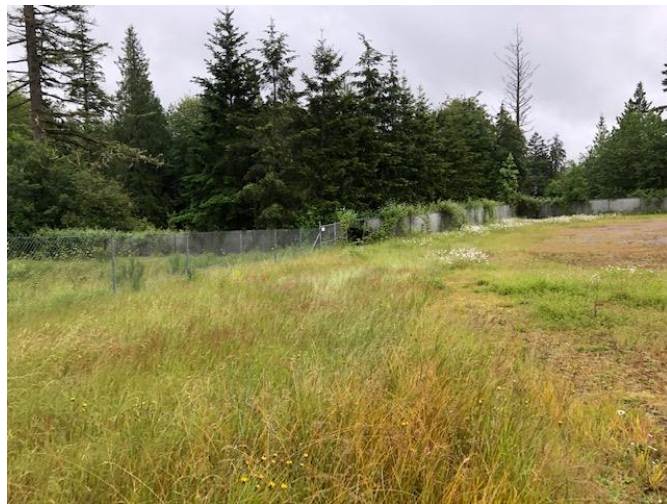
Photo 2 was taken from the same location as Photo 1 and looks southeasterly. The fence continues along the east edge of the gravel pad and around the south end of the property.

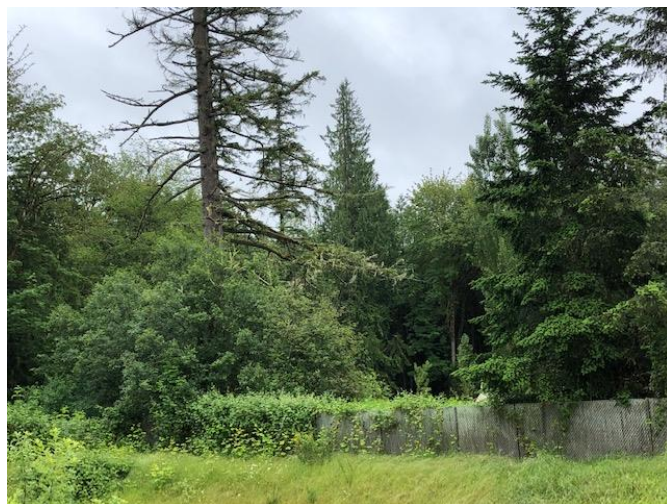
Photo 3 was taken from the south end of the existing stormwater ponds. The 75-foot stream buffer is interrupted by the fence and ponds. The blackberry coverage within the interrupted buffer will be removed and replaced with native plants as part of the mitigation plan.

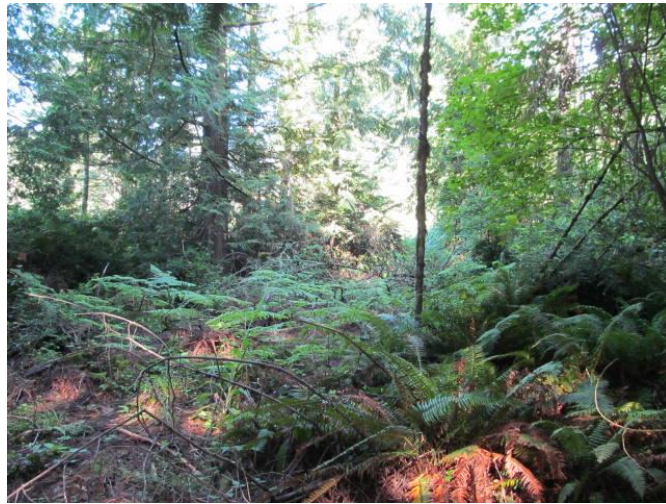
Photo 4 was taken in the upland forest north of the open grassy portion of the property. It looks west towards an example of the vegetation on the north half of the property.

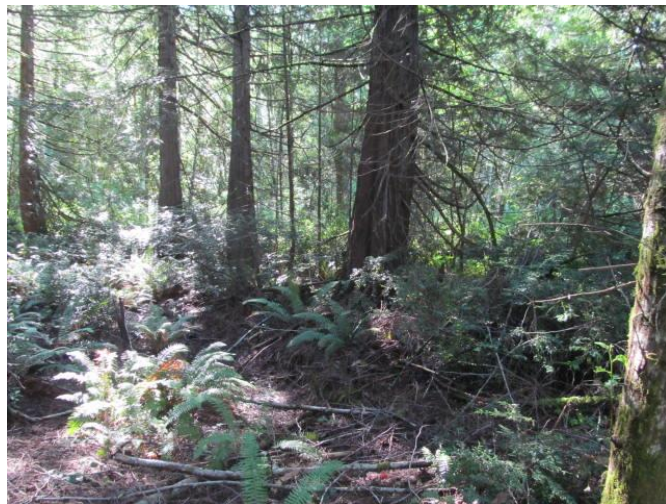
Photo 5 was taken from the same location as Photo 4 facing south. It demonstrates an even aged stand of conifer trees with a relatively bare understory.

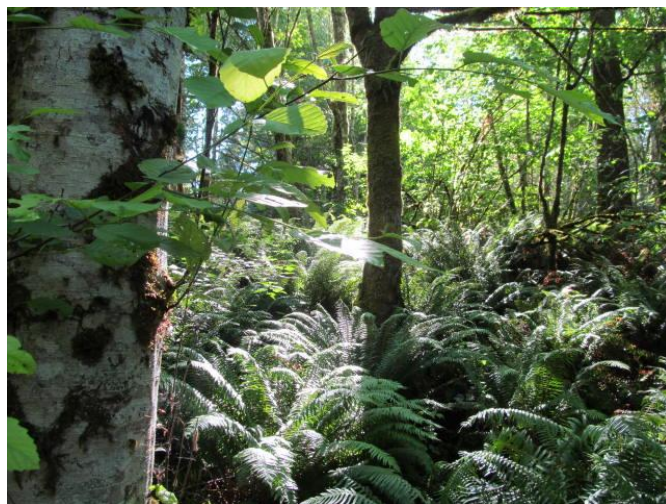
Photo 6 was taken from the same location as Photos 4 and 5. It looks at deciduous stands with upland understory vegetation.

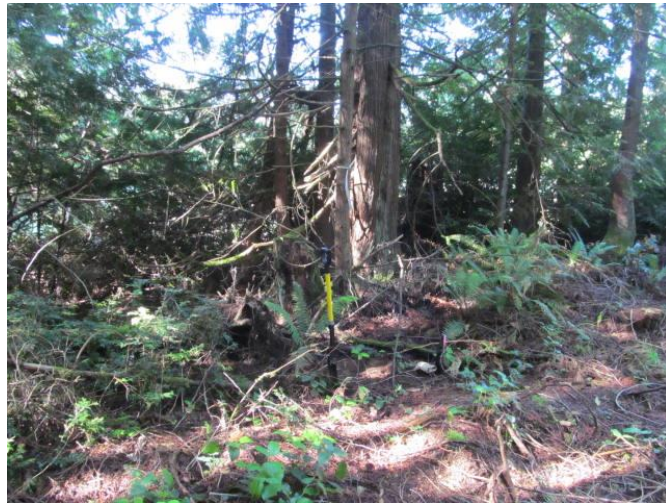
Photo 7 was taken of the area where Test Plot 1 was conducted. It was located about halfway between the open grassy area and the Type N1 stream in the upland forest.

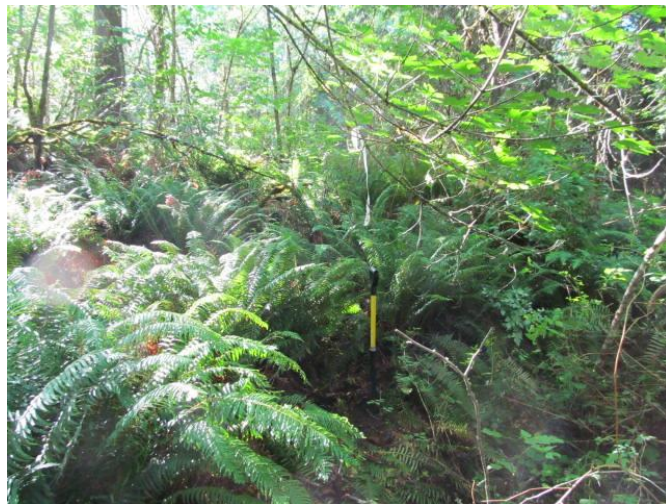
Photo 8 was taken of the area where Test Plot 2 was conducted. It was located on the east side of the Type N1 stream. There was no evidence to indicate wetland indicators in this area.

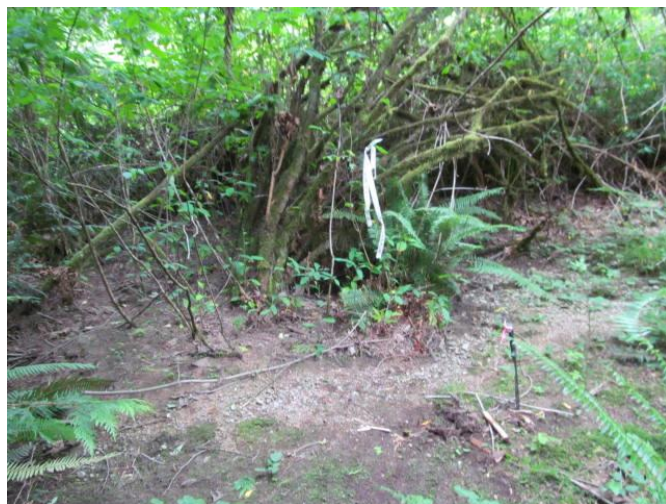
Photo 9 was taken in July 2016 of the area where Test Plot 3 was conducted. This area is a designated stream per WDFW and the Suquamish Tribe as of June 2020. There were no wetlands present in 2016 or 2020.

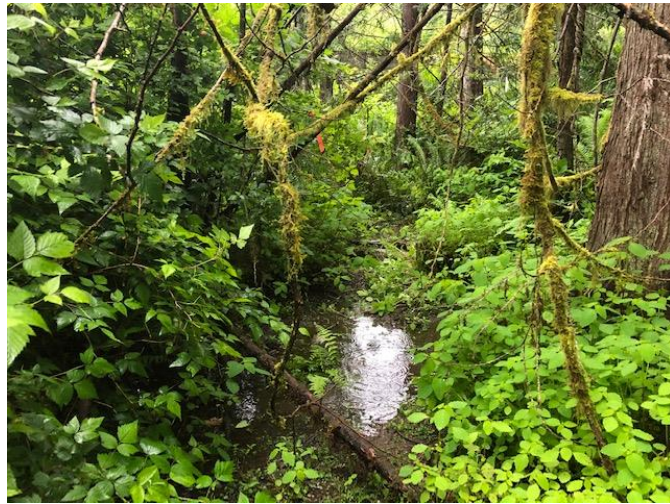
Photo 10 was taken of the northern portion of the Type N1 stream just downstream of the discharge from the transit center pipe. Several trees have died in this location due to the sudden increases in discharge to the stream from offsite stormwater ponds.

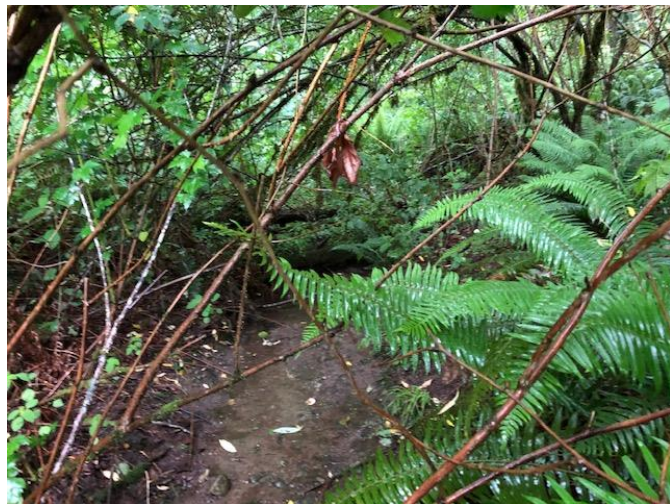
Photo 11 was taken from a point south of Photo 10 and shows another section of the stream where there is a defined channel.

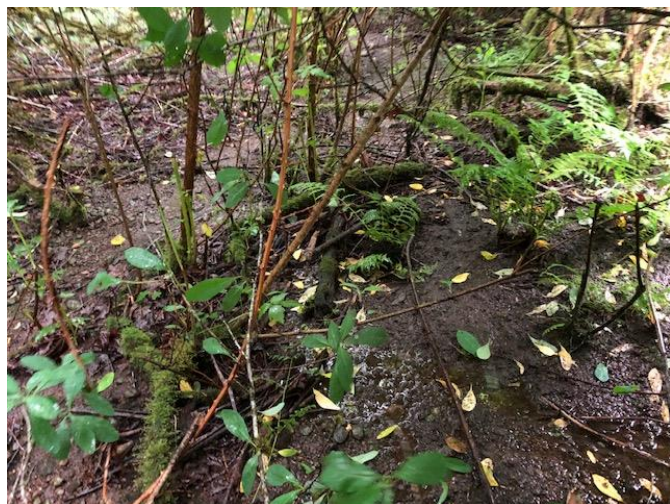
Photo 12 was taken of the stream channel during the June 2020 site visit. This section is one of the wide swale like locations where water seems to sheet flow rather than create a defined channel.

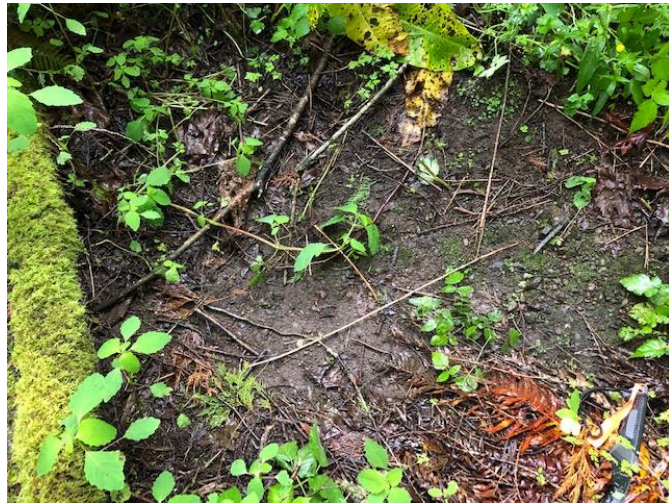
Photo 13 was taken along the south end of the onsite section of the stream channel. This area is slightly channelized and did not contain water during the OHWM delineation visit in June 2020.

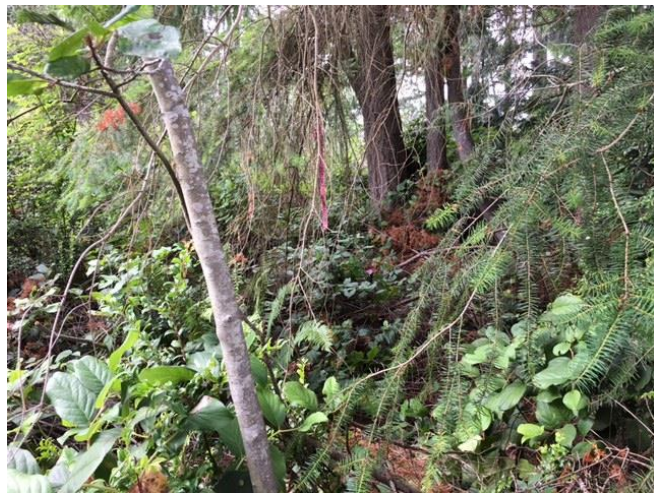
Photo 14 was taken of the area where Test Plot 5 was conducted. It was near the west property line and represented the upland forest west of the grassy, open area.

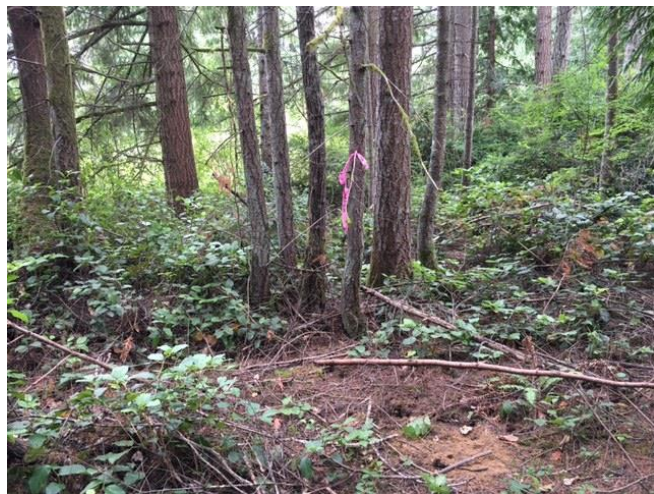
Photo 15 was taken of the area where Test Plot 6 was conducted. It was located east of the open grassy area in the upland forest. This area was located just west of the mapped hydric soil and data revealed there were no positive indicators for any of the three wetland parameters.

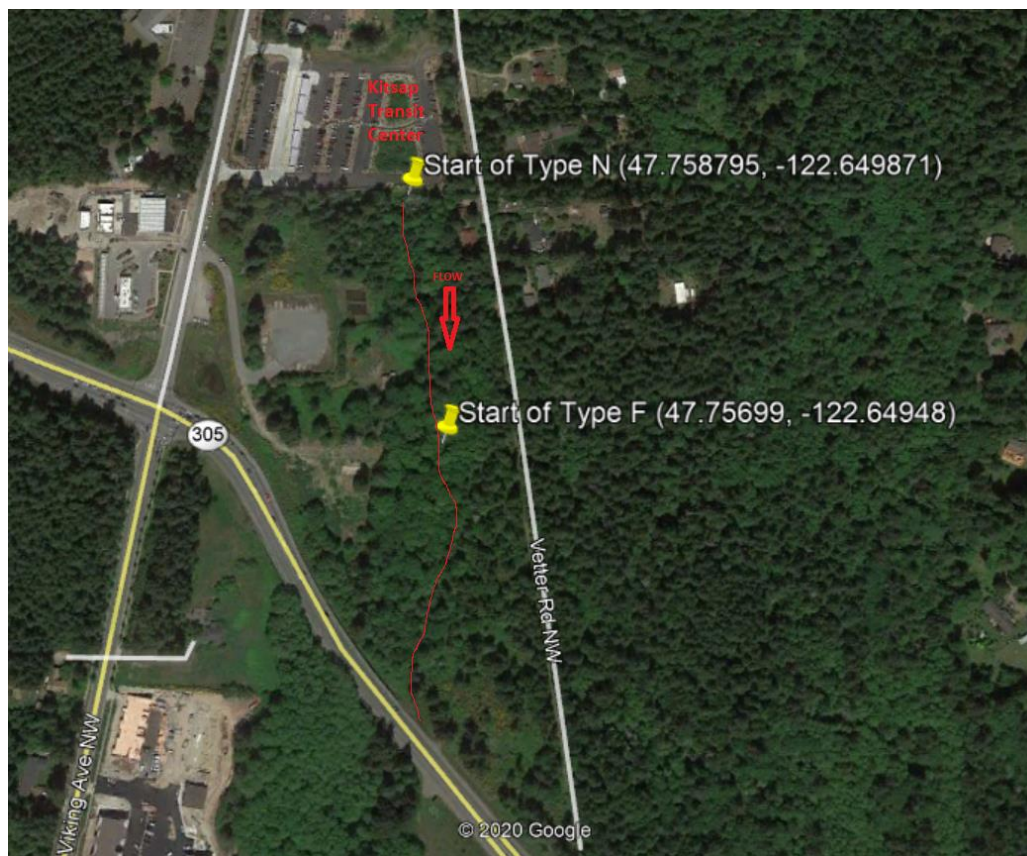
On June 3rd, 2020 I met with Marla Powers and Michael Bateman of City of Poulsbo, Alison O'Sullivan with the Suquamish Tribe; as well as consultants Joanne Bartlett, Robbyn Myers, Berni Kenworthy, and Chad Wallin on site to determine the stream type of the unnamed tributary to Dogfish Creek on the subject parcels. During this site review we identified the initiation of stream to be approximately 15 ft south/downstream of a stormwater outfall and rock rip rap scour pad coming from the Kitsap Transit Center to the north. At this location (47.758795, -122.649871), the Type N stream begins and continues to run south through the subject parcels to the location of the type break (47.75699, -122.64948) where the stream begins to exhibit Type F characteristics. Please see figure below.

This stream typing determination was based on observed physical characteristics of the stream such as presence of sorted sediment and scoured banks, as well as determinations made during previous site inspections by WDFW personnel in August 2001 (attached letter by Jeff Davis), May 2011 (attached email by Gina Piazza), and January 2018 (attached WDFW Fish Passage and Diversion Screening Inventory Database Site Description Report for Site 934421).
