**SUBJECT:** Stream Typing; Oslo Bay Apartments, Kitsap Parcels 102601-4-028-2003, 102601-4-027-2004, 112601-3-044-2004, and 102601-4-022-2009.

# Fish Passage & Diversion Screening Inventory Database Report Cover Sheet

#### **Site Description Report**

### **Level A Culvert Assessment Report**

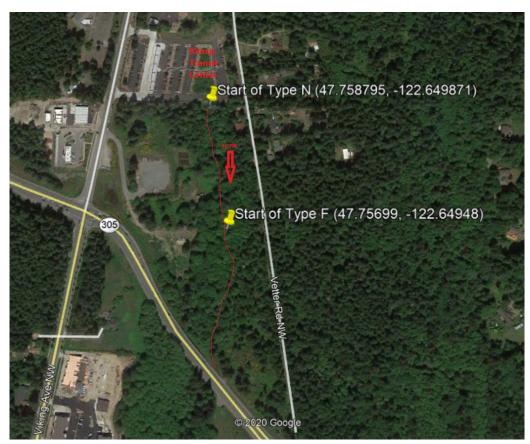
On June 3<sup>rd</sup>, 2020 I met with Marla Powers and Michael Bateman of City of Poulsbo, Alison O'Sullivan with the Suquamish Tribe; as well as consultants Joanne Bartlett, Robbyn Myers, Berni Kenworthy, and Chad Wallin on site to determine the stream type of the unnamed tributary to Dogfish Creek on the subject parcels. During this site review we identified the initiation of stream to be approximately 15 ft south/downstream of a stormwater outfall and rock rip rap scour pad coming from the Kitsap Transit Center to the north. At this location (47.758795, -122.649871), the Type N stream begins and continues to run south through the subject parcels to the location of the type break (47.75699, -122.64948) where the stream begins to exhibit Type F characteristics. Please see figure below.
